KÖZLEKEDÉSBIZTONSÁGI
SZERVEZET
TRANSPORTATION SAFETY
BUREAU

FINAL REPORT

2006- 0027-5 RAILWAY ACCIDENT

Between Rákospalota-Újpest and Fót stations 5 July 2006

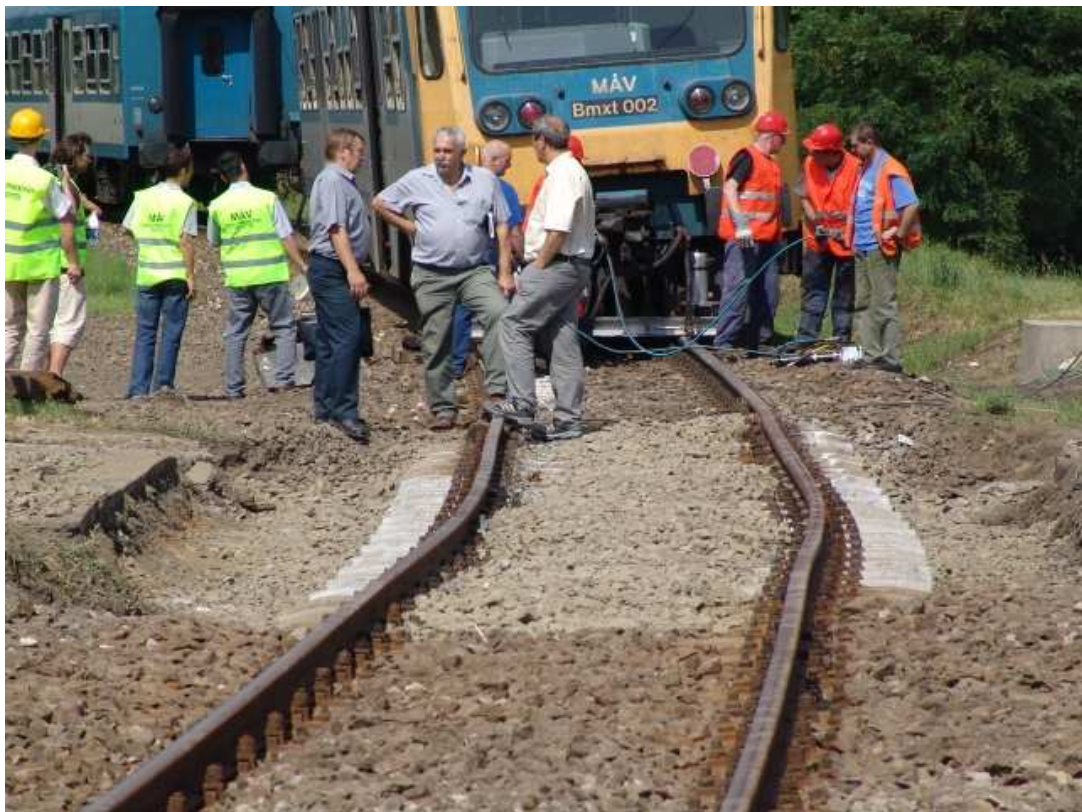
Figure 3: The rail track at the accident site

Having arrived at the accident site, the IC noticed that the new track was substantially deformed, pushed outwards, and the inner rail was lifted. The sleepers in the crossing were found moved sideways, and the cant which was clearly visible at the edge of the crossing became practically nonexistent by the middle.

The occurrence of the accident could directly be related to human factors, namely that the technological regulations were not complied with during the reconstruction of the level crossing. Furthermore, the track section was opened to traffic after the construction work had been stopped temporarily that the stability and transversal rigidity of the track was not ensured.

BA 27.1: In order to maintain transport safety, the IC recommends MÁV Zrt. to take measures during construction work requiring dismantling of track panels without gaps - when weather conditions may affect the work - so that railway traffic shall not be started before ensuring the stability and sufficient transversal and longitudinal resistance of the reconstructed track section and before the bedding has temporarily or permanently been resettled.
