**FINAL REPORT**

**2006- 0048-5**

**RAILWAY ACCIDENT**

**Komárom station**

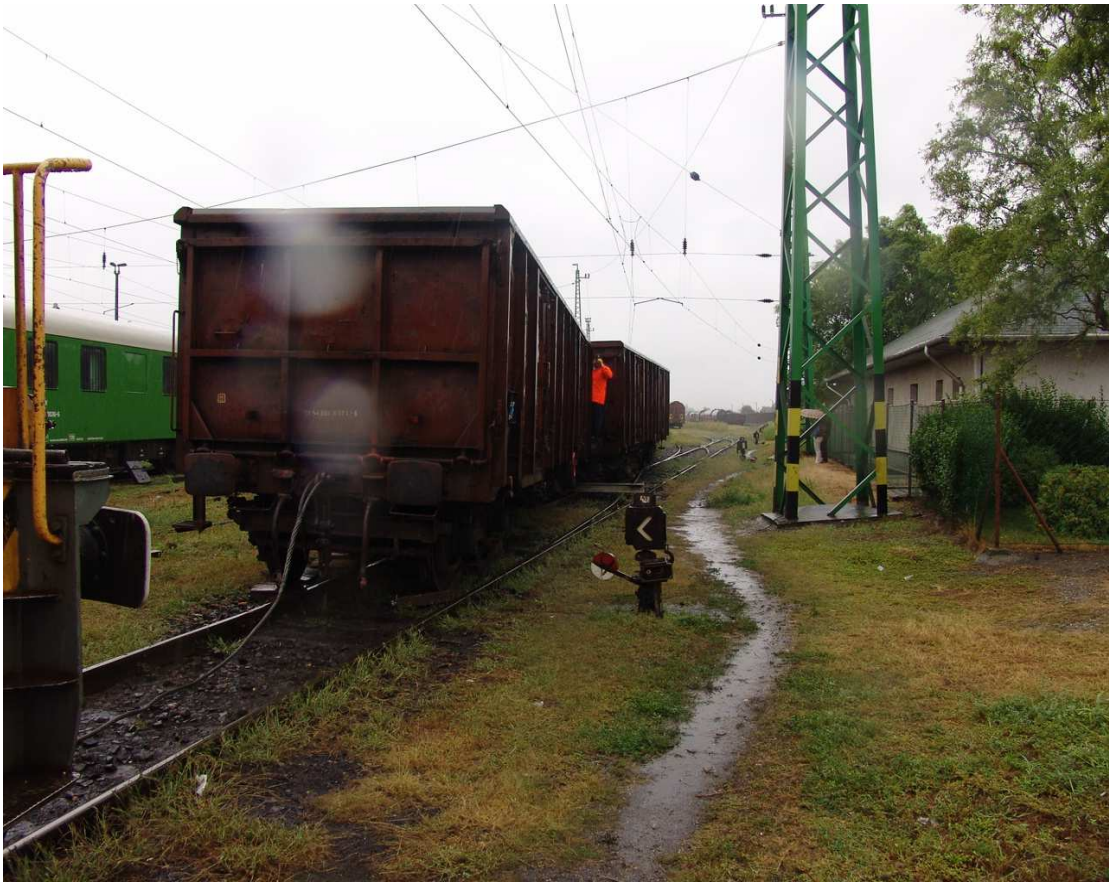
Train no. 45552 of BRKS a. s. railway undertaking was signalled out from platform no. XVI at Komárom marshalling yard in the direction of Komarno. At 05 hours 55 minutes, the first freight car derailed with 4 shafts and the second freight car with 2 shafts at the common crossing of switch no. 428.

Figure 5: Location of the accident (switches 427, 428)

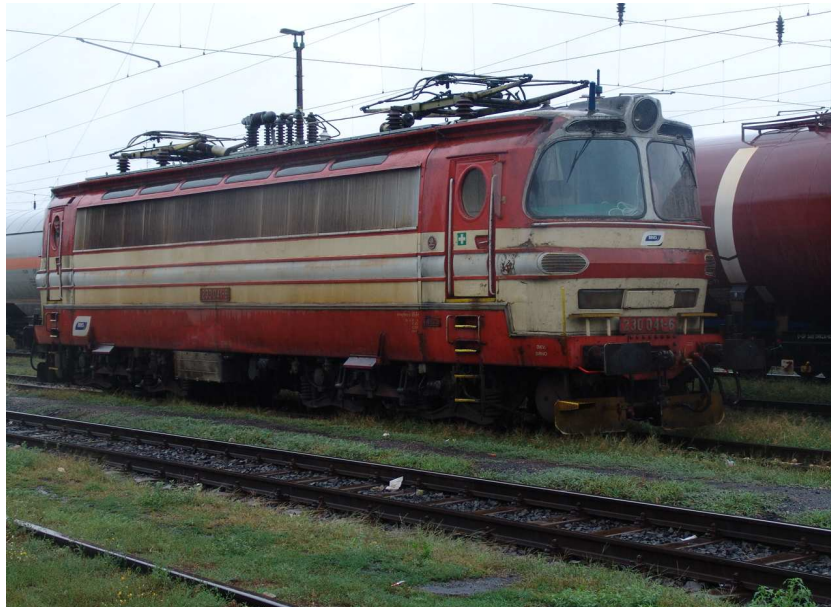
- The electric locomotive (registration number: **BRKS a. s. 230 041-6**) was not damaged.

Figure 6: electric locomotive of train no. 45552

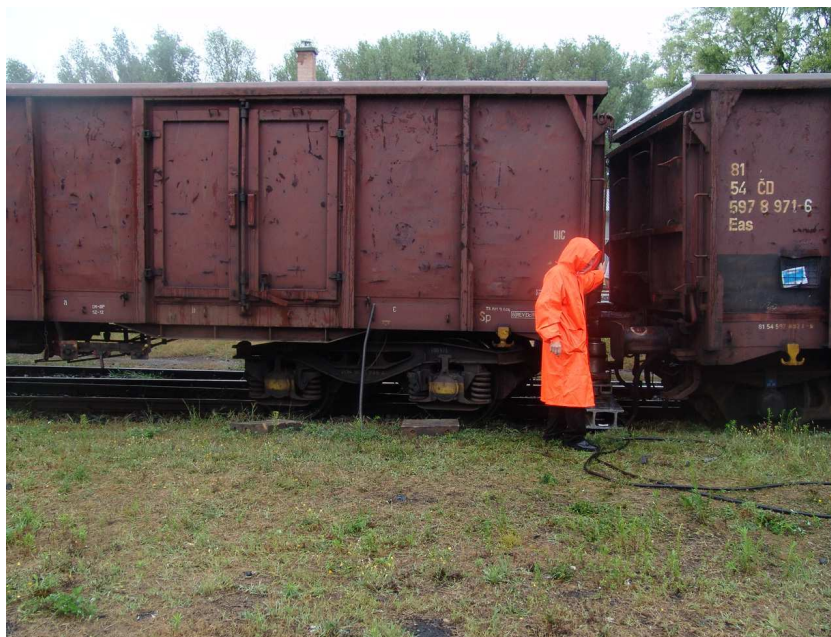
- **Sequenced cars**
  - 31 54 596 19864 Easu car derailed with 2 shafts and
  - 81 54 597 89716 Eas car derailed with 4 shafts and both were slightly damaged.

Figure 7: Derailed freight cars

The signalled out train 45552 departed from platform XVI and accelerated approximately to 15 km/h. The left front wheel of the first car pushed the scotch block in front of itself until the common crossing of switch no. 428 where the scotch block got stuck. As a result, the first freight car derailed with two shafts and the second freight car with four shafts. The scotch block flew off the rail due to the arising forces.

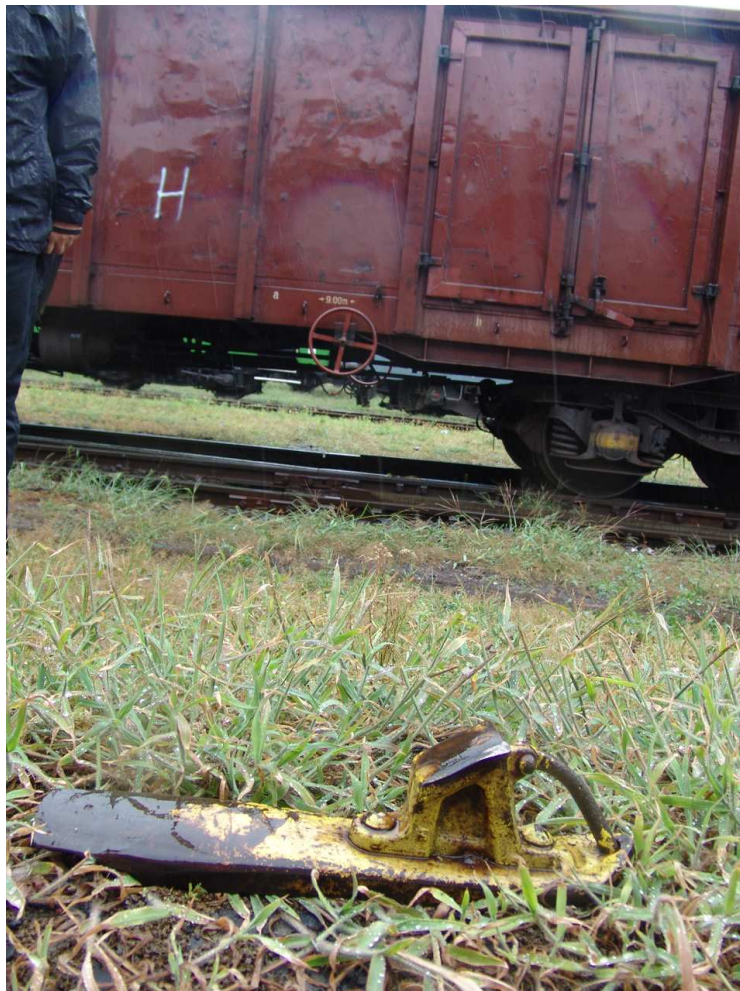
Figure 8: The scotch block left under the first freight car causing the accident.

The movements inspector - walking along the right side of the train – checked whether there is any foreign object under the train. However, he did not check the first five cars behind the locomotive. Before signalling out the train, he checked the screw coupling and the air-brake hose between the locomotive and the first car. As he did not notice anything unusual, he signalled out the train.

The immediate cause of the accident was that during the coupling and the inspection of the train it was not noticed that the scotch block had been left under the left front wheel of the first freight car.

Nevertheless, the coat of paint on the scotch blocks wears off and become dirty very quickly during the constant usage which makes it difficult to notice them and therefore may lead to similar occurrences.

**BA2006-048-5\_1:** TSB recommends the introduction of an instrument or sign which makes the scotch block clearly visible from a distance.

Having regard to the fact that the new Traffic Regulations - came into force on 6<sup>th</sup> April 2008 – prescribe the application of scotch blocks in a significantly wider range, a decision should be made on whether it is possible to maintain the condition (better visibility) of scotch blocks prescribed in the current regulation. If it is not possible, a new sign or indication should be applied which would make it easier to notice scotch blocks. (For examples for this solution, see 7.1.6 and 9.12 of No F.1. Signs Regulation).
