KÖZLEKEDÉSBIZTONSÁGI
SZERVEZET

FINAL REPORT

2006-009-6

40-tonne ferry: DK 1135

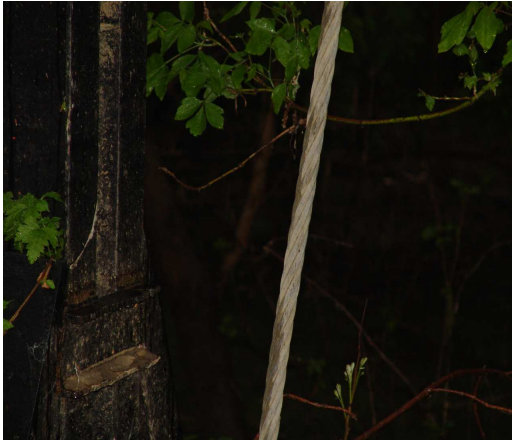
Ferry-rope

On the basis of the samples, it can be stated that the rope had worn away, its staple fibres had lost their stretchiness and therefore they broke easily even when bending only slightly.

The cause of the casualty: the neglect of check and maintenance of the rope, the rope having been worn away, and finally, its breakage.

BA2006-009-6_05: The IC recommends the NTA to ordain that the ropes of ferries shall be inspected by a level specialist as well at fixed intervals. The inspection should be entered on record and be kept on the ferry. Furthermore, the up-to-dateness and professional contents of regulations regarding the checking of ropes should be reviewed.

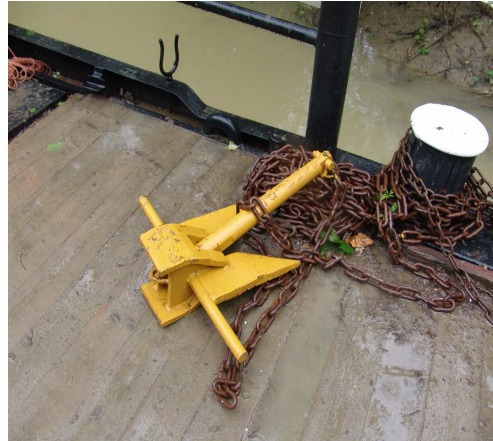
Anchor

It can be ascertained that the experience and composure of the ferrymen saved the passengers and cars on board as well as the ferry itself from suffering serious injuries and damages by casting the anchor (which stopped the ferry) in time.
