TRANSPORTATION SAFETY BUREAU

FINAL REPORT

2006-010-6 MARINE INCIDENT

Passenger boats MS MONET (ST-R 1064 F) and MS DNIPRO (PA09281)

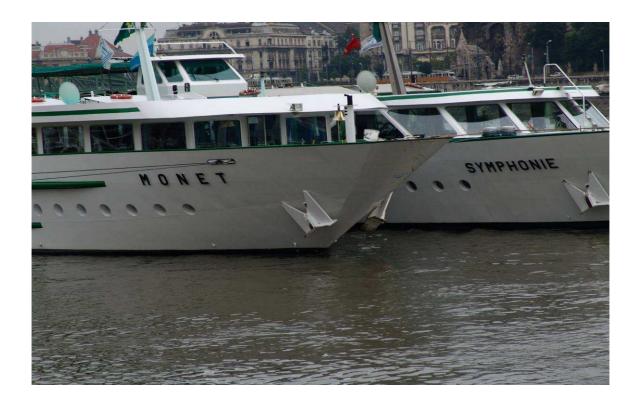
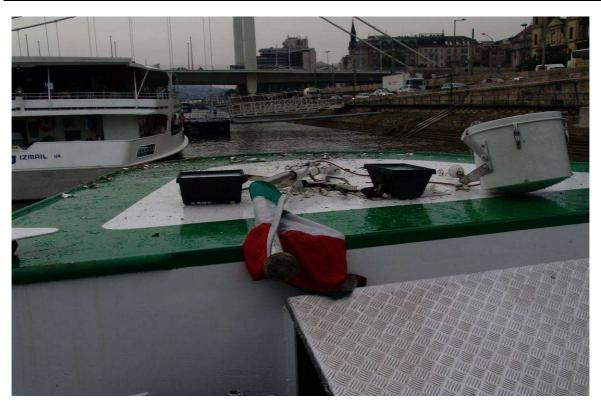
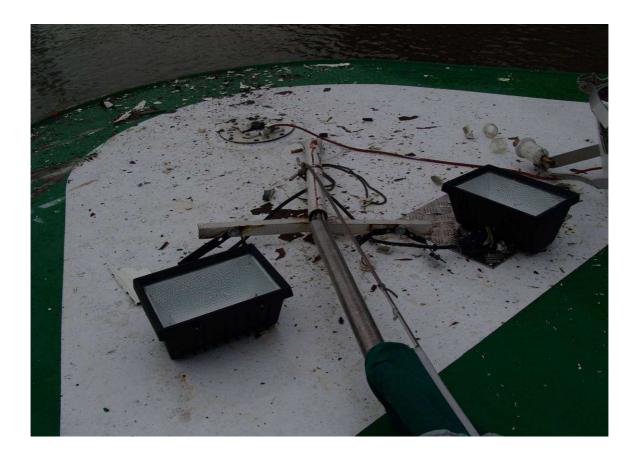
Photos of MS Monet

Both ships were damaged in the course of the incident. MS Dnipro sustained substantial damage, while MS Monet was only slightly damaged.

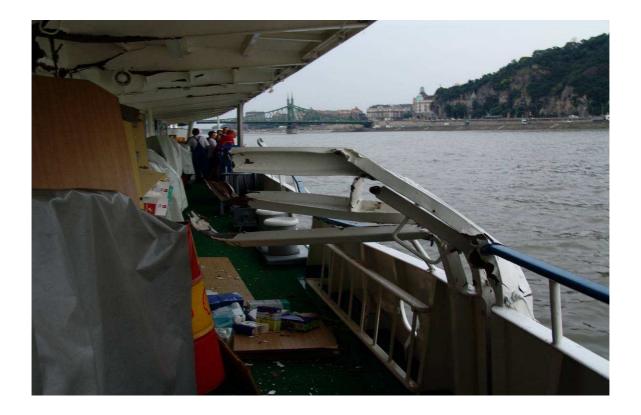
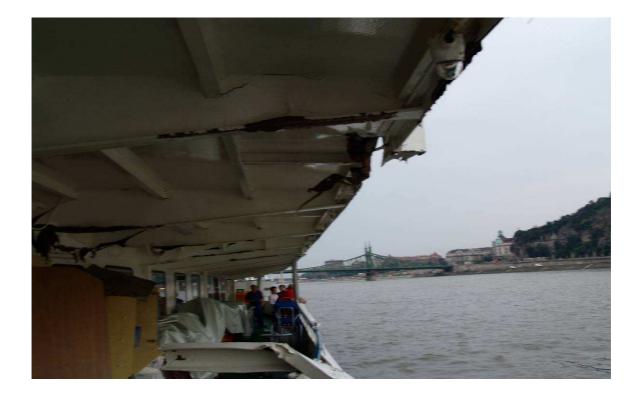
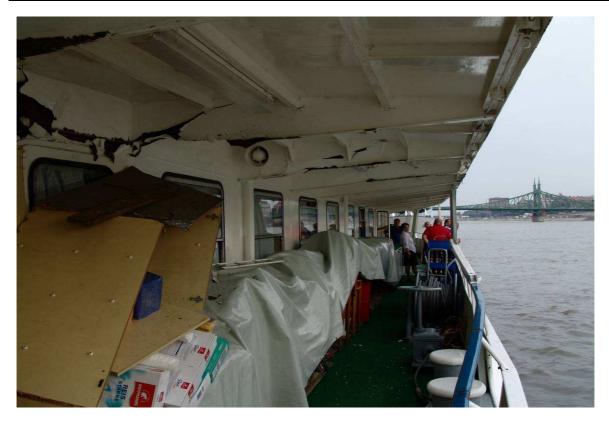
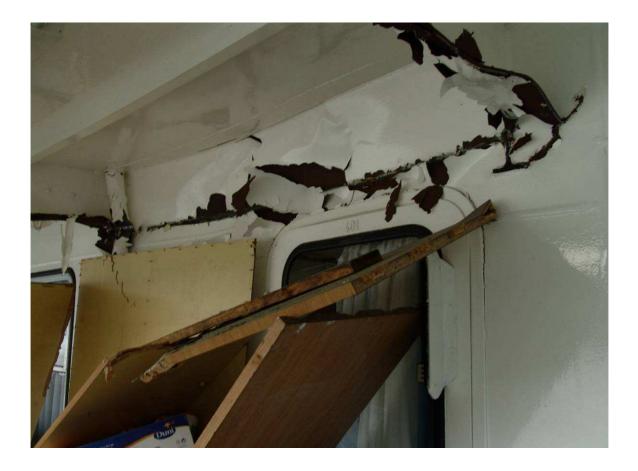
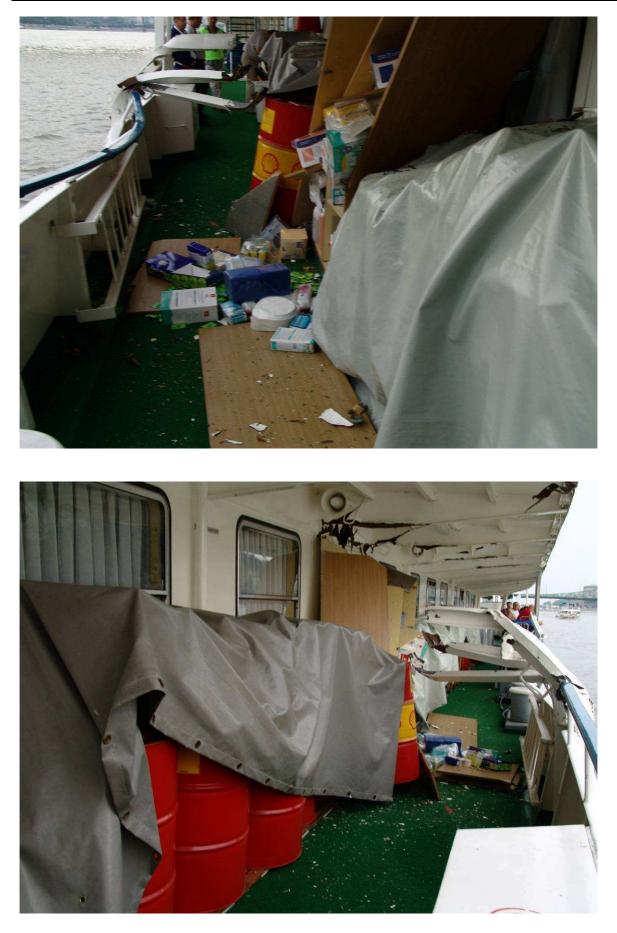
Photos of MS Dnipro

It has been found that the captain of MS Claude Monet made a mistake in the turning manoeuvre and therefore collided into the portside of MS Dnipro causing substantial damage to its deck.
