KÖZLEKEDÉSBIZTONSÁGI
SZERVEZET

FINAL REPORT

2006-028-6

Collision of passenger ships MS Mozart and MS Csárdás

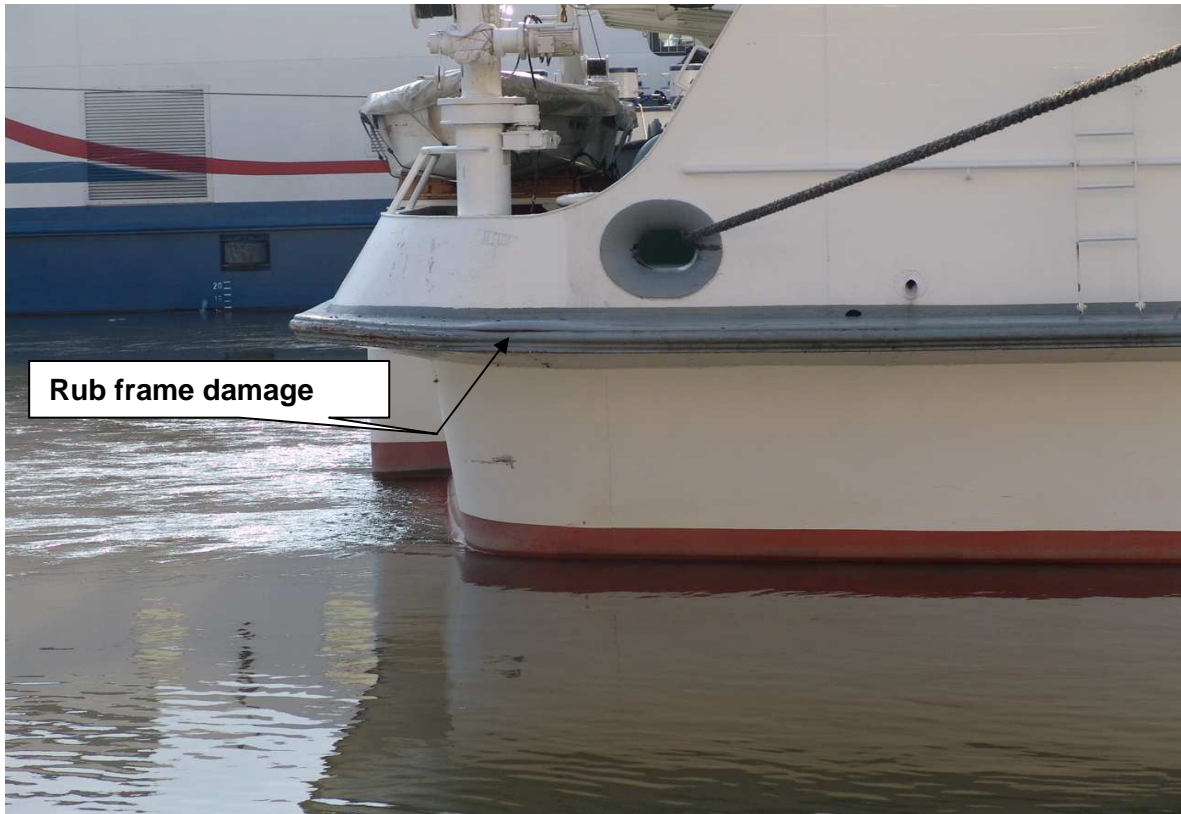
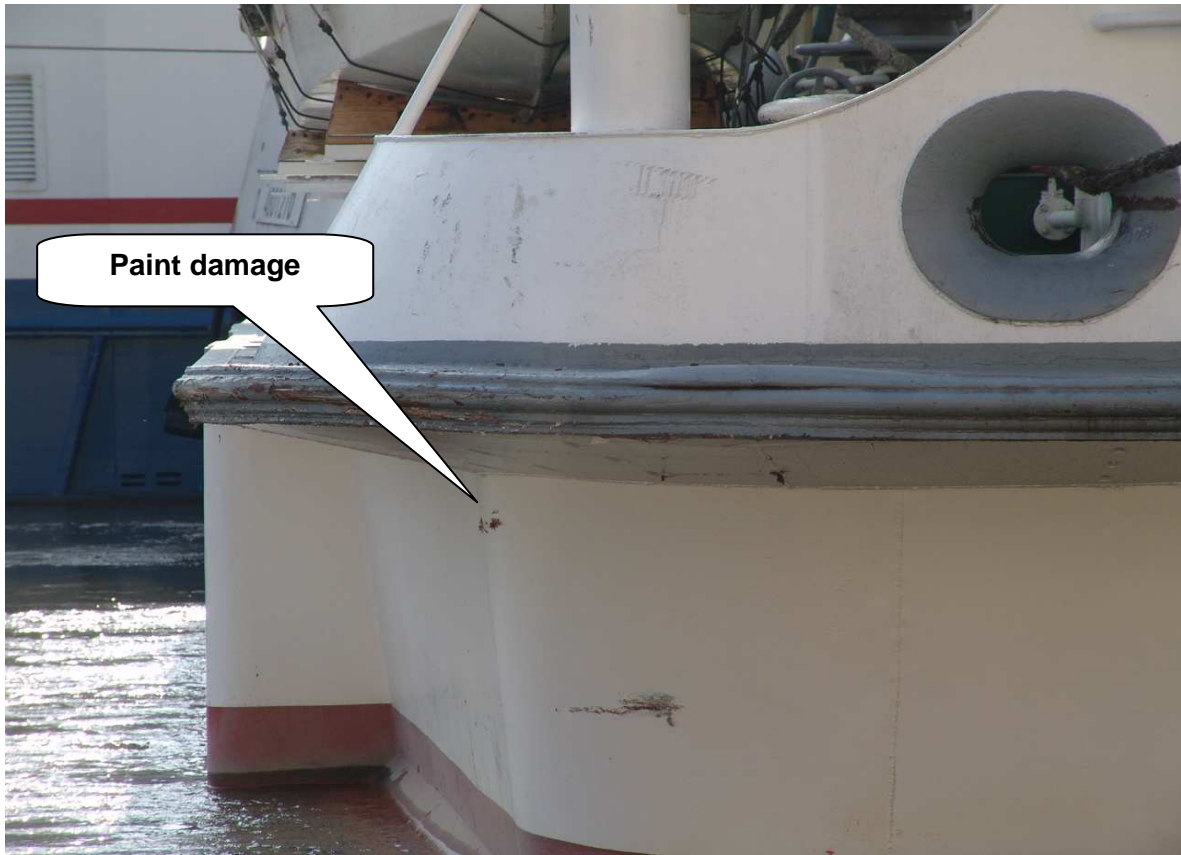
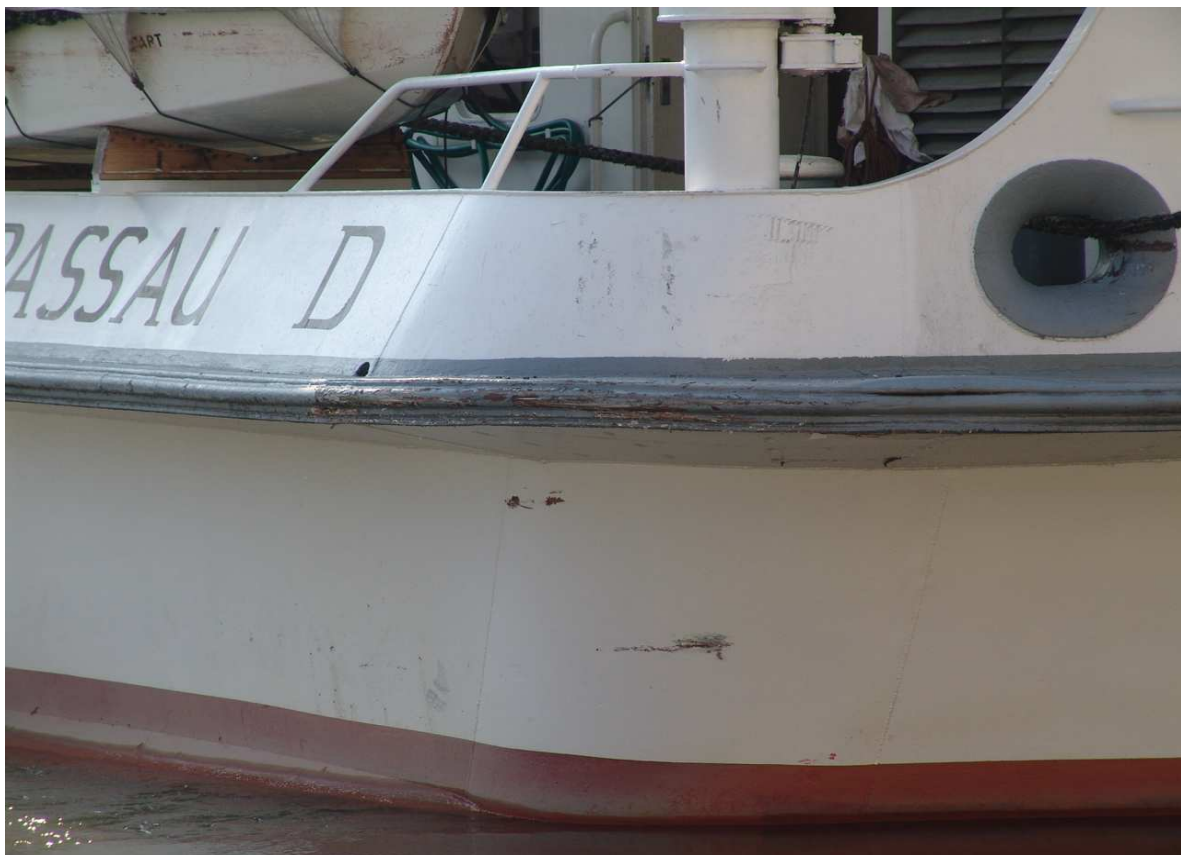
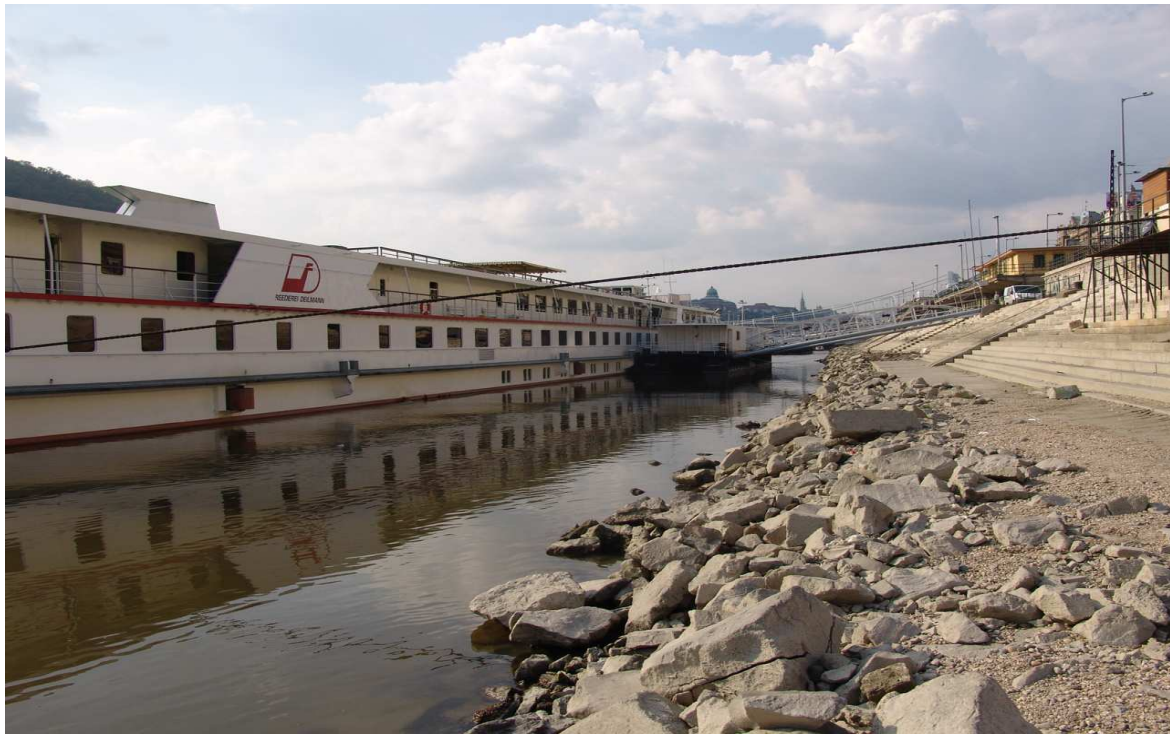
Photos of MS Mozart

The MS Mozart was only slightly damaged. Only a minor scratch was detectable and the paint came off where the two ships collided.

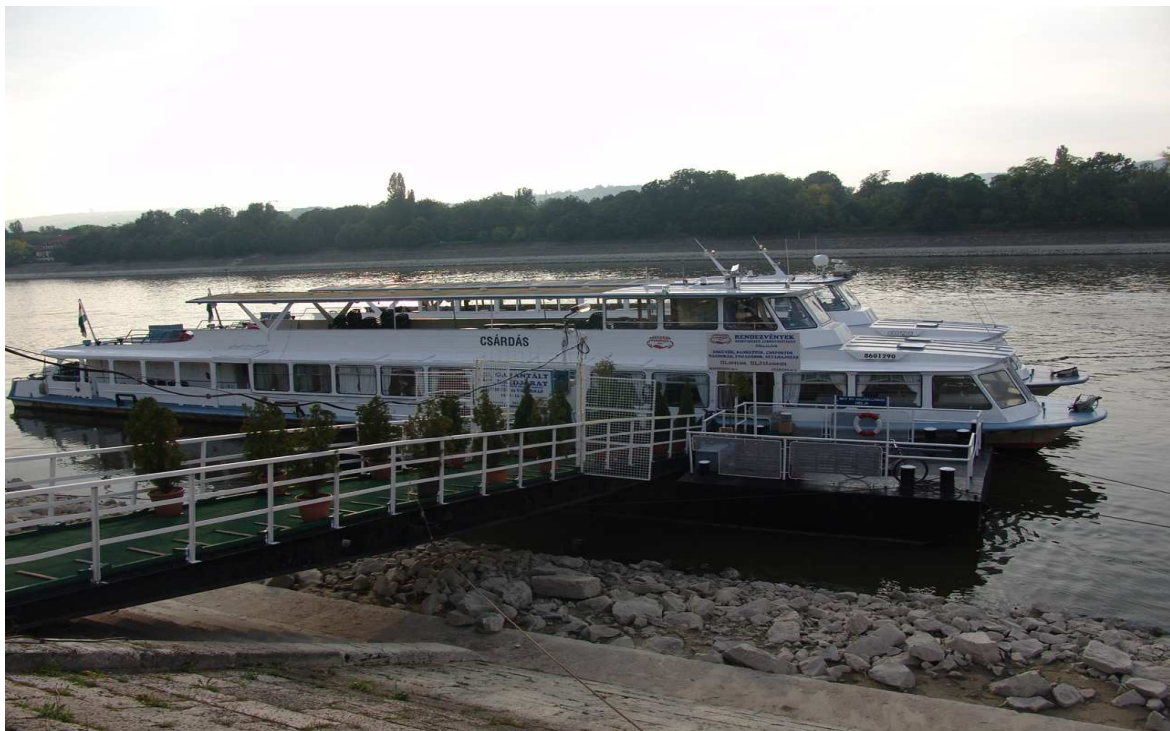
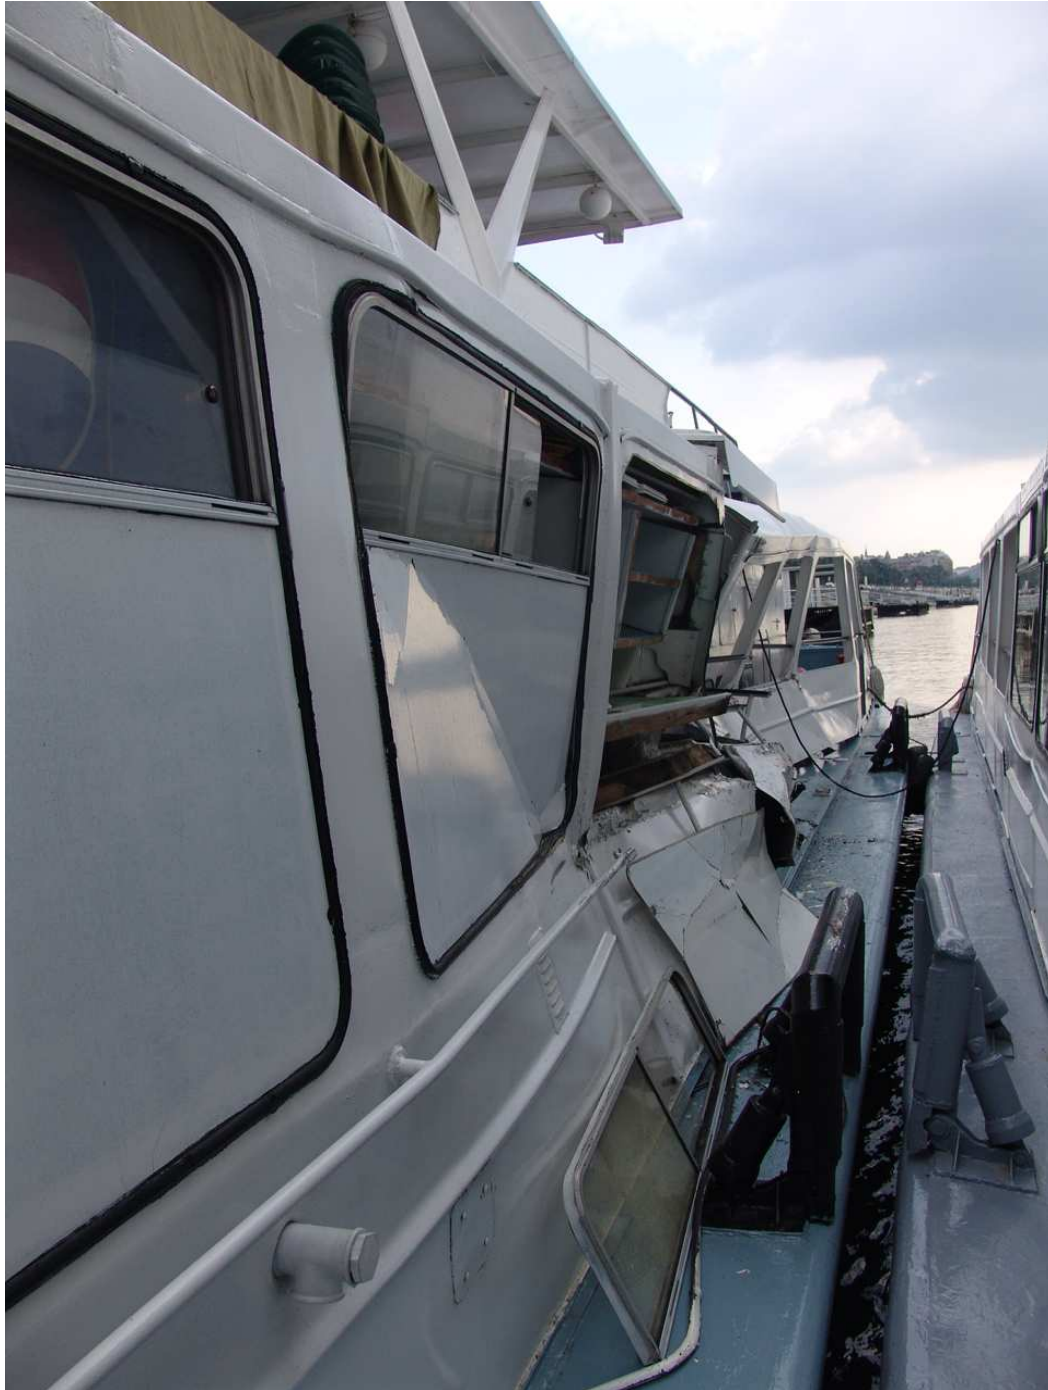
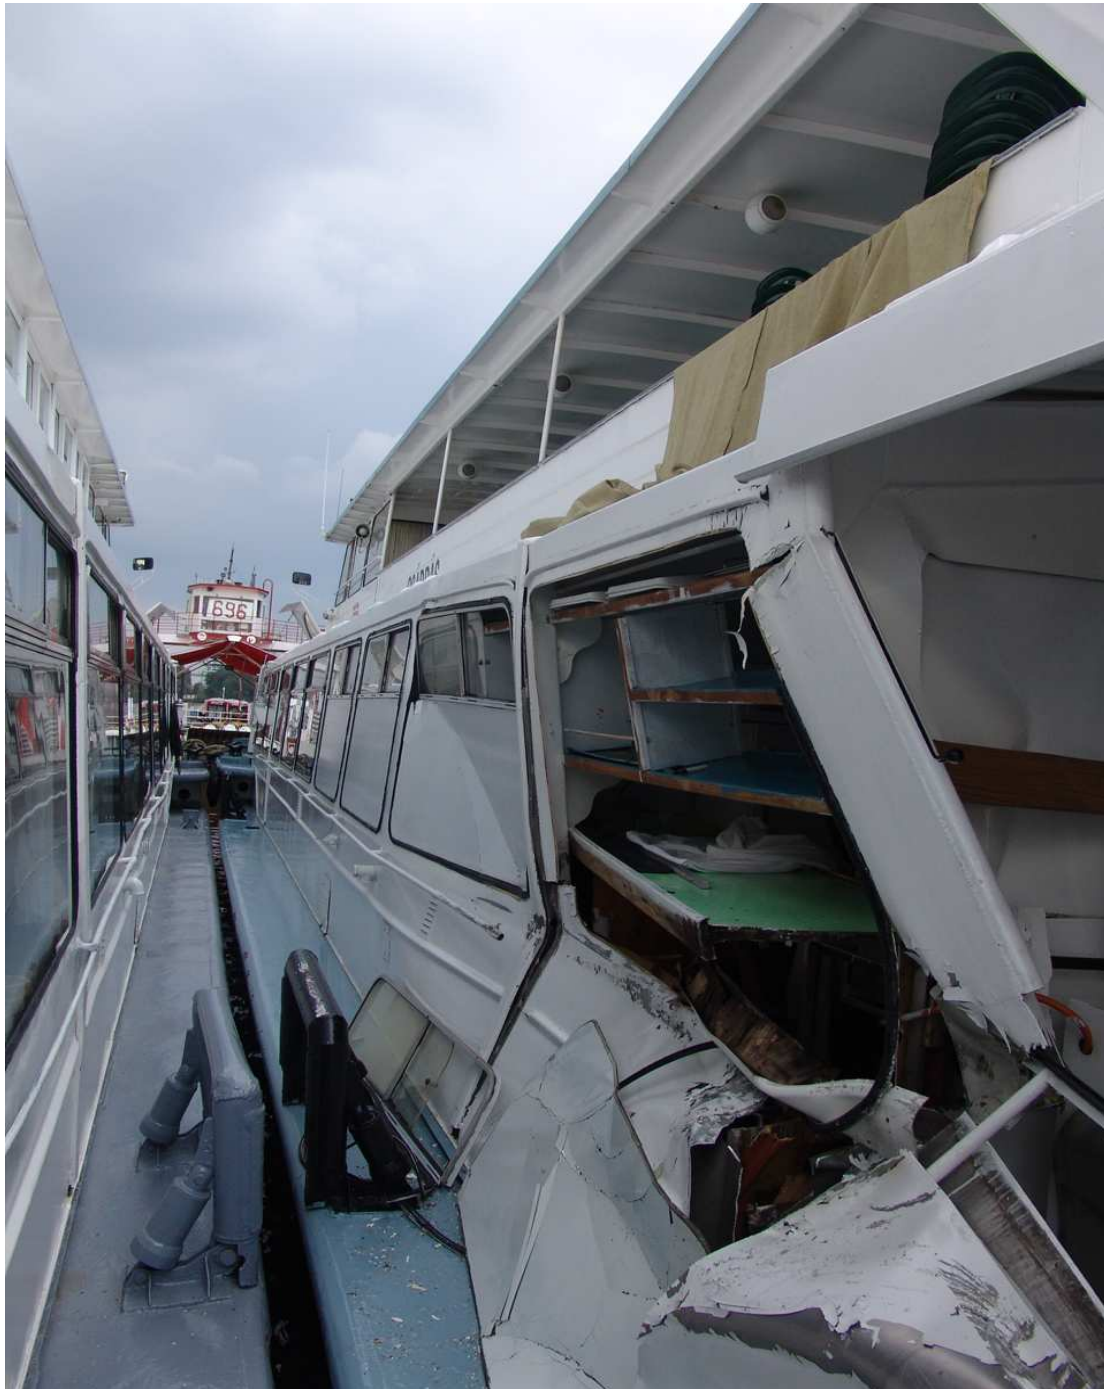
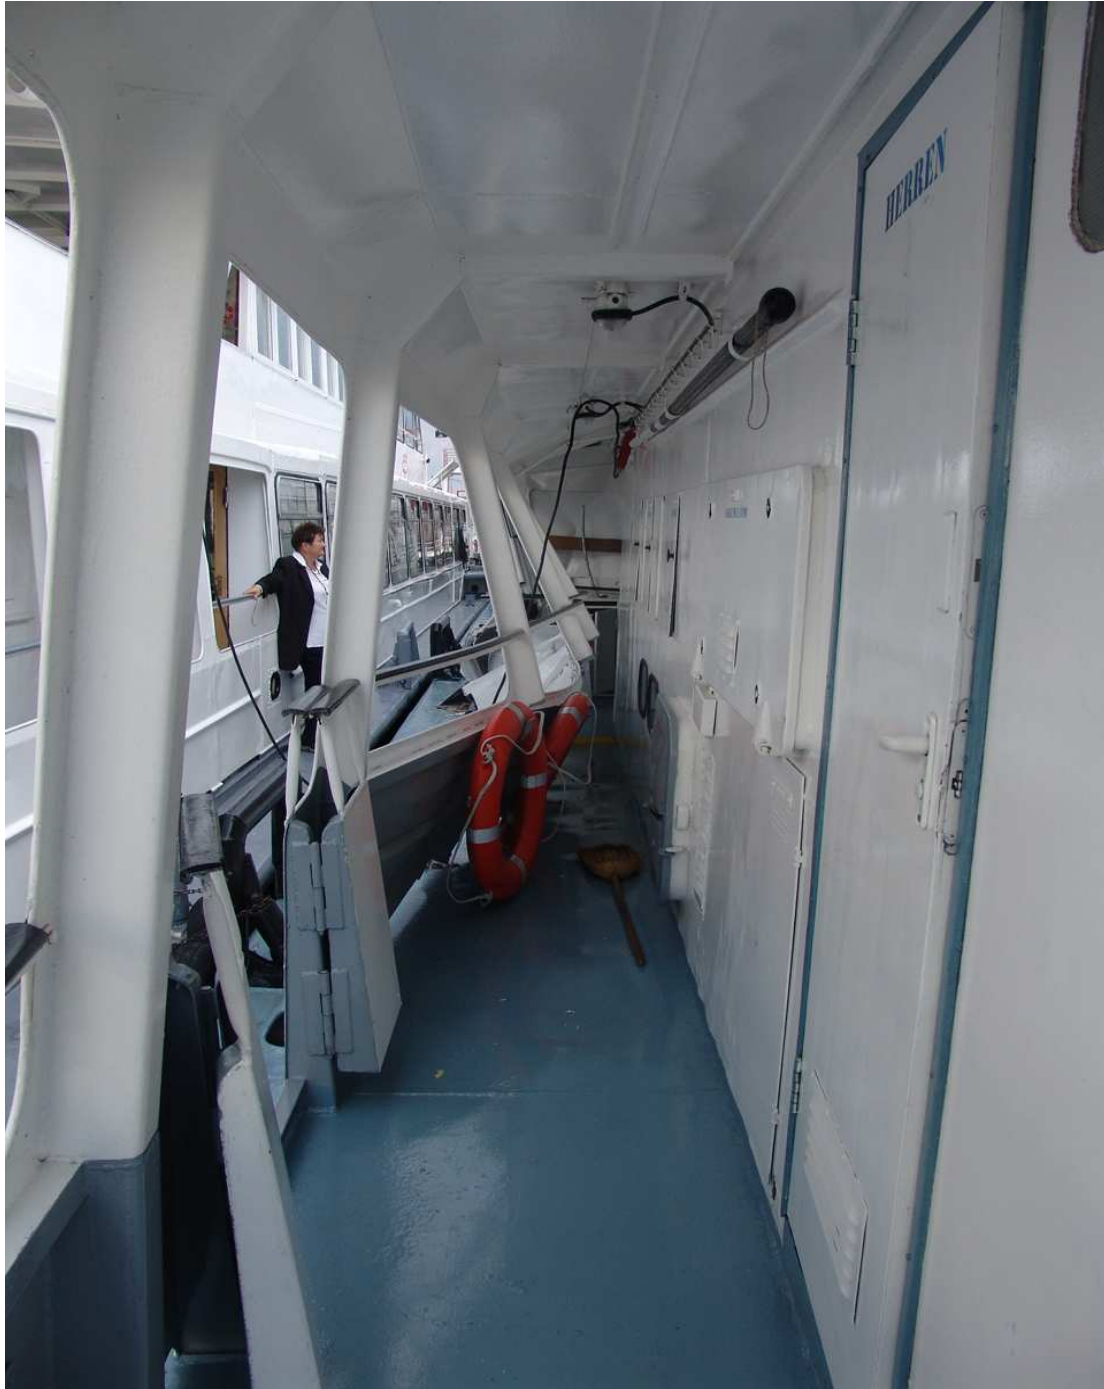
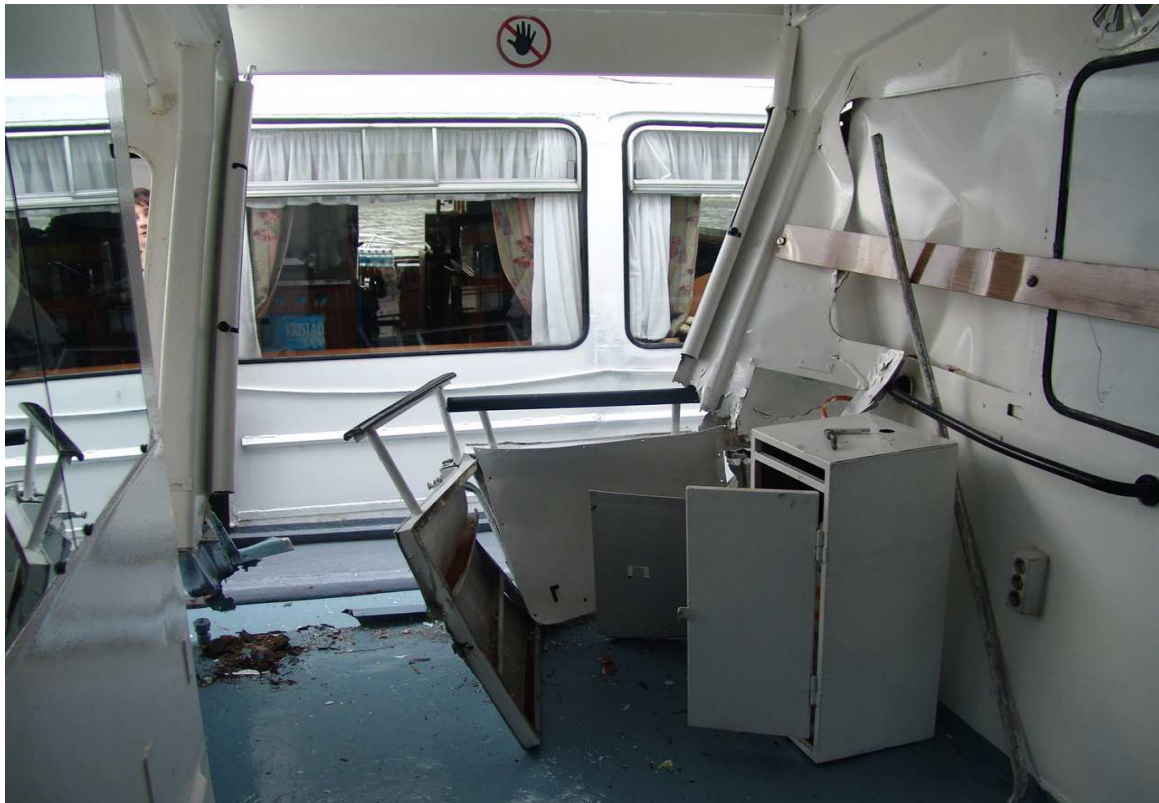
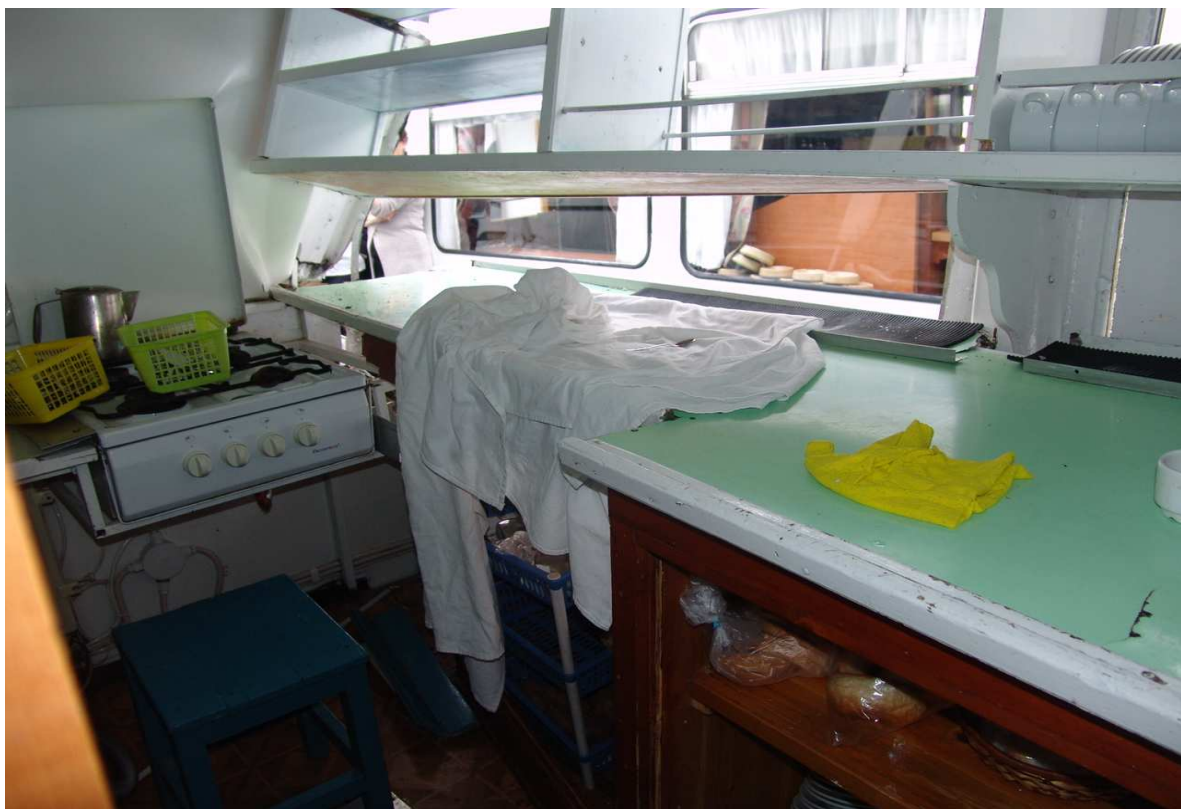
Photos of MS Csárdás

The MS Csárdás sustained substantial damage. Parts of the galley sidewall and galley furniture as well as 6-8 metres of the railing on the portside were completely damaged.

The skipper of MS Mozart signalled the ship's turn in advance a number of times. The two skippers consulted before the incident by radio on channel 10 and agreed that MS Csárdás would slow down and give MS Mozart a safe turning space. The skipper of MS Csárdás evidently failed to follow the conditions agreed upon, and due to the inadequate distance and the draw-in effect, the two vessels collided. The MS Csárdás sustained heavy superstructure damage at her portside near the galley.
