The full, official version of the final report is only available in Hungarian language

2006-044

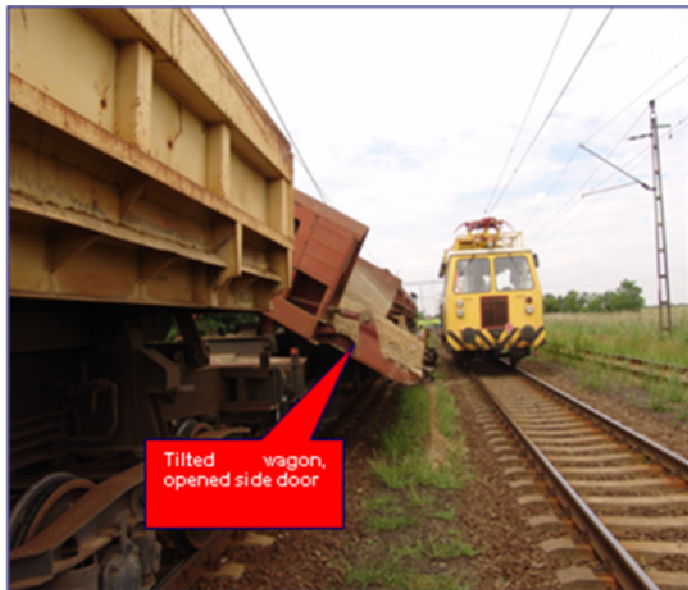
A freight train was running from Tiszatenyő to Pusztapó and its 16th wagon (self-discharging wagon carrying ballast chips) tilted to its side, its side door opened and damaged some installations and masts beside the track at Pusztapó station. The engine driver noticed the event from the rear-view mirror and stopped the train immediately by applying emergency brake.

The IC conducted tests to check the operation of the control levers, and established that even when moving the levers only slightly, the release valve of the self-discharging wagon was being slowly re-pressurized and after about 8-10 minutes, the side door shifted to tilted position. This slight shift of the lever was hardly visible.

Based on the available information, the IC established that the most probable cause of the accident was the technical failure of the Ua type self-discharging wagon and the uncertain/insufficient operation of the levers. As there was no information on where exactly the side door opened, the IC had no possibility to examine other circumstances and contributing factors.

The IC did not consider necessary to issue safety recommendations, however, it draw the attention of the concerned parties (especially the supervisory authority and railway construction companies) that particular attention should be paid to the revelation and correction of similar technical deficiencies and failures.
