TRANSPORTATION SAFETY
BUREAU

FINAL REPORT

**2006-047-6
MARINE INCIDENT**

**Dunaföldvár, Danube river, at river km 1561
11 December 2006**

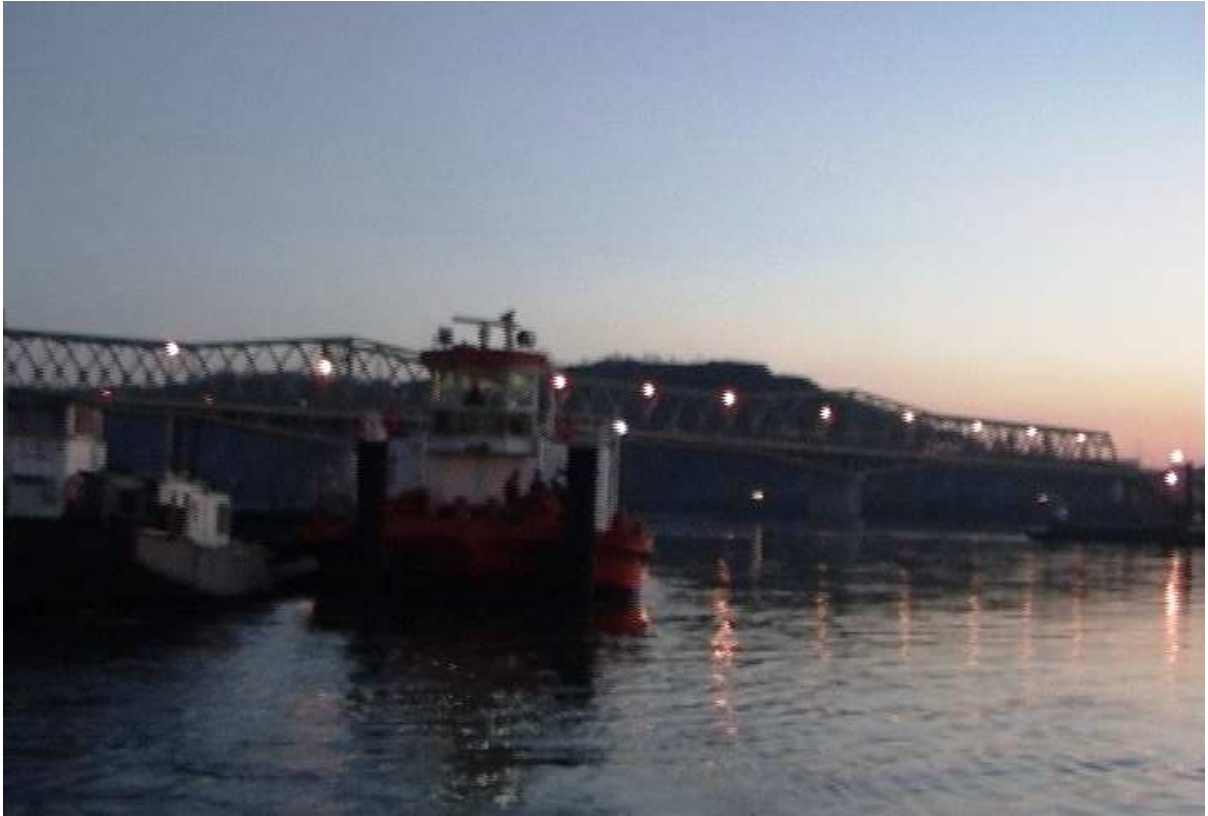
The IC established in the course of the site survey that there was no damage to the boat above the water-line. The ropes connecting the boat and the barge-assembly broke in several places.

The tugboat and its disassembled barges.

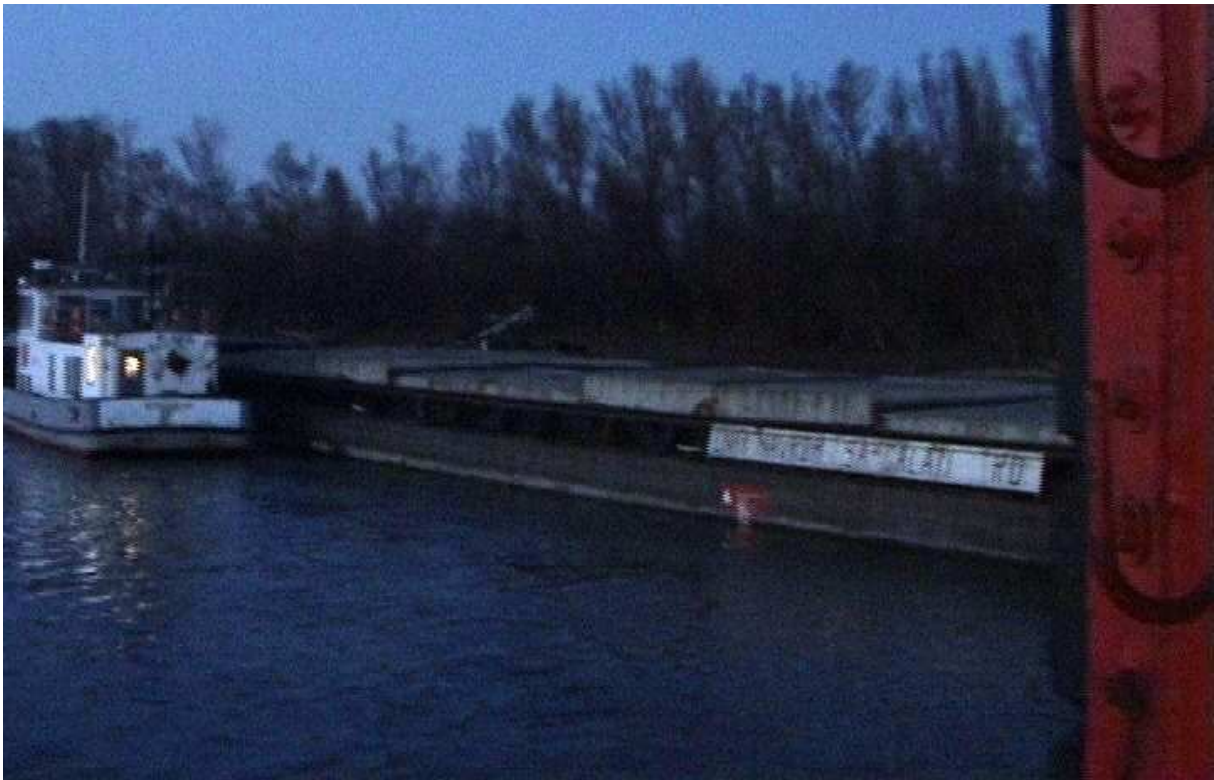
The barges should have been anchored before Dunaföldvár bridge as the ford depth is 20 dm between river kilometres 1559.8 and 1559.7. Although the barge-assembly got through this reach, the skipper should not have assumed that the boat with the barges would pass under the bridge safely, without problems.

Although the tugboat with the barges was sailing at a rather difficult reach, the incident was most probably caused by the inattention and impatience of the skipper as well as the fact that he took too much risk in manoeuvring. Dunaföldvári bridge and its area is a critical reach of the river as to chances of grounding. The skipper of Mercur 201 ms. tried to sail under the bridge with 6 barges loaded with an almost 6000-ton-cargo. According to the skipper, when sailing under the bridge, the strong current pushed the barge-assembly towards the left bank. In order to keep the boat and the barge-assembly in the waterway, the skipper applied maximum thrust and steering force, as a result of which - according to the skipper - the connecting ropes broke at four places and the front right barge grounded. (However, the IC considers it highly unlikely that almost all the ropes broke *as a result of* the sudden counter-steering.) If he had anchored at least two barges under the bridge, he would probably have managed to sail under the bridge at the difficult reach with the other four barges without problems. Based on the data of Hydroinfo, the ford depth on 11th December 2006 was 20-22 dm at Dunaföldvár. The draughts of the barges were 2.05 dm and 2.17 dm respectively. Therefore it can be concluded that the skipper took too high risk when trying to sail at that reach with six large-draught barges.

The barge grounded at the left bank.

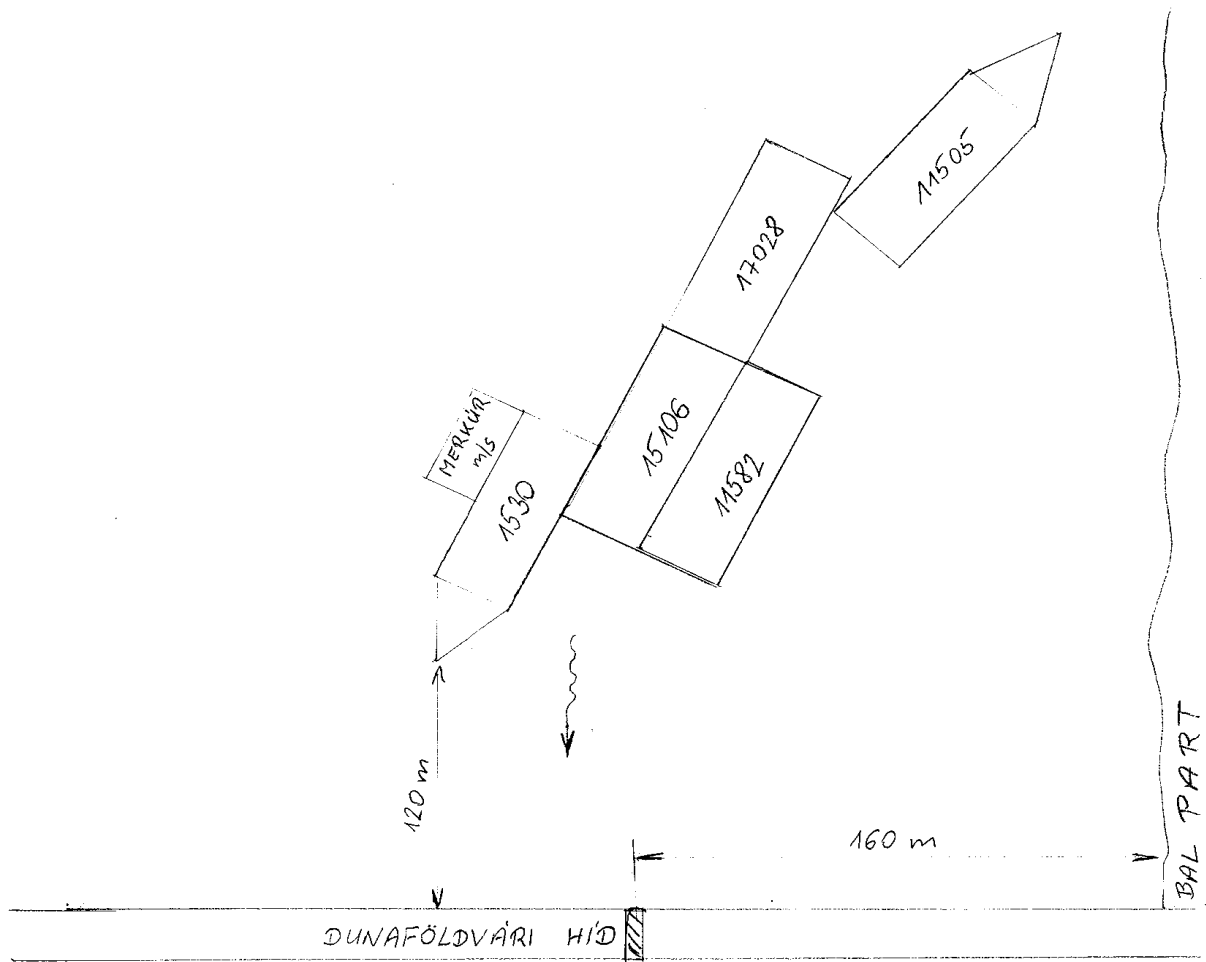
According to the captain of the tugboat, the boat sailed upstream from Mohács towards Bratislava with three manned and three unmanned barges. When passing under Dunaföldvár bridge, the assembly of barges was pushed towards the left bank by strong currents. The skipper tried to direct the barge-assembly towards the red buoy close to the right bank by firm counter-steering. During the manoeuvre, the connecting ropes broke and the front right barge grounded at the edge of the waterway at river kilometre 1561. As a result of the breakage of the ropes, the barges became detached from the tugboat and were positioned (at the time of the site survey) as shown in the pictures/sketch at the end of this report.

Sketch made by the skipper of the boat.
