**2007-400-5  
Railway accident**

On 2 November 2007 at Pestszentlőrinc station a freight train collided with a lorry which transported construction material for the rebuilding of the platforms. The lorry was moving in reverse between two tracks.

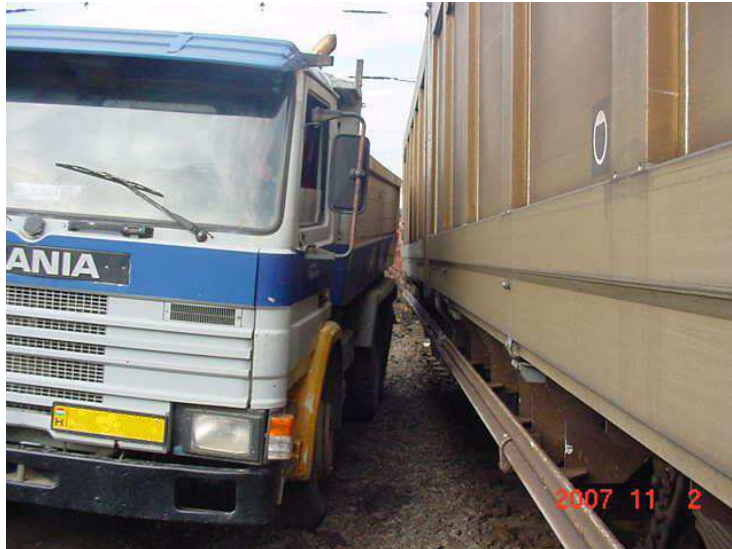
The lorries were using a route which interfered with the clearance of the track with active traffic, although it would have been possible to mark an alternate route outside the clearance, There was no movement control for the lorries which would have considered the train traffic,
