KÖZLEKEDÉSBIZTONSÁGI  
SZERVEZET  
TRANSPORTATION SAFETY  
BUREAU

**FINAL REPORT**  
**2008-0446-5**  
**SERIOUS RAILWAY ACCIDENT**  
**Monorierdő**  
**6 October 2008**

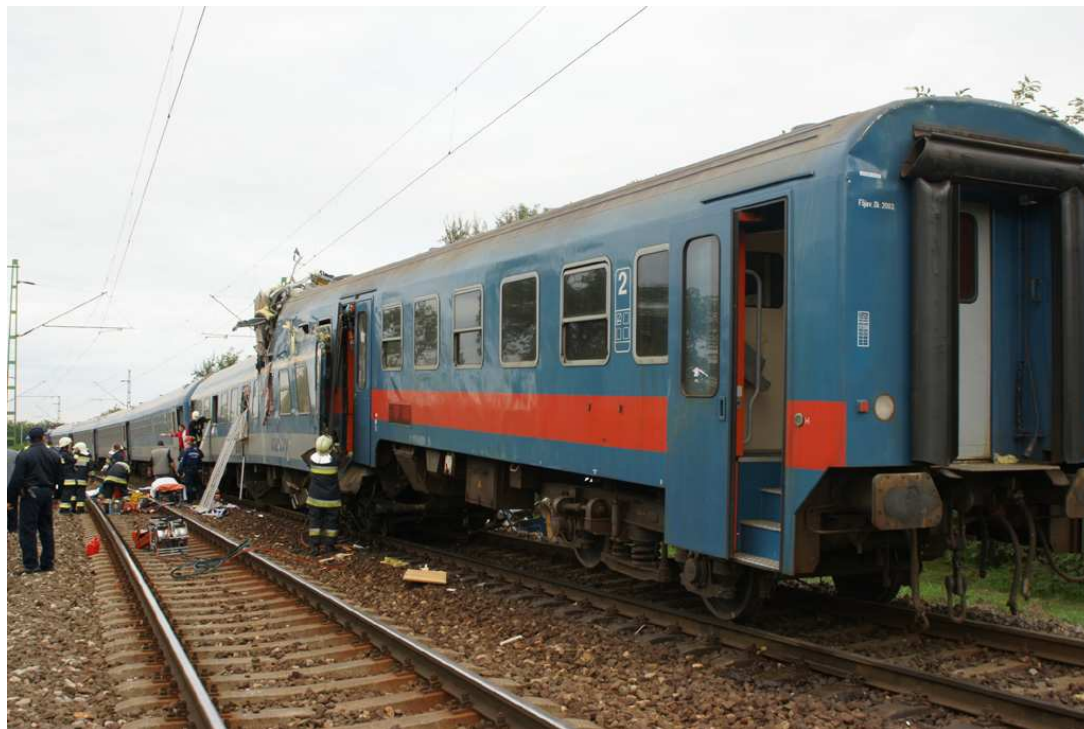
Figure 4: the site of the accident

As a consequence of the collision, the control car penetrated into the last carriage of the IC on an approximately 11-metre length (See Figure 4). The passenger train got disengaged and its second carriage derailed. Three people travelling in the last carriage of the IC train lost their lives at the site and another person died in the hospital (3 passengers and 1 crew). Four people suffered serious injuries and further 40 were injured.

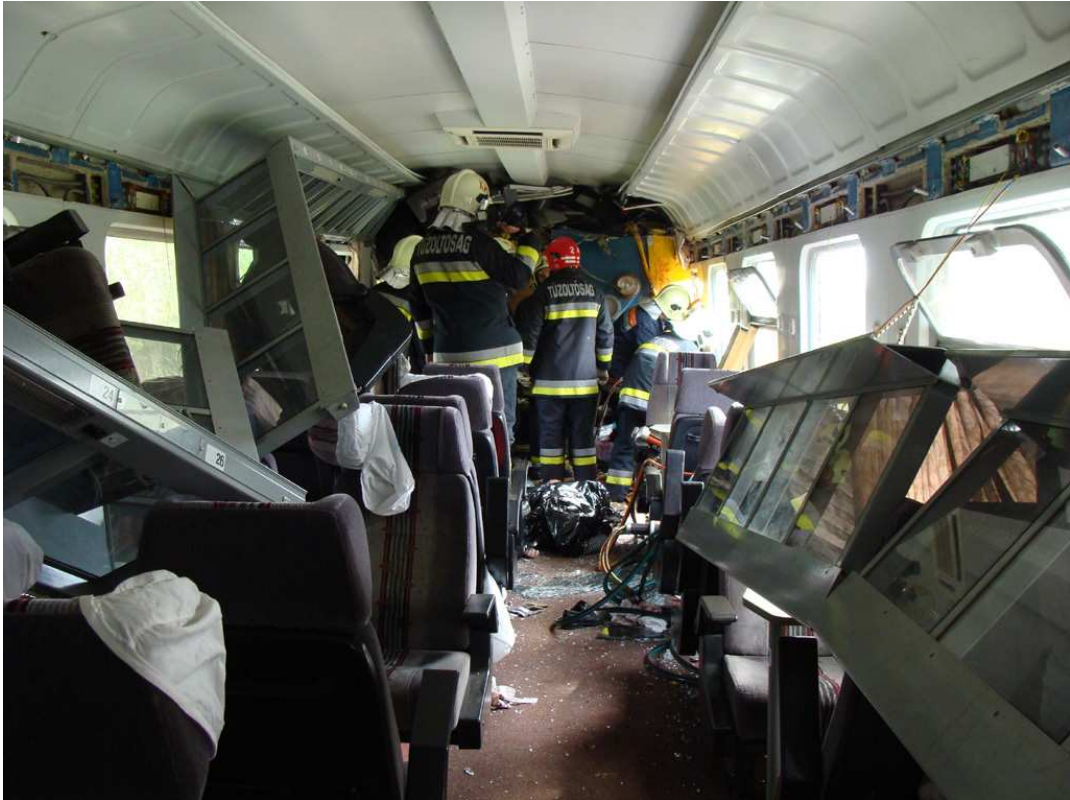
In the course of the site survey, the IC established that the overhead luggage-racks in the seriously damaged last carriage broke off, even in parts of the compartment whose carriage-body was not damaged.

**Figure 5: The inside of the last carriage of train no. IC 560-1 with the torn off luggage-racks**

- to revise the speed limit of 15 km/h to be observed under subsidiary signal;
- to put more emphasis on passive safety during the design of construction and furnishings of passenger rail carriages;
- to develop regulations and rules which provide basis for making decisions on when can / should block signals be considered inoperative,
- to focus on decision-making during staff training.

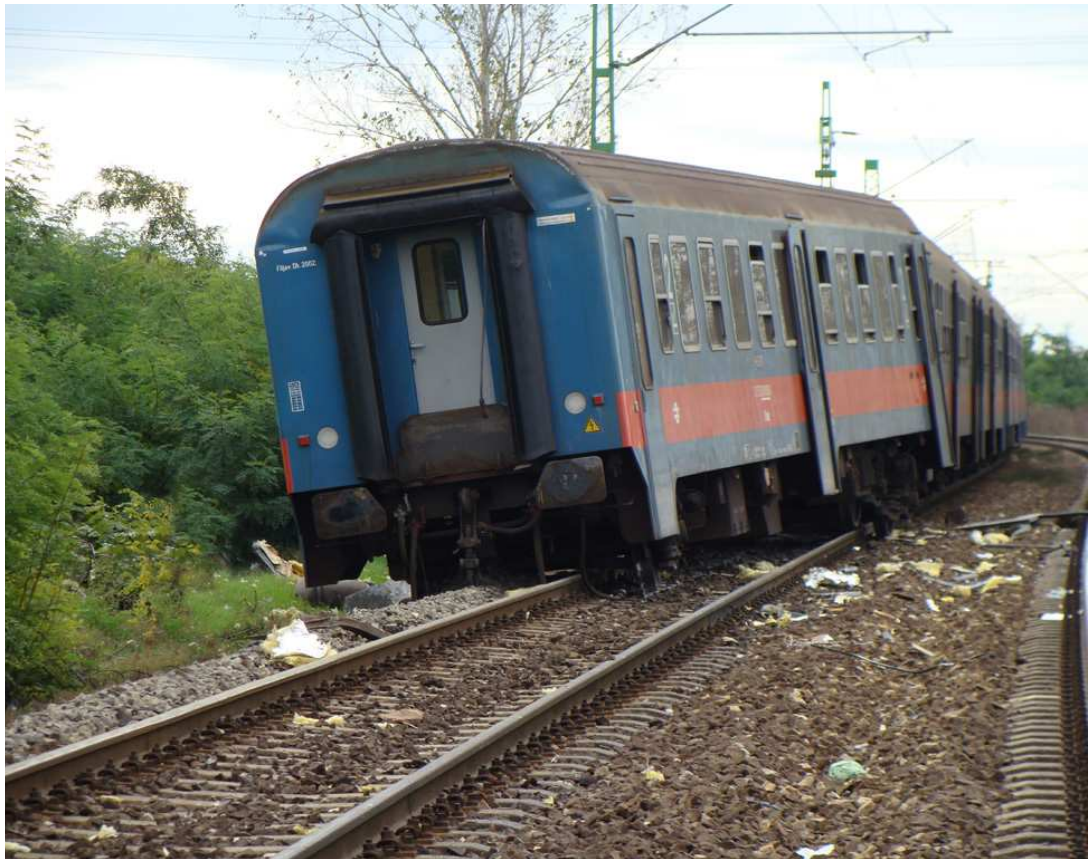
The railway vehicles sustained various damages. The control car in the front became unserviceable; its driver's cab and luggage carriage (for carrying bicycles on the train) were destroyed and the second carriage derailed.

**Figure 6: The derailed second carriage of the passenger train and some scattered debris**

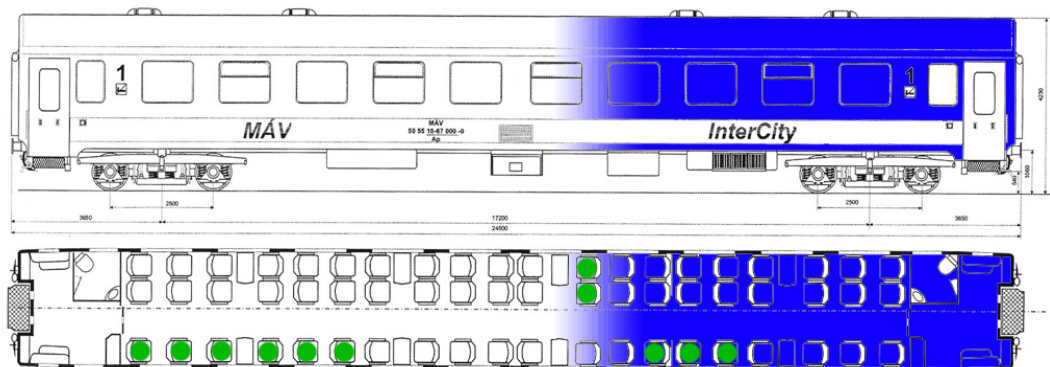
**Figure 11: The last carriage of train IC 560-1; the destroyed part of the passenger compartment indicated with blue and the sold seat tickets are indicated with green colour**

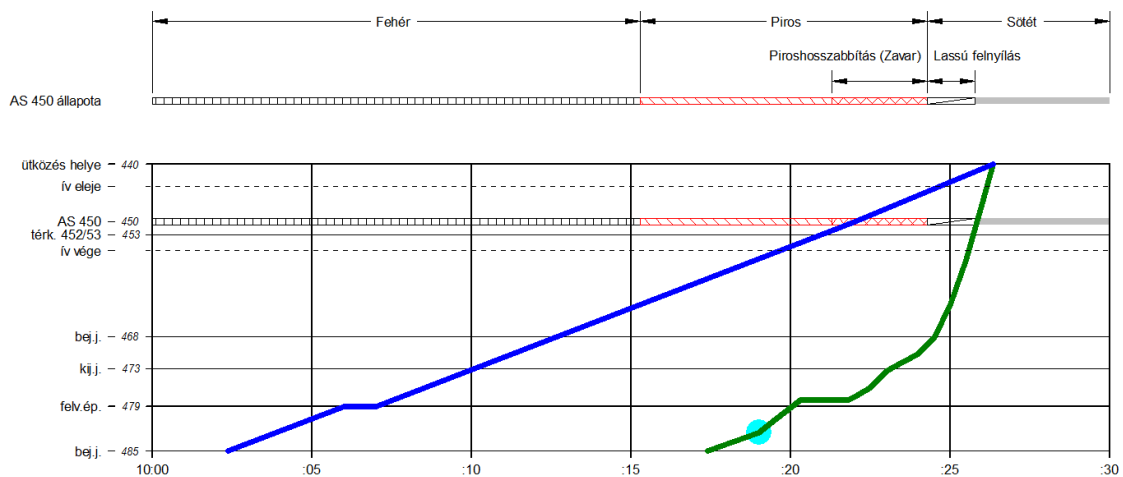
**Figure 13: the distance-time diagram until the collision and the state of LC AS 450 (bej.j.: entry signal, kij.j.: exit signal, felv.ép.: station office, térk.: block signal, AS: LC on the open track; green: train 2537, blue: train IC 560-1; light blue dot: EÉVB place of deactivation)**

The light blue dot in Figure 13 indicates the moment when the EÉVB of the control car was deactivated. It is visible from the breakage of the green line that after deactivating the control function, the train ran on with higher speed.

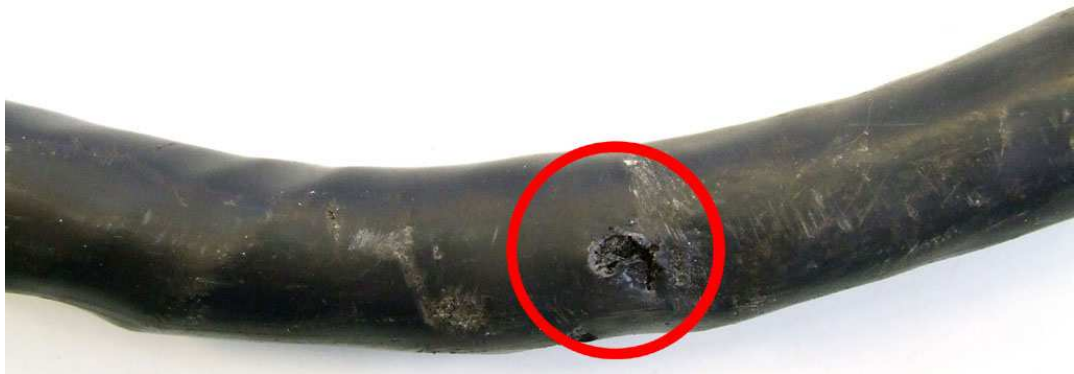
The failure was caused by the short circuit of the cables supplying 75 Hz, however, the cause of the short circuit was not found. The insulation of the wires in the cable was damaged to such an extent that it was impossible to determine whether the damage was a consequence of the short circuit or it had been damaged earlier.

Figure 19: the burn mark on the surface of the faulty cable

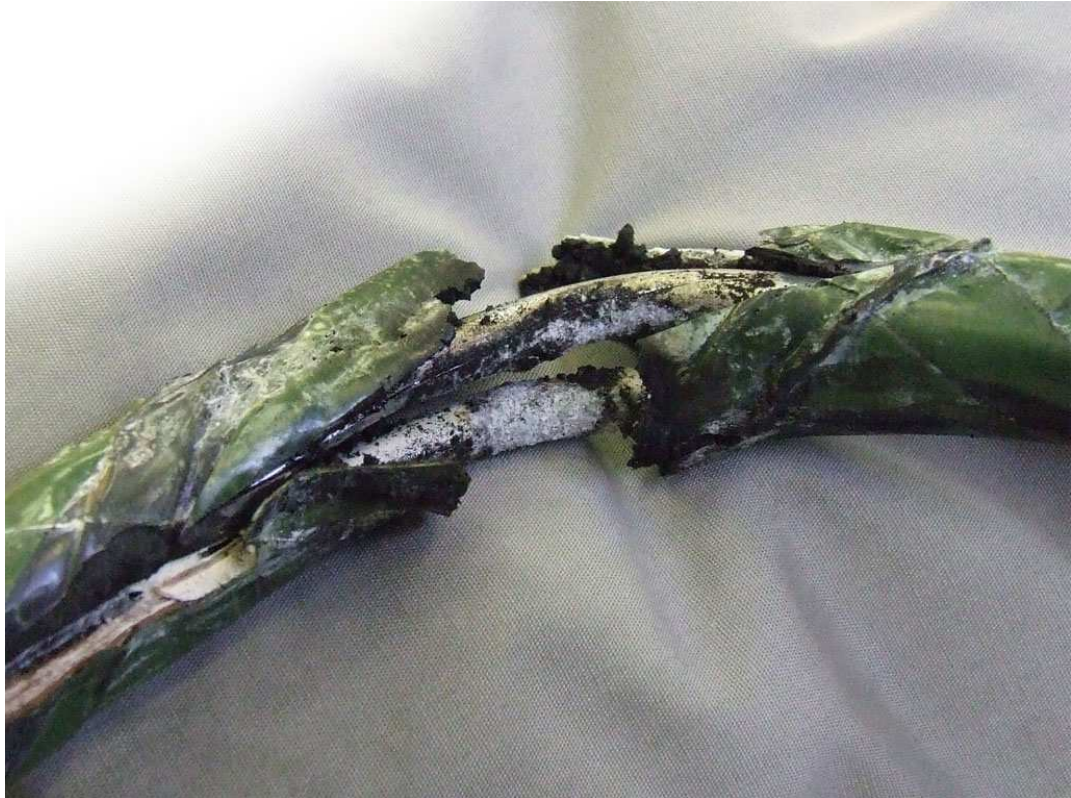
- After opening the cable, the expert and the members of the IC established that the short circuit of the 75 Hz cable was generated from inside - without outer mechanical input - and was probably caused by inadequate cable core insulation at production

**Figure 20: the wires of the opened cable with the burnt insulation**

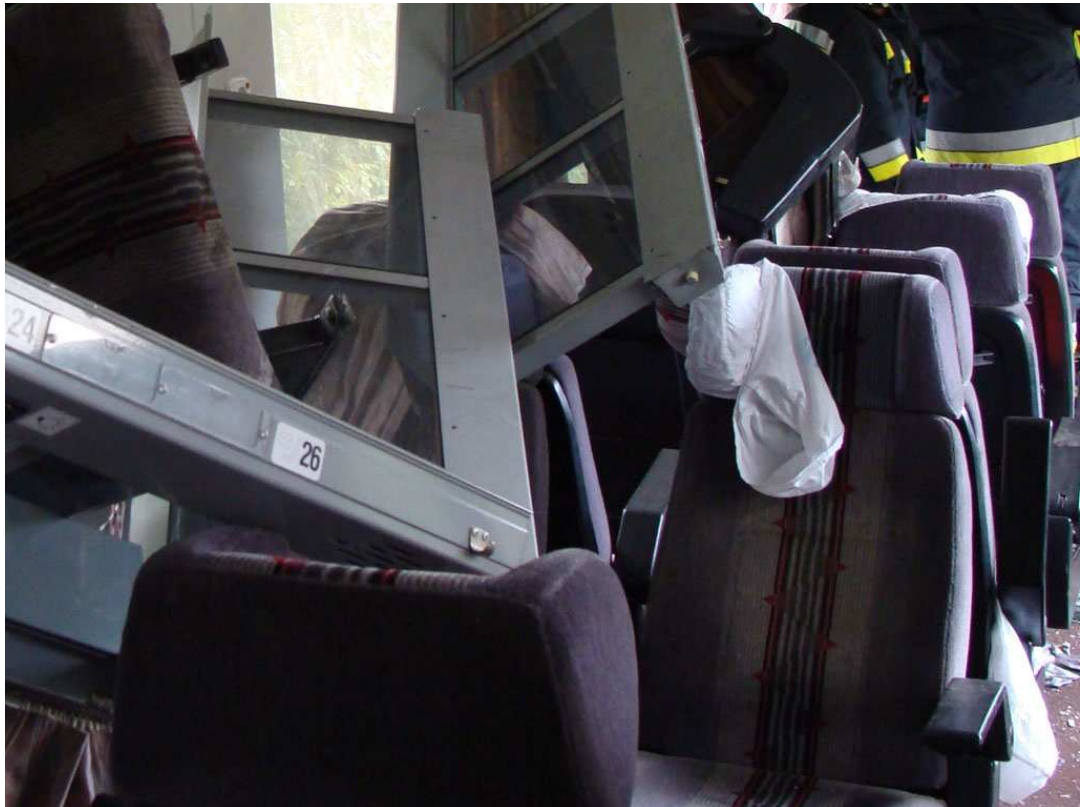
In the course of the site survey, the IC established that in the last carriage of train IC 560-1, the overhead luggage racks broke off, separated from each other and their parts/pieces fell in between the seats (Figure 18). These may have caused further injuries to the passengers. Some injuries most probably caused by the sharp edge of the fallen luggage racks were life-threatening.

Figure 24: Torn down, broken luggage racks in between and on top of the seats

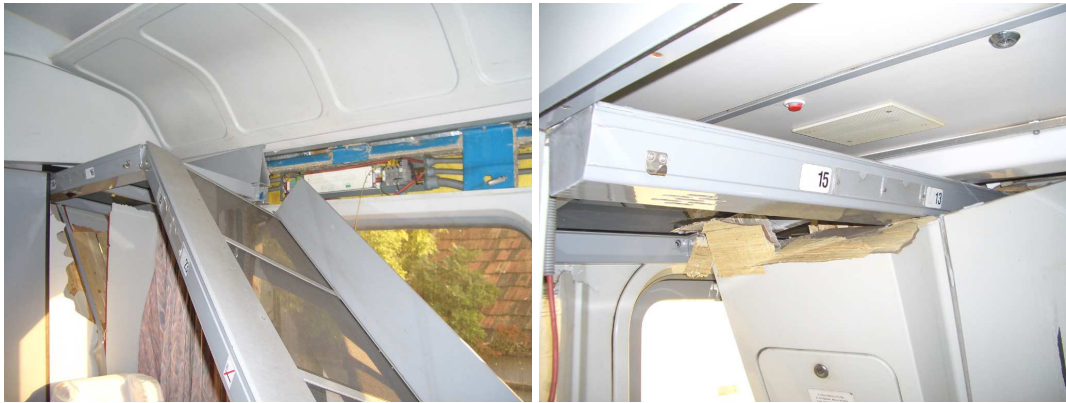
**Figure 25: the luggage rack penetrating the wall of the toilet**

It is visible in Figure 5 and 25 that the luggage racks fell as a result of the collision, however, they themselves remained in one piece, were not damaged or broken.
