KÖZLEKEDÉSBIZTONSÁGI
SZERVEZET
TRANSPORTATION SAFETY
BUREAU

FINAL REPORT

**2009-028-6
SERIOUS MARINE CASUALTY**

**Szigetköz
Cikolaszigeti Kőhídi Duna
3 May 2009**

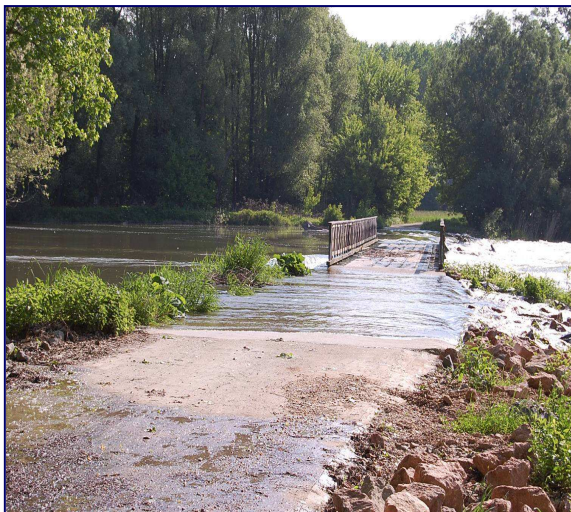
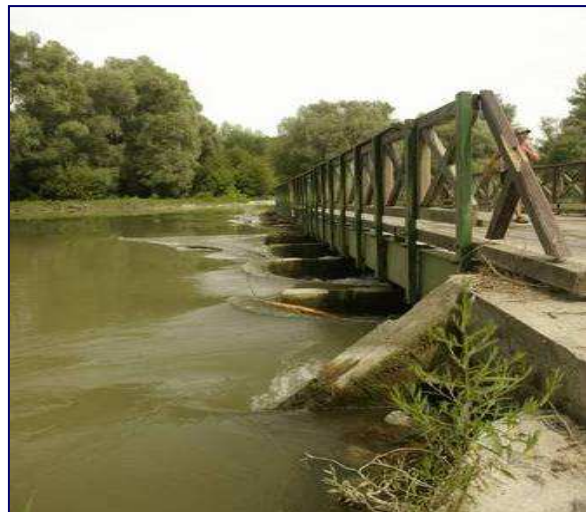
The casualty did not occur at a port. The river is 50 metres wide after the bridge and it widens to 160 metres under the bridge. Both roads leading to the bridge are concrete and their sides at the bridge are reinforced with ashlar. In time of floods, the scum can get caught on these ashlars as a consequence of which, irregular water movements are possible.

Figure 2: Stone-bridge at Dunakiliti, where the boat overturned

The captain of the boat disregarded the characteristics of the swollen river and the stronger current when he was planning to moor in the immediate vicinity of the bridge. Therefore they were so close to the bridge that the current swept the boat and dragged it under the bridge. In this high water level, they should have moored way before the bridge so that they would be able to pull the boat out of the water. None of the participants of the river tour wore life jackets - they might have been overconfident of their swimming skills or found them uncomfortable to wear - yet wearing them would have prevented the occurrence of the fatal casualty.
