FINAL REPORT
CONCERNING
THE TECHNICAL INVESTIGATION
OF AVIATION ACCIDENT

[REDACTED]
LET L-410UVP-E
HA-LAR
27.01.2005
Iasi Airport

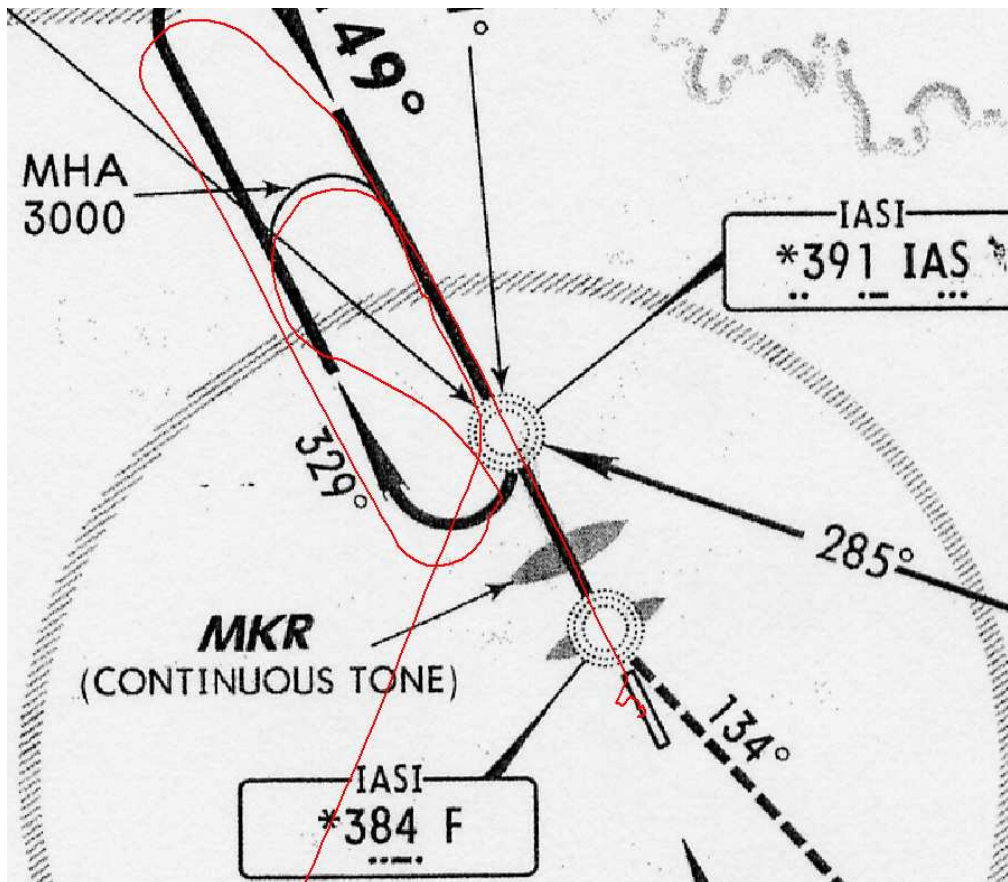
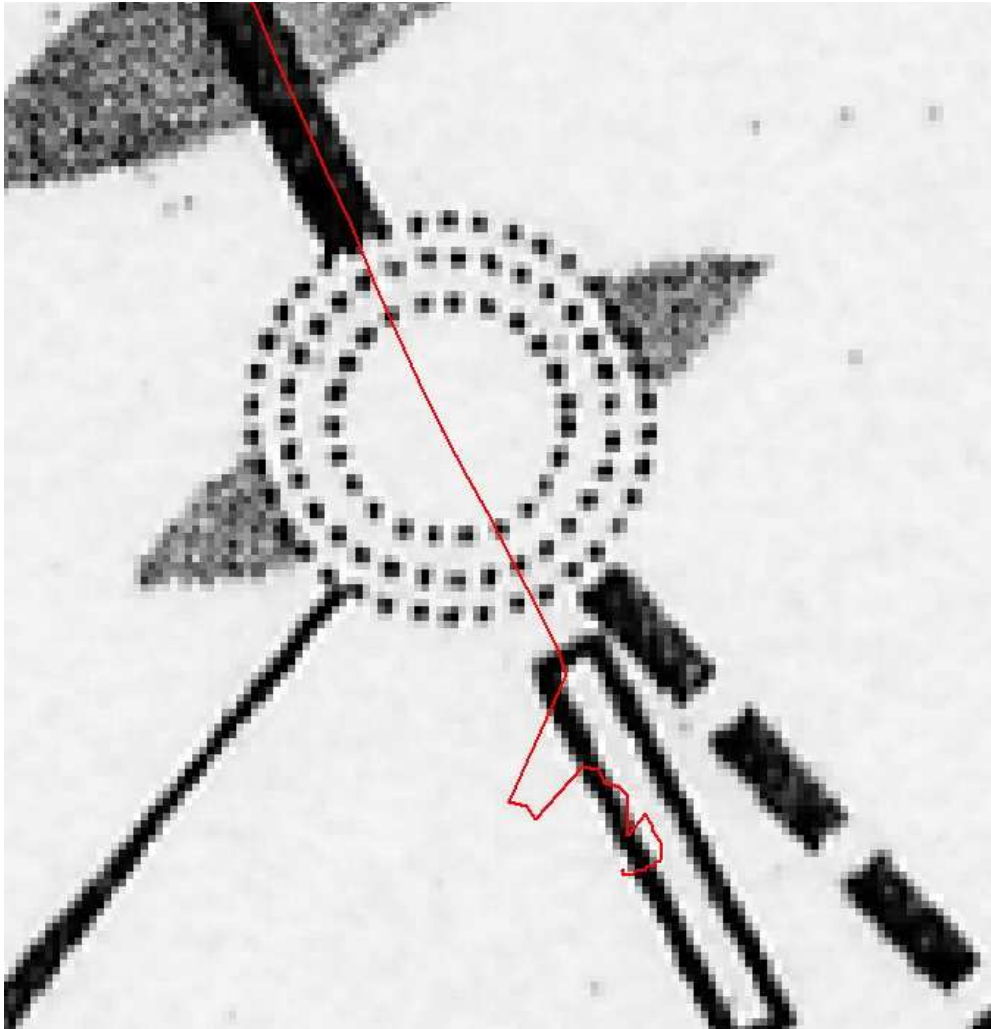
The logged flight path is shown hereinafter:

The result of this test shows that the GPS data could be affected by the PAR radar frequency as shown in the figure above (the red line). However, in case the crew conducted the flight using GPS, they could follow an erroneous track during the short final approach. The amount of erroneous data could increase during icing condition.

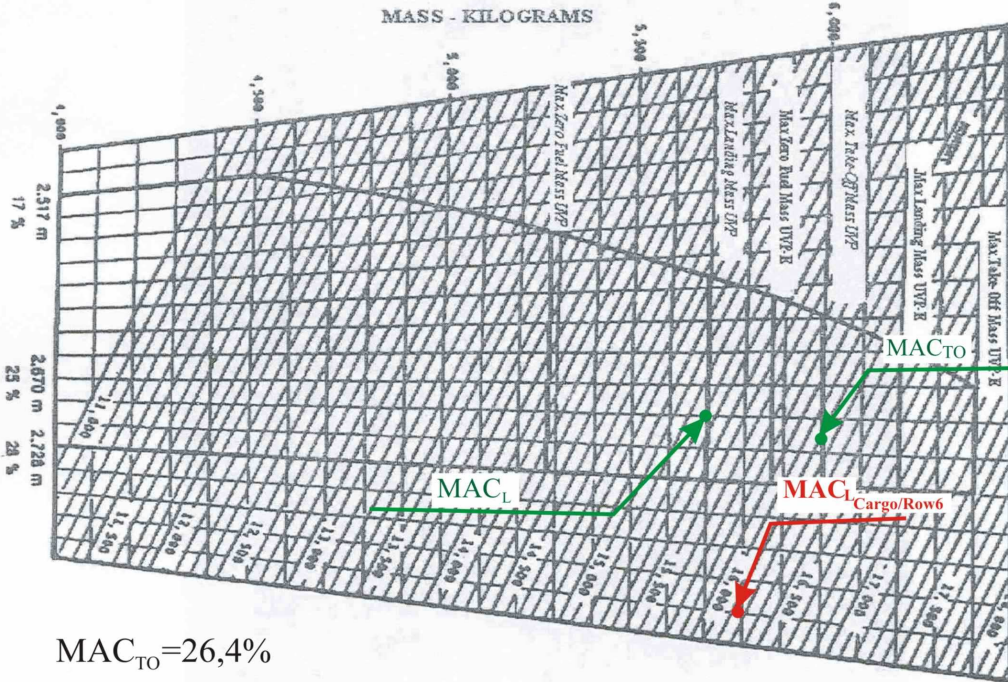
LOAD SHEET AND BALANCE CHART FOR CARGO VERSION
L-410 UVP, L-410 UVP-E

MAC_{TO} = 26,4%

MAC_L = 25,8%
