**Accident Report a/c HA-SUD
Tympaki Airport, Crete
29th June 2008**

Report No 06 / 2009

Accident of the a/c HA-SUD near Tympaki Airport, Crete on 29th June 2008

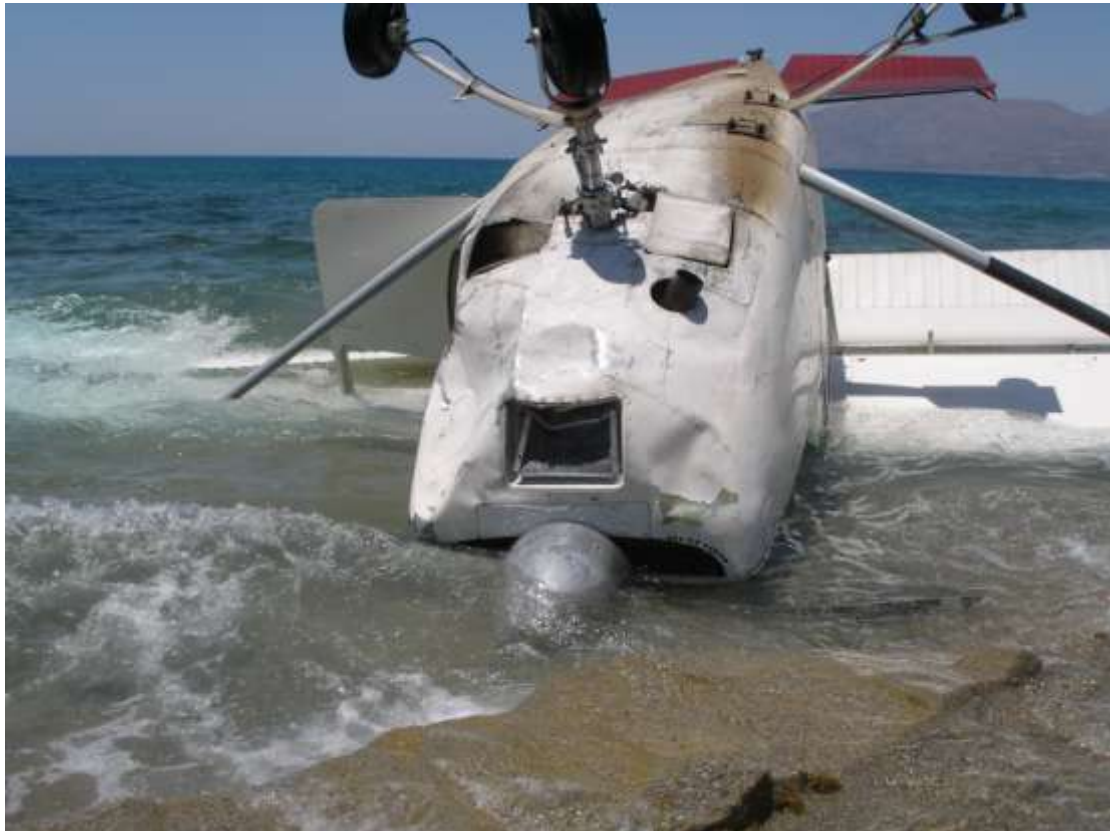
Photo 1

Because of low altitude and the large distance to the runway, K1 saw that it was impossible to reach the airport, and so he chose to ditch the plane near the coast. As there were people on one part of the coast, he manoeuvred in the form of an S to reduce altitude and to ditch it on a clear space along the coastline. During the last phase before ditching the aircraft and whilst flying parallel to the coast he unsecured the left door of the aircraft, reduced the descent speed to minimum (40 – 45 kt) and then extended the flaps to their full position, with a ground speed of 22 – 25 kt, and selected to touch the water with the aft of the aircraft first and to reach as near as possible to the coast. As soon as the main parts of the landing system touched the water, the aircraft turned around its transverse axis and overturned. After it overturned the left wing and the engine sank into the sea and the right wing stayed almost out of the water because it was touching land. The pilot and passengers department were half sunk into the sea. (photo 1).

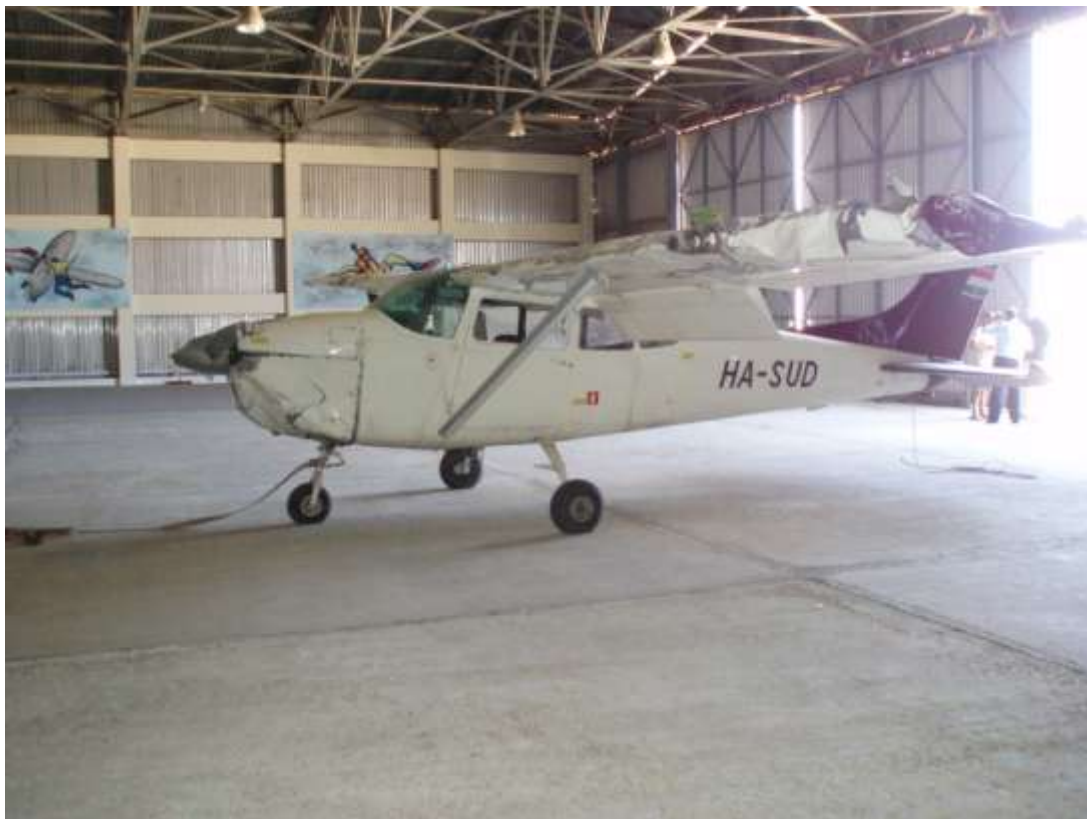
Photo 2

The external optical check reveals that the aircraft suffered serious damage, as described below (photo 2):

- Extended damage to the leading edge and the wing tips of both wings are damaged and deformed.
- Distortion of the propeller.
- Deformation of the propeller's cone and the engine covers.
- Snapping of the antennae of the communication and navigation system.
- Breaking of the windscreen.

The distortion of the propeller, the sinking of the engine and the instrument panel in sea water caused a series of inner damage to the engine, the instruments and other equipment of the aircraft which are not possible to be defined.

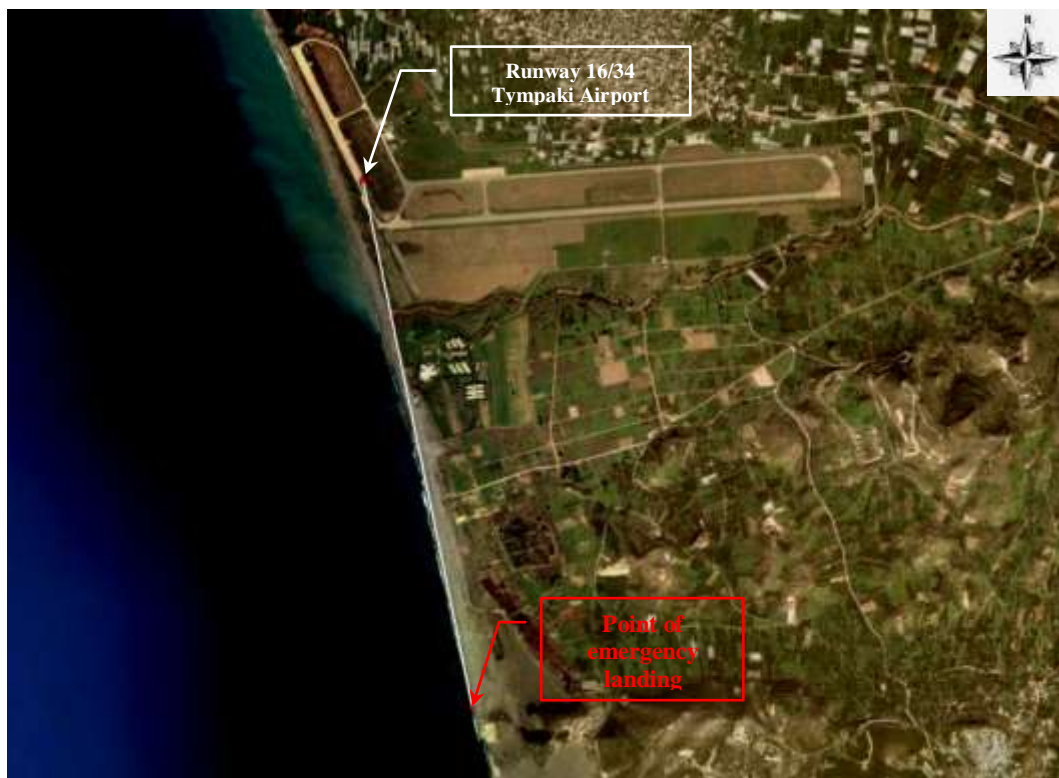
Photo 3

The aircraft was immobilized at location 35°02'14'' N, 024°45'23'' E and at a distance of 2 miles from the threshold of runway 34 (photograph 3).

During the ditching of the aircraft it overturned by turning around its transverse axis, its propeller suffered distortion and both its wings suffered serious damage. The aircraft remained immobilized inside sea water, which covered its engines, the instrument panel and the passenger compartment, without any further debris.
