KÖZLEKEDÉSBIZTONSÁGI  
SZERVEZET  
TRANSPORTATION SAFETY  
BUREAU

## **FINAL REPORT**

### **2006- 0027-5 RAILWAY ACCIDENT**

#### **Between Rákospalota-Újpest and Fót stations 5 July 2006**

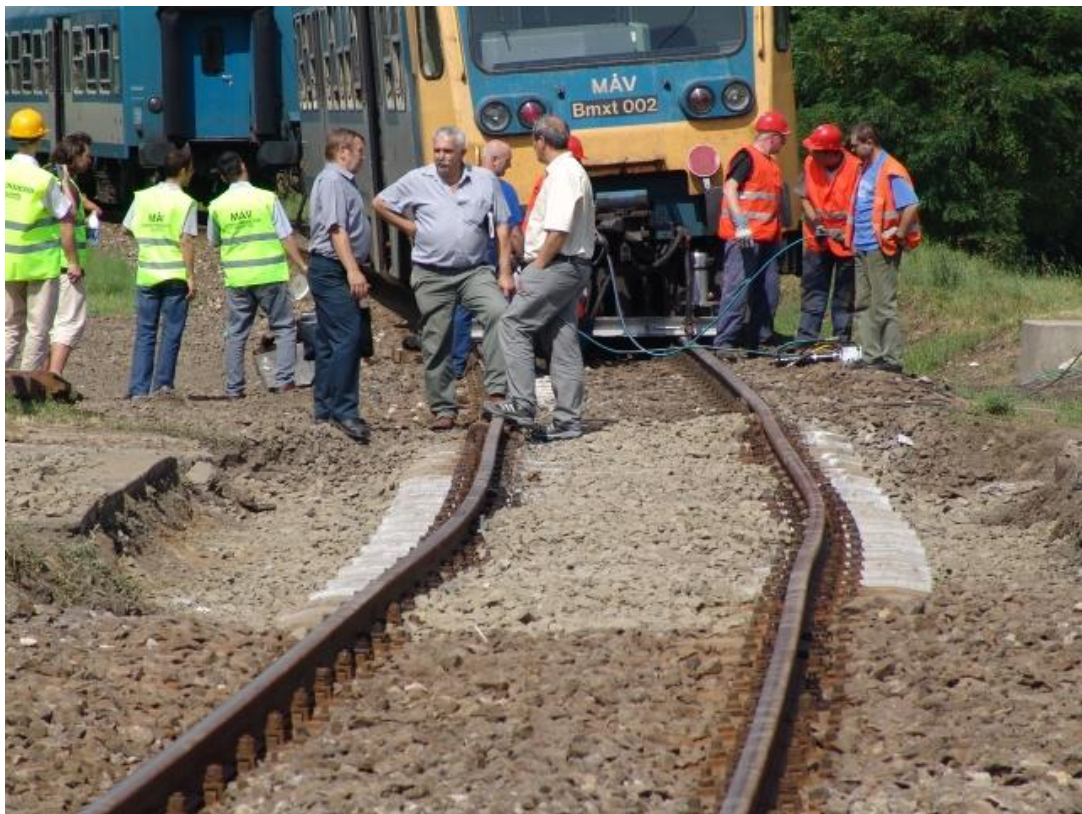
Figure 3: The rail track at the accident site

Having arrived at the accident site, the IC noticed that the new track was substantially deformed, pushed outwards, and the inner rail was lifted. The sleepers in the crossing were found moved sideways, and the cant which was clearly visible at the edge of the crossing became practically nonexistent by the middle.

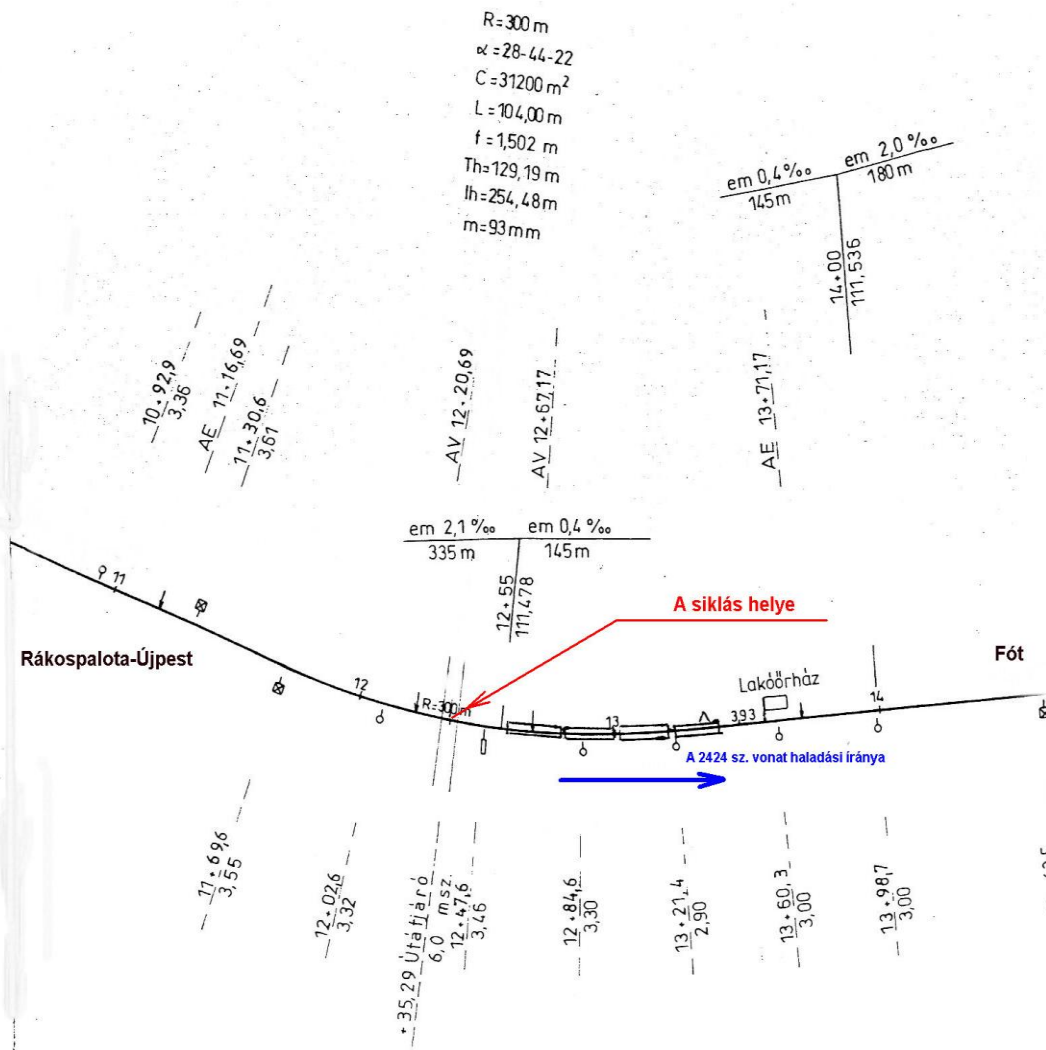
Figure 4: The schematics of the track

The design speed for the track is 60 km per hour, however, there was a (temporary) 20 km per hour speed limit in force between sections 12+00 and 12+50 due to a level crossing construction. The rails of the level crossing section were connected to the main track with clips and C fasteners, and their embedding had not been done yet.
