KÖZLEKEDÉSBIZTONSÁGI  
SZERVEZET  
TRANSPORTATION SAFETY  
BUREAU

# **FINAL REPORT**

**2006-009-6  
SERIOUS MARINE CASUALTY**

**40-tonne ferry: DK 1135**

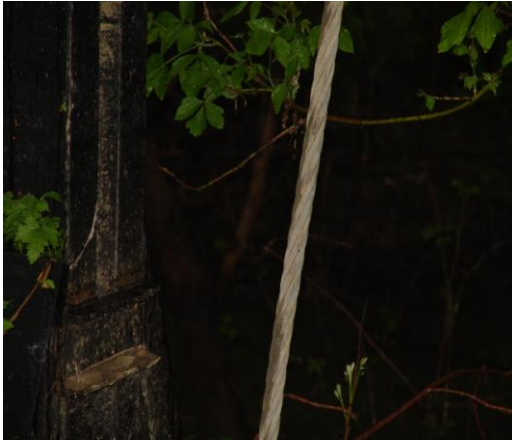
Ferry-rope

On the basis of the samples, it can be stated that the rope had worn away, its staple fibres had lost their stretchiness and therefore they broke easily even when bending only slightly.

**BA2006-009-6\_05:** The IC recommends the NTA to ordain that the ropes of ferries shall be inspected by a level specialist as well at fixed intervals. The inspection should be entered on record and be kept on the ferry. Furthermore, the up-to-dateness and professional contents of regulations regarding the checking of ropes should be reviewed.
