TRANSPORTATION SAFETY BUREAU

FINAL REPORT

2006-020-6 MARINE INCIDENT

MS Almádi

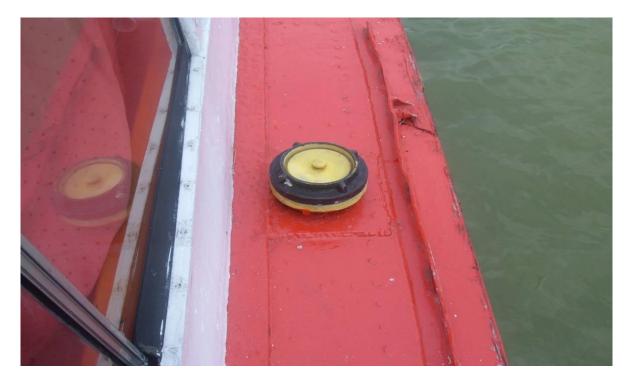
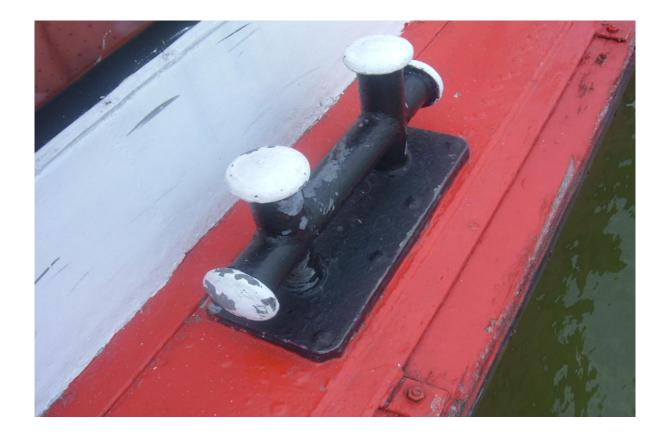
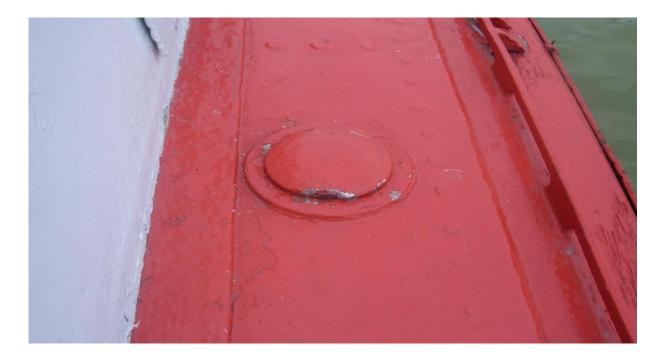
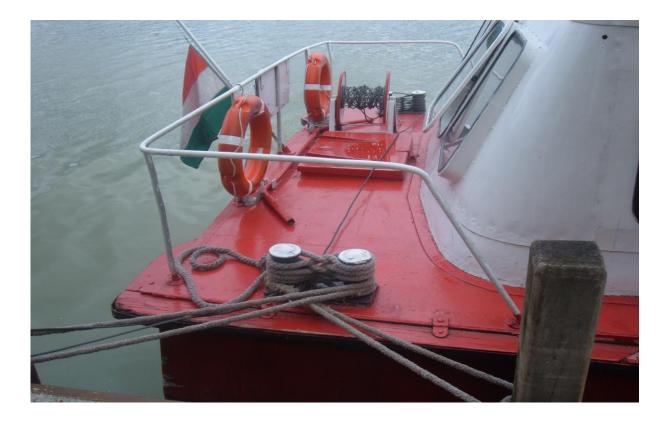
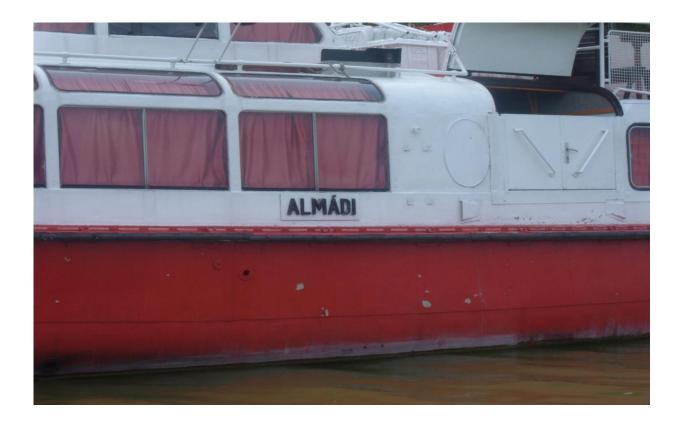
Photos of MS Almádi

The seaman left his post and went to the nearby pub with his friends where they drank alcohol. According to the police record, the seaman's blood alcohol level was 1,75 g/l a thousandth. Coming back to the ship, the seaman probably slipped and tripped over some protruding mountings on the deck of the hull and he fell into the water.

BA 2006-020-6_01. The IC recommends the NTA that it should prohibit the fitting of protruding mountings on the narrow and slippery deck on the sides of the ship. These mountings (except for the fittings for mooring the ship) should be designed in a 'sinkable' form to be able to let them down into the level of the deck.

BA 2006-020-6_02. The IC recommends the NTA that based on previous years' experiences, a so called 'floating rescue pole' should be fitted to the stern on a rope. This method was applied by MAHART in the 1970s and 1980s on their river cruising passenger boats at overnight stops. Naturally, the pole shall be paid down when sailing.
