FINAL REPORT

2006-028-6

MARINE INCIDENT

Collision of passenger ships MS Mozart and MS Csárdás

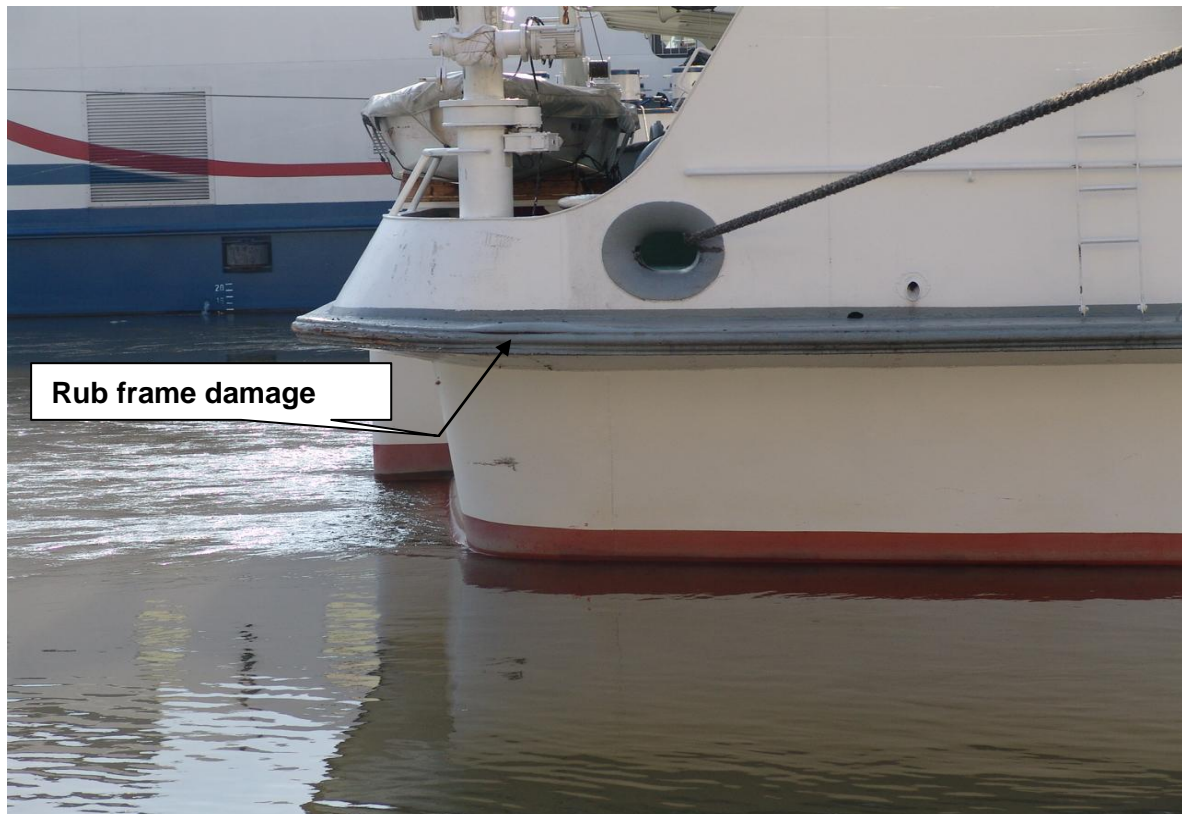
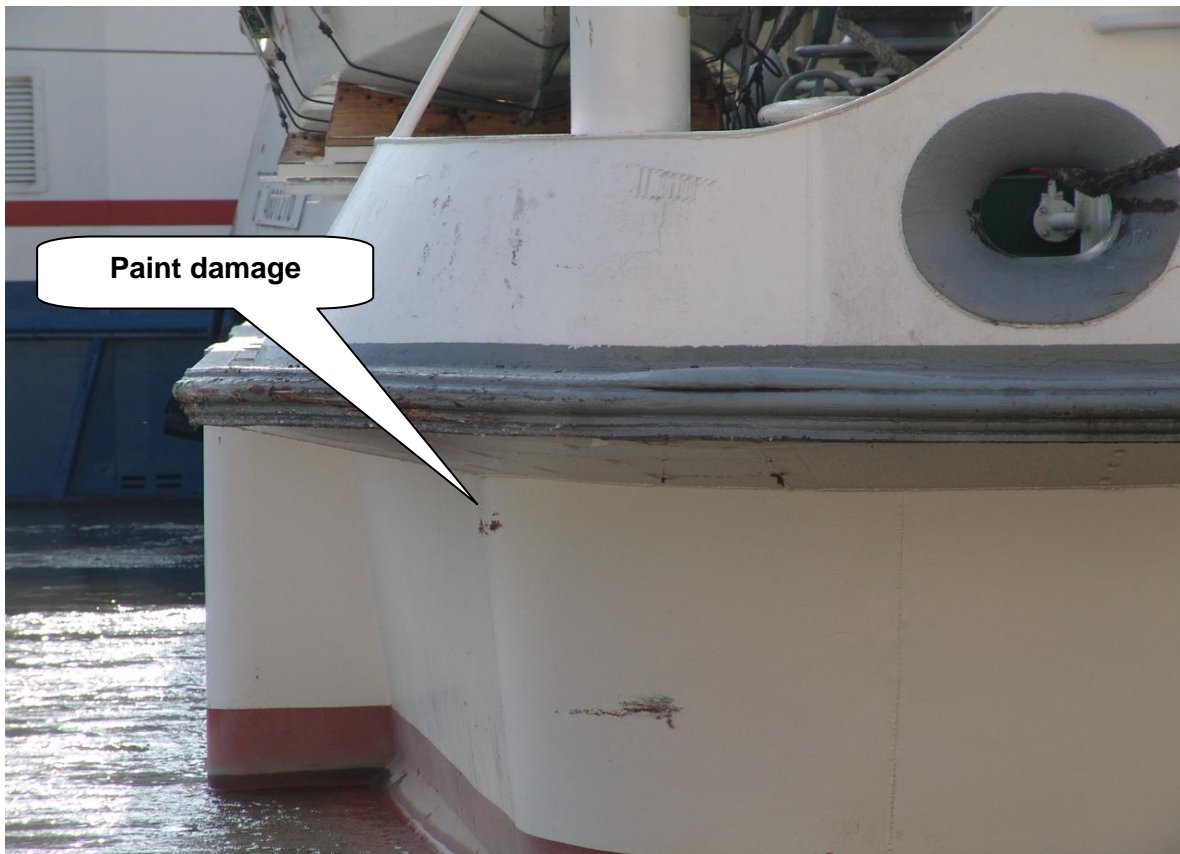
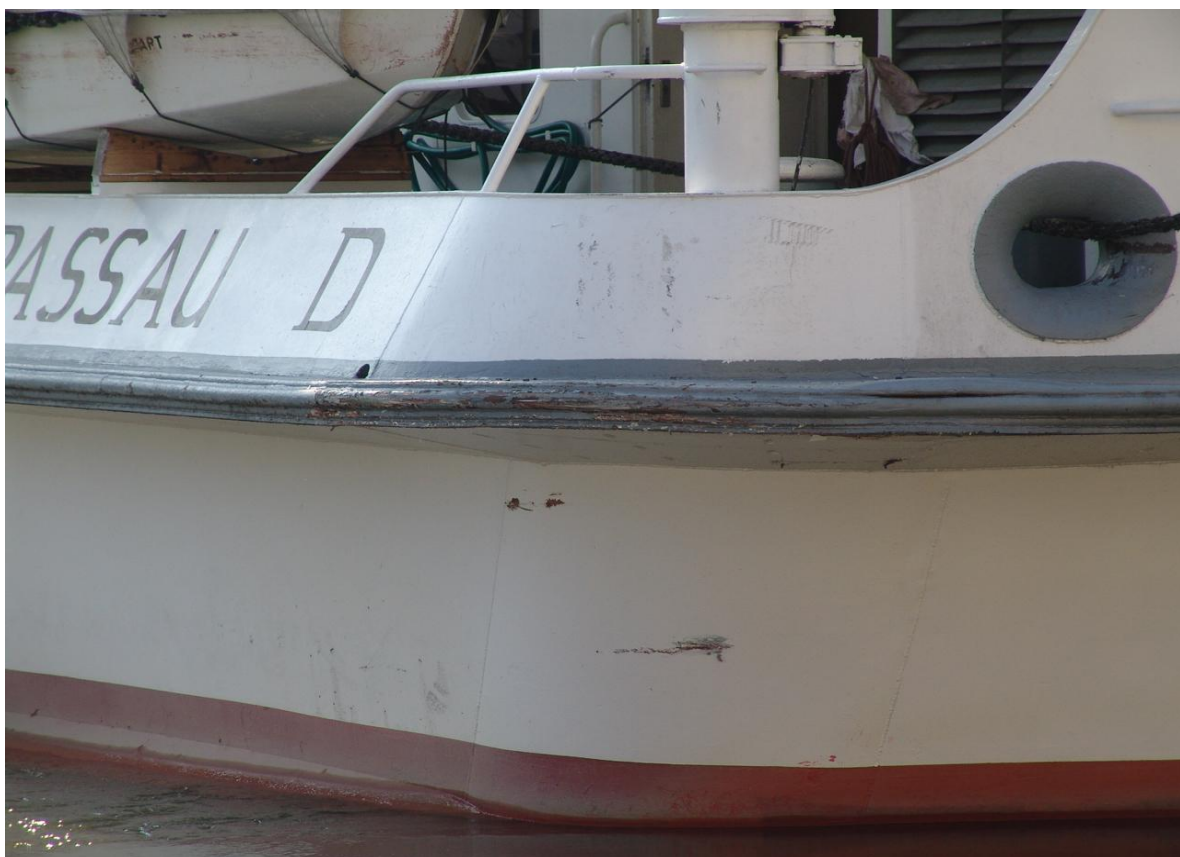
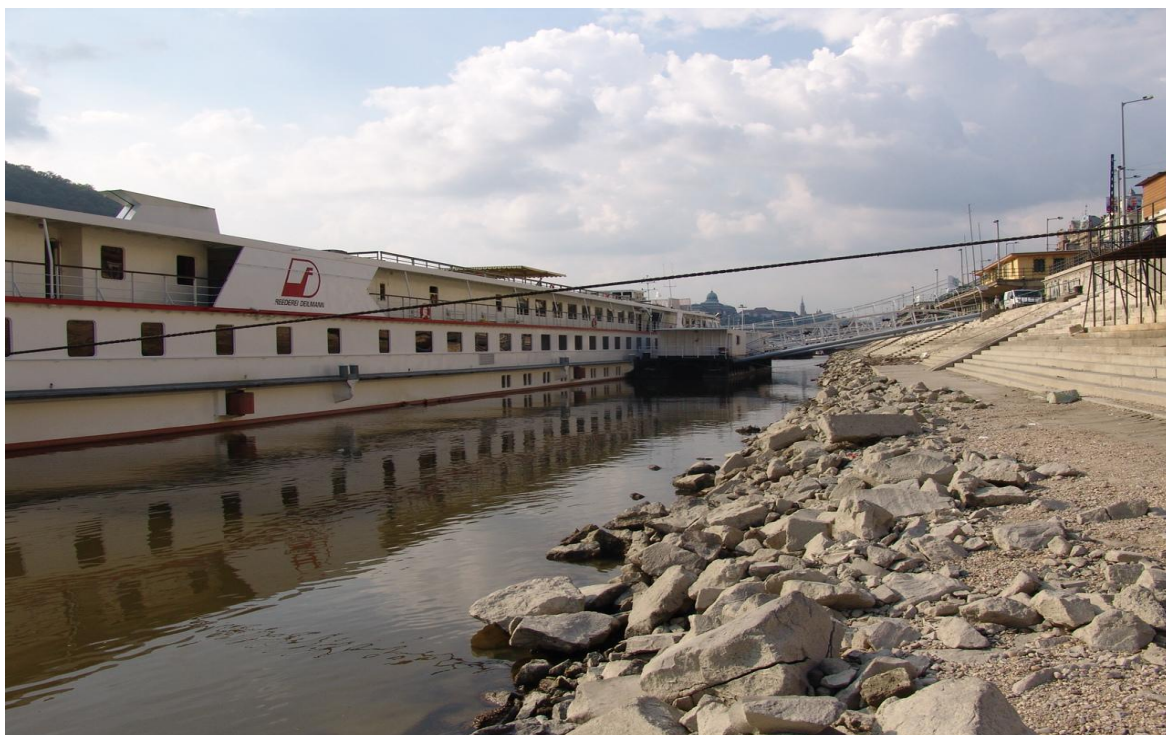
Photos of MS Mozart

The MS Mozart was only slightly damaged. Only a minor scratch was detectable and the paint came off where the two ships collided.

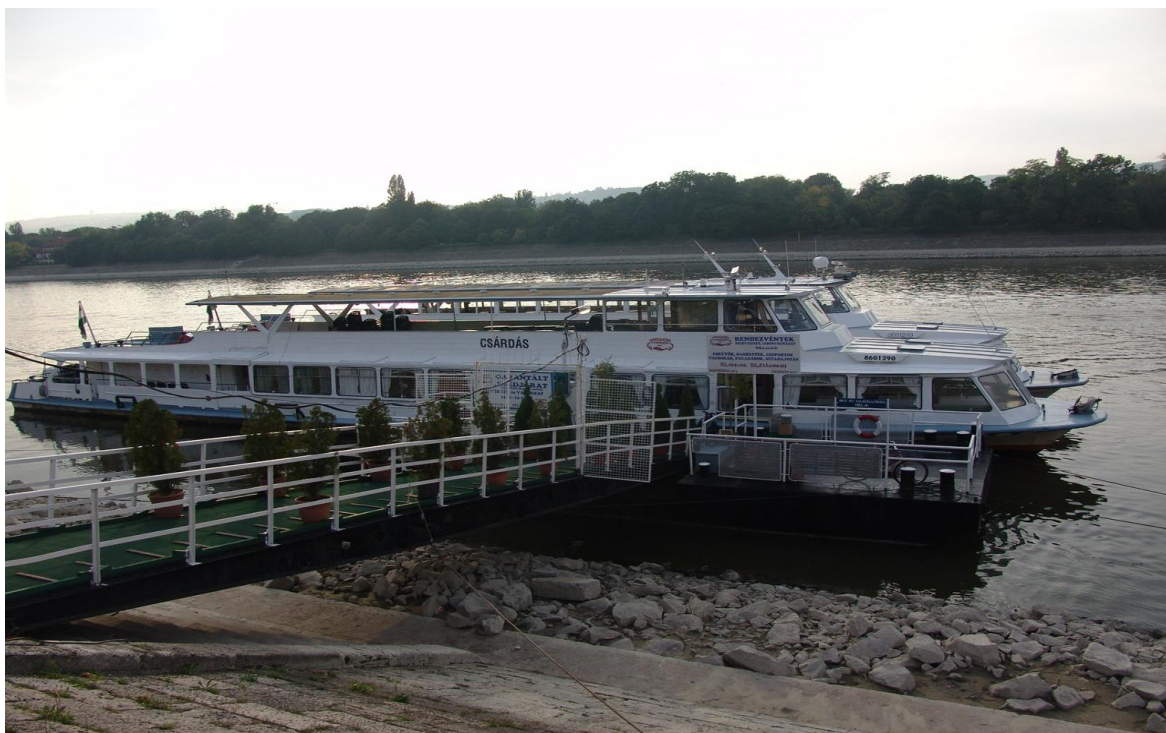
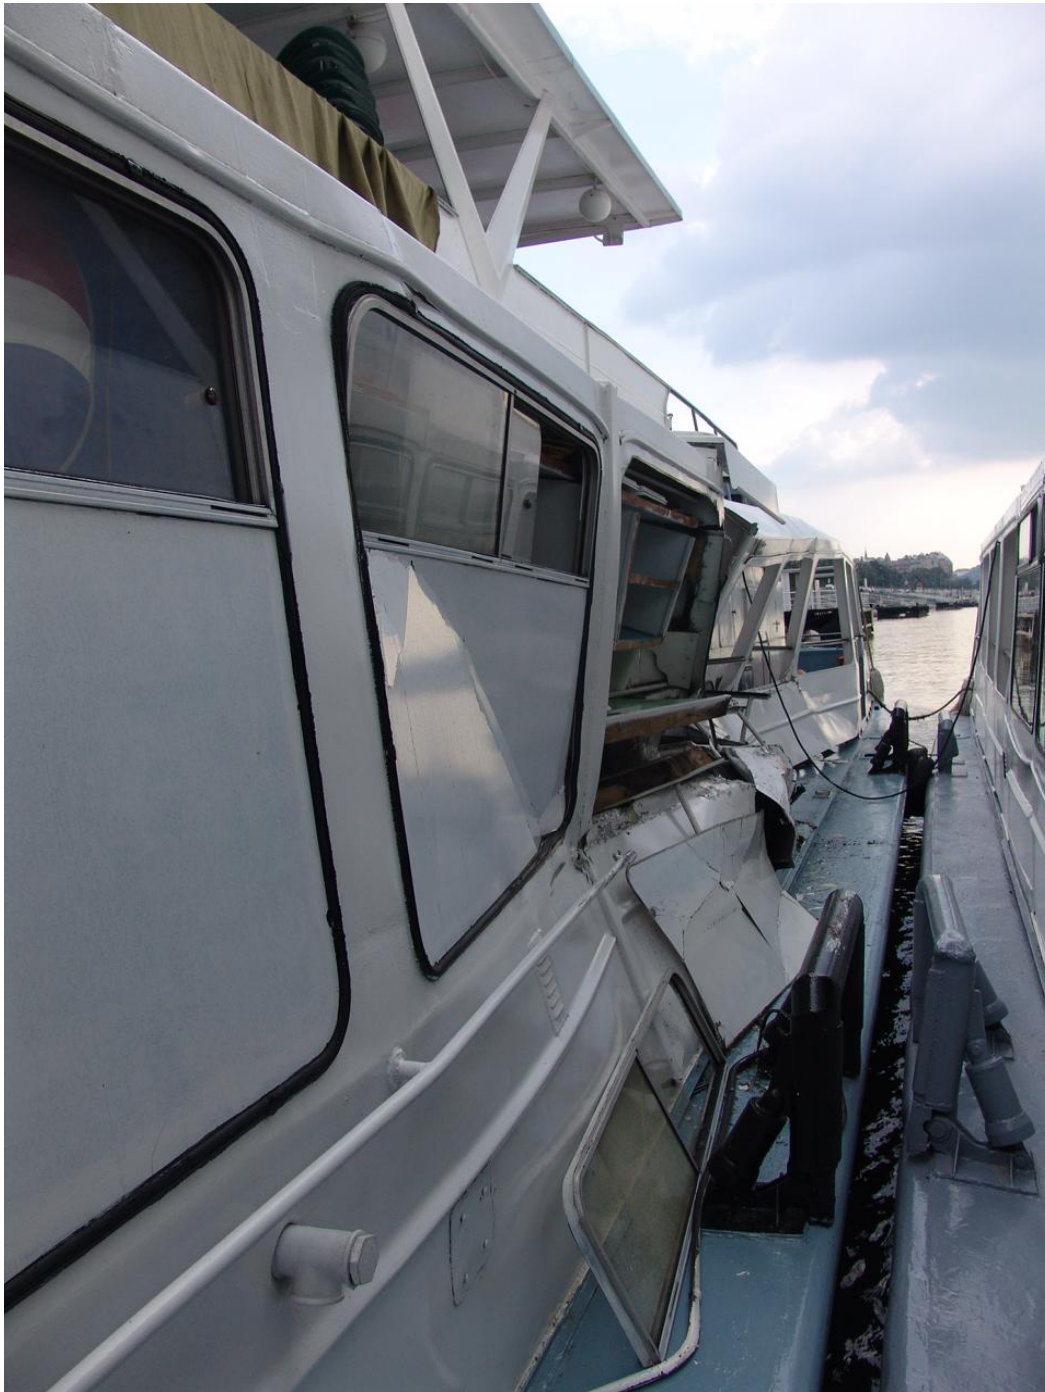
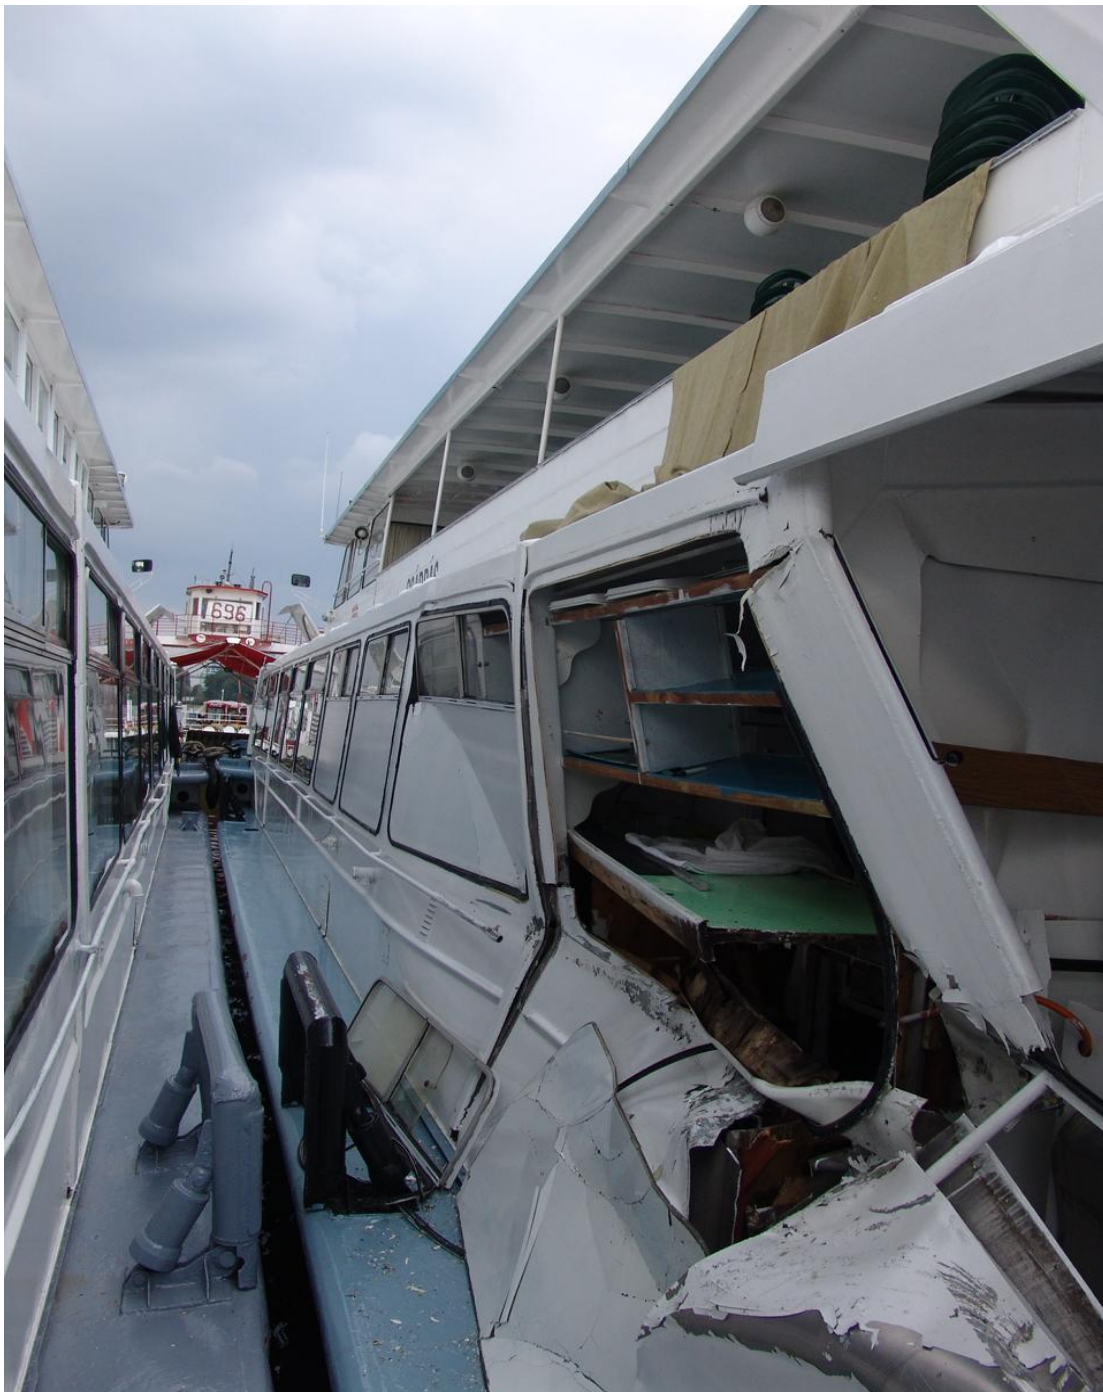
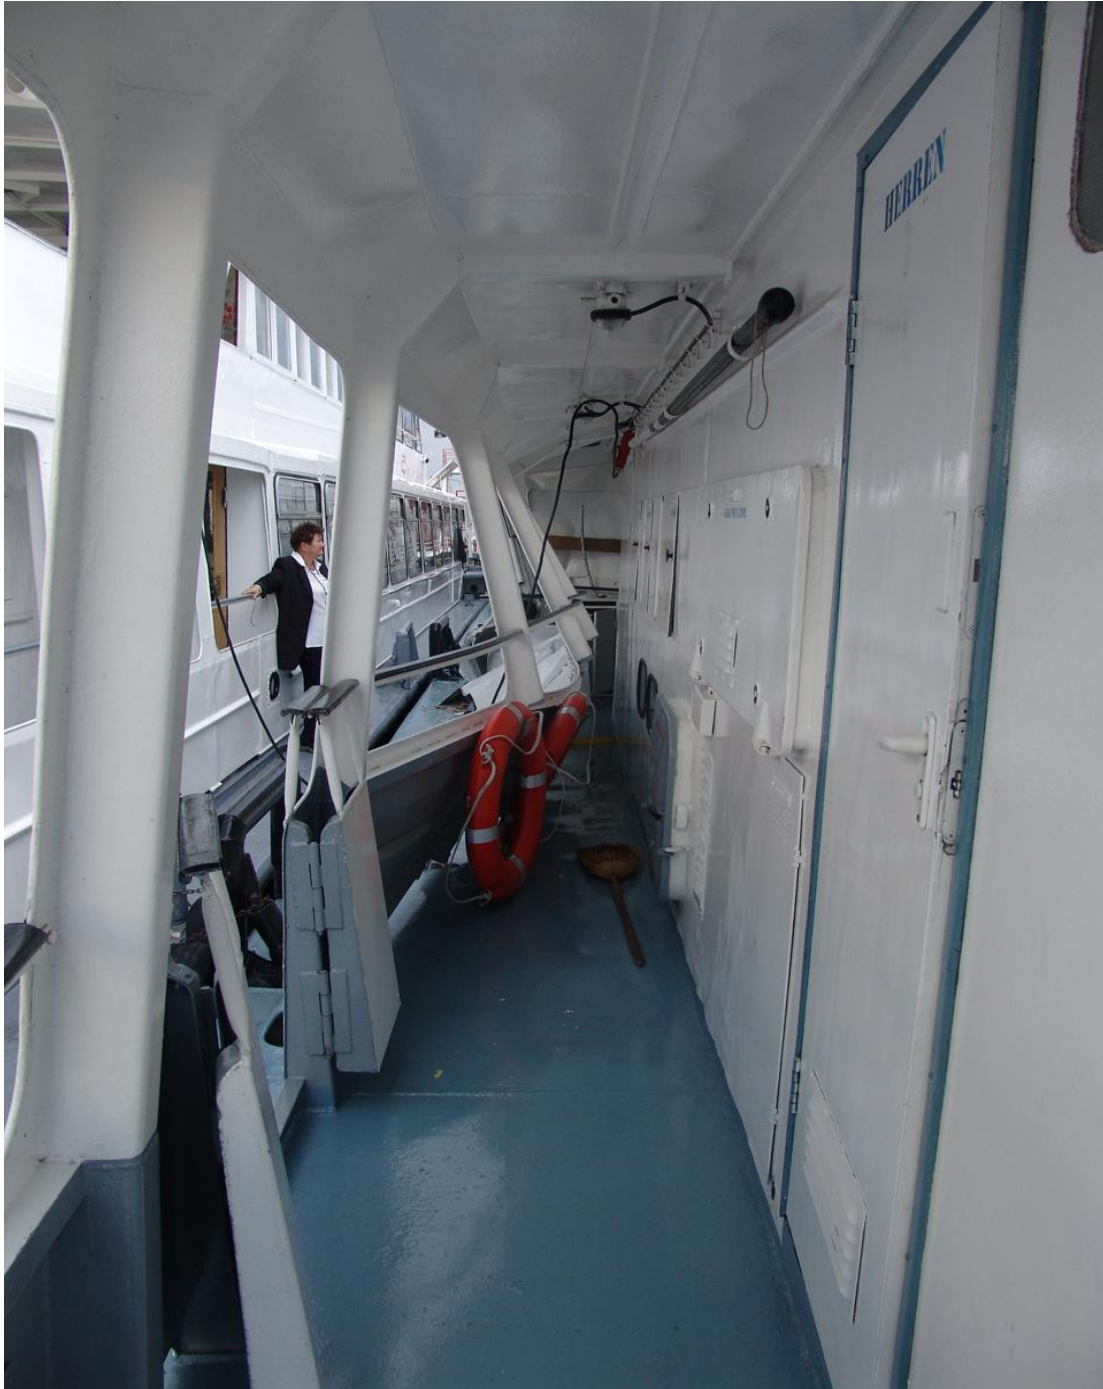
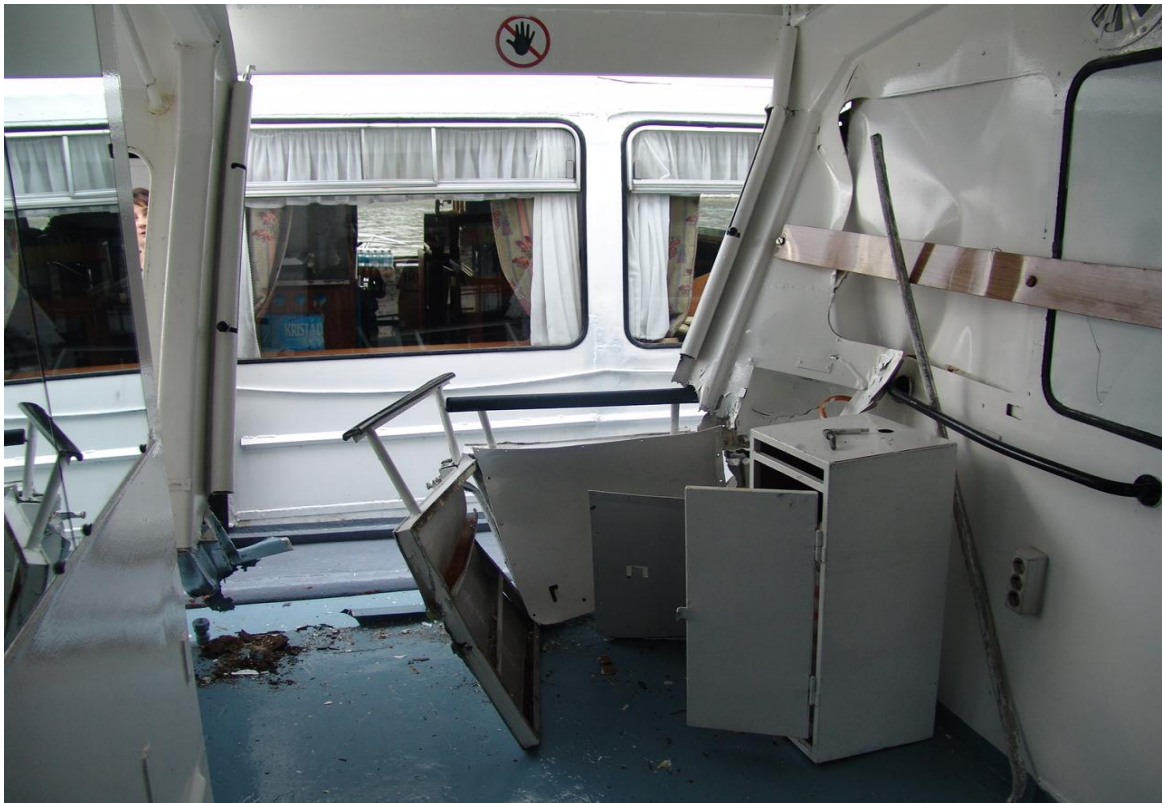
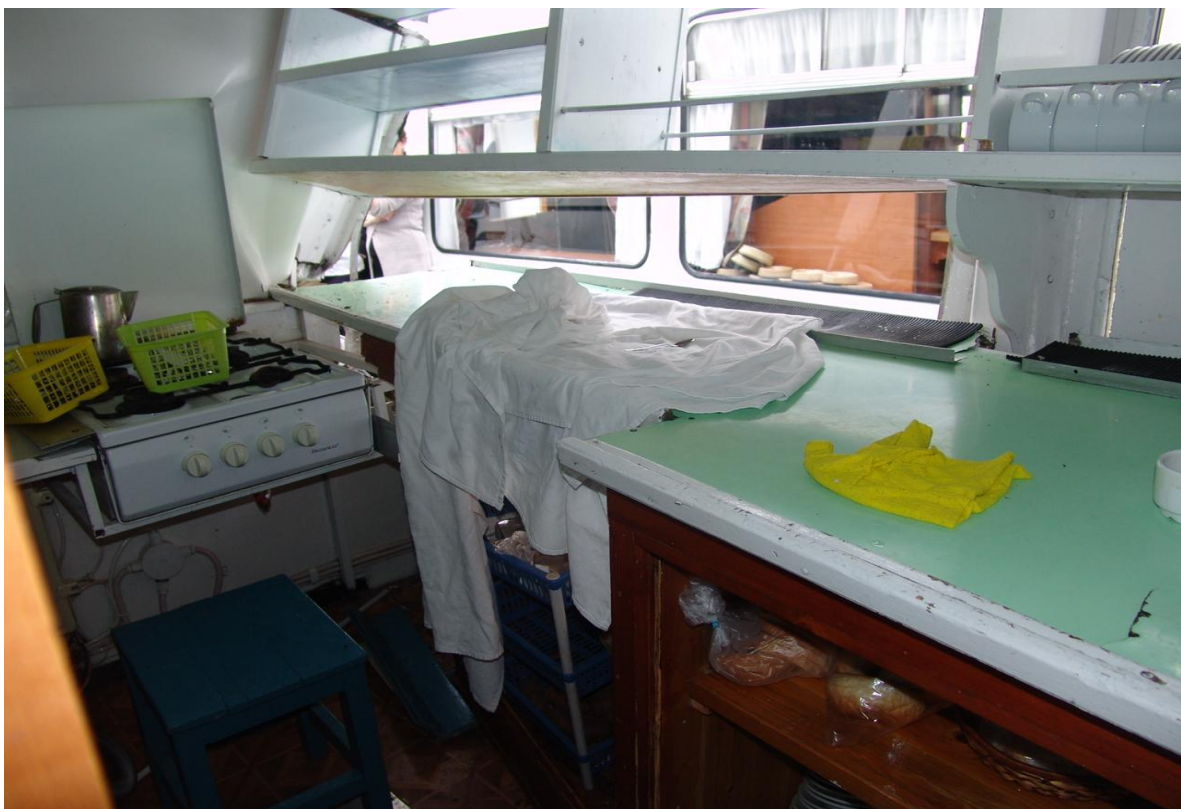
Photos of MS Csárdás

The MS Csárdás sustained substantial damage. Parts of the galley sidewall and galley furniture as well as 6-8 metres of the railing on the portside were completely damaged.

The skipper of MS Mozart signalled the ship's turn in advance a number of times. The two skippers consulted before the incident by radio on channel 10 and agreed that MS Csárdás would slow down and give MS Mozart a safe turning space. The skipper of MS Csárdás evidently failed to follow the conditions agreed upon, and due to the inadequate distance and the draw-in effect, the two vessels collided. The MS Csárdás sustained heavy superstructure damage at her portside near the galley.
