OPERATOR SUPPORT DEPARTMENT

INVESTIGATION REPORT

REF : MTEA 2008/237-1

ENGINE FAMILY	N/S	DATE OF REPORT	WARRANTY CLAIM	COMMERCIAL FILE		
ARRIUS 2B2	32155	28 th January 2009	N/A	N/A		
OPERATOR	DATE OF ARRIVAL	REASON FOR ENGINE RETURN				
National Air Ambulance	06 th August 2008	HELICOPTER ACCIDENT INVESTIGATION (31 st July /2008)				
ACCIDENT	INCIDENT					
OUI <input checked="" type="checkbox"/> NON <input type="checkbox"/>	OUI <input type="checkbox"/> NON <input checked="" type="checkbox"/>					
REFERENCE ACCIDENT / INCIDENT						
2008/237						
ENGINE MODULE	S/N	WORKS PERFORMED	TOTAL HOURS	TOTAL CYCLES	HOURS SINCE OH	CYCLES SINCE OH
Regulation harness	690B	Investigation	1170.28			
Control harness	680B	Investigation	1170.28			
Module 01	1048	Investigation	1170.28

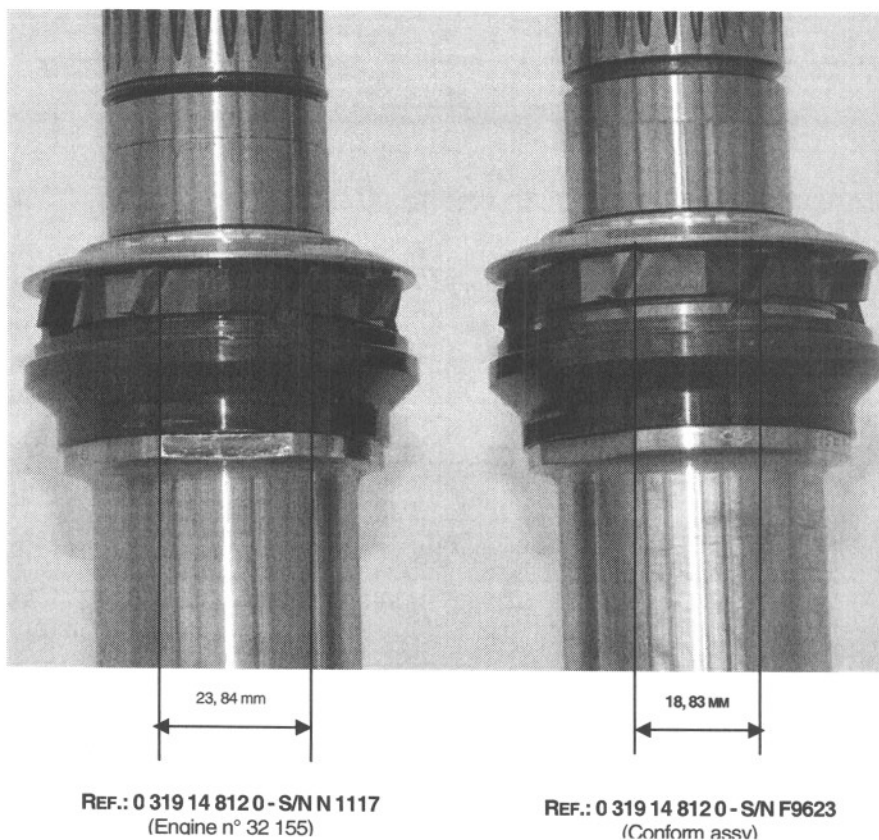
Photo n° 1

The first findings revealed a movement of the 'Reference shaft' with regard to the 'Power shaft'. This movement was made upward (approx. 2 mm) and in rotation (approx. 12,4 °) and was the consequence of the impact undergone by the 'Power shaft' during the crash. (See photos n° 1 and n° 2)

This finding is consistent with the damage observed on the splines of the Power shaft.

The movement of the 'Reference shaft' with regard to the 'Power shaft' is the result of the rupture of the pin at impact. The variation of consequent phonic distance from the teeth of the phonic wheel in the movement of the 'Power shaft' induced a angle shift (approx. $12,4^\circ$) outside nominal functioning range (maxi of $3,7^\circ$). (See photo n°1)

During the engine test performed on the test bench, the EECU which continuously check the torque signal characteristics has detected a torque value out of nominal range which led to the loss of the torque indication and the display of the message '0x22' (equivalent to 'TQ channel failure' message).

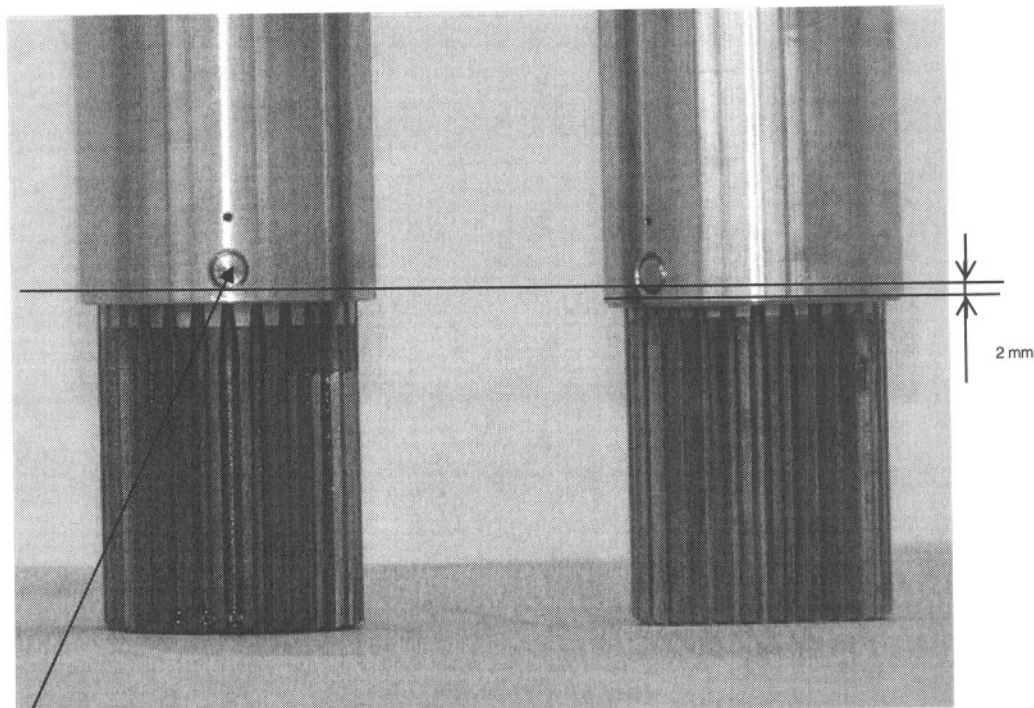
Photo n° 2

Pin
