**FINAL REPORT  
2010-171-4P  
AVIATION ACCIDENT**

**Balatonkeresztúr (outer area)  
10 July 2010**

**TL-2000 Sting Carbon (Ultralight)  
I-9603**

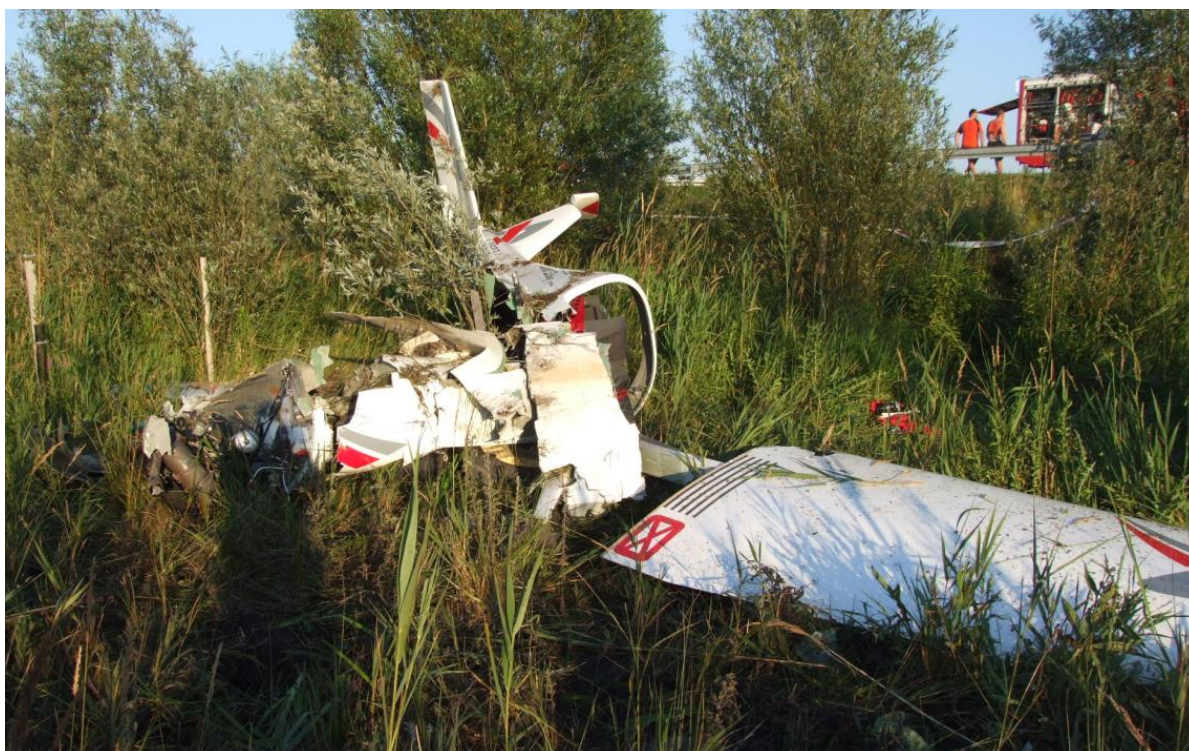
The uncontrolled manoeuvre lasted until the fence of the M7 highway was reached, where the banked aircraft was spun by colliding with the fence, and then impacted the peaty ground and skidded with its tail forward, being shattered and slowing down for 18 m, when it came to a halt. The wreckage can be seen on fig 1.

Fig. 1. The wreckage

The aircraft was completely destroyed in the accident.

The traces left on the ground by the impact and also the position of the wreckage implies that first the aircraft hit the wire fence with its left wing, then after having spun and the left main landing gear having been torn off, the body of the aircraft

impacted the ground with its nose part, in an angle of approx. 25-30 degrees. On the soft, peaty ground it skidded with its tail forward, being shattered and slowing down for 18 m, when it came to a halt 600 m from the runway. The resulting wreckage was seized by the competent police authorities for investigation.

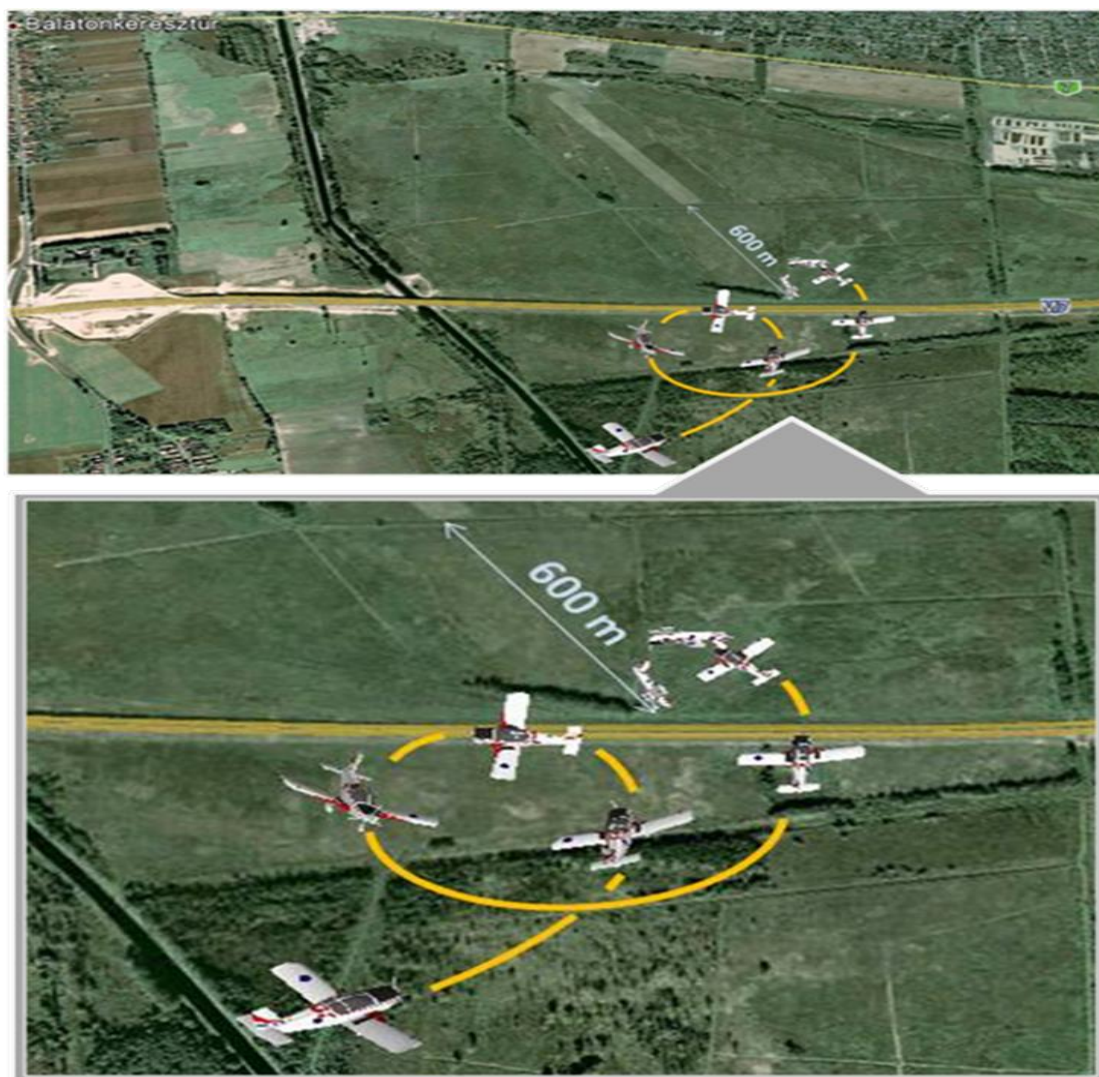
Before turning to the runway heading, he carried out a 360 degree left turn by a bank angle of approx. 30-40 degrees, in order not to disturb another aircraft on the glide slope, preparing to land. After the full turn, at 60-80 m, the pilot reduced the power of the engine to idle. As a consequence the aircraft slowed down, stalled and got into a spin.

The pilot told the IC that the interruption of the approach (carrying out the 360 degree turn, as seen on fig. 2) was necessary to increase the distance between his aircraft and a landing aircraft. The eyewitnesses, however, were united in their view that there was no aircraft on the glide slope.

In the opinion of the IC the pilot conducted the last turn before final with a relatively low airspeed and reduced engine power to idle without pushing down the nose of the aircraft. As a result the inner wing stalled and the aircraft went into a tailspin.

Fig. 2. The flight path of the aircraft prior to the occurrence
