MINISTRY OF
NATIONAL DEVELOPMENT
TRANSPORTATION SAFETY
BUREAU OF HUNGARY

FINAL REPORT

**2014-230-4P
Incident**

**Boeing 737-600
TS-IOK**

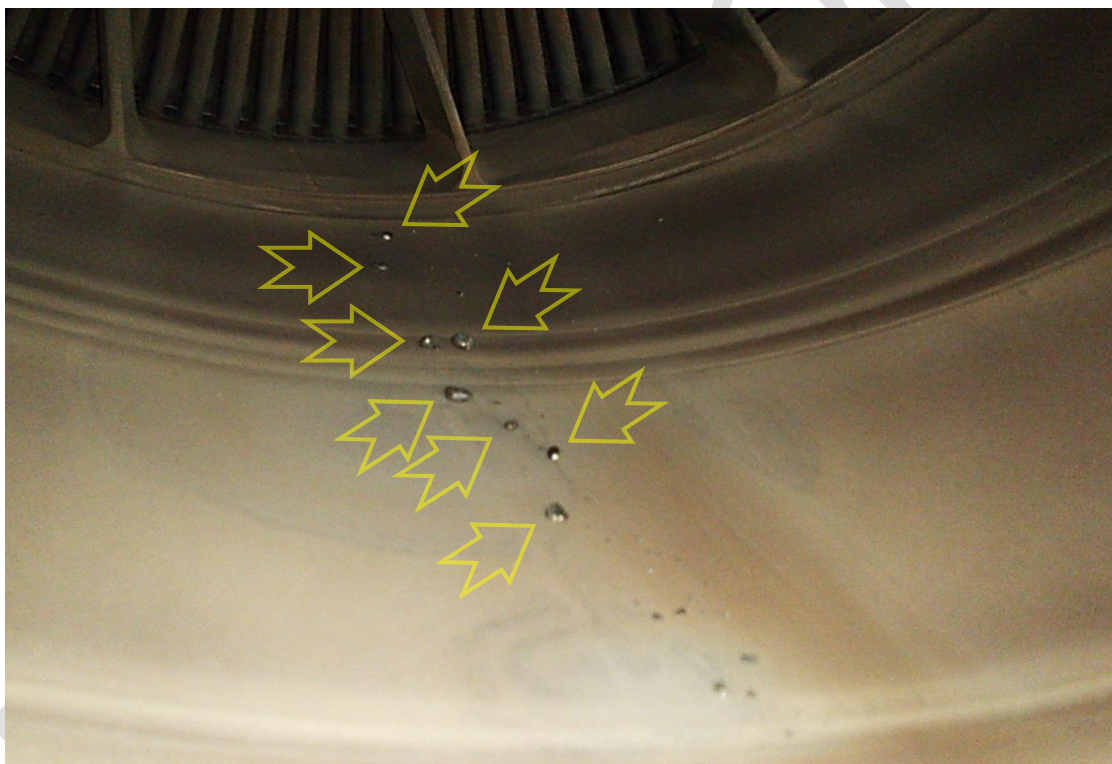
Figure 3: Molten metal in the tail pipe of the Engine №1 after the event

During the check of the aircraft, molten metal debris was found in the tail pipe of the malfunctioned engine, and, at the same time, the FMC screen showed "EGT HOT START", an engine start fault message. Between 17:20 and 17:30 hours, the aircraft was towed from Runway 31L to Stand №223. The "Aircraft Related Incident" alert was cancelled at 17:31, with giving notification to those involved. After checking it for obstacles and contamination, Runway 13R/31L was reopened for traffic at 17:39.

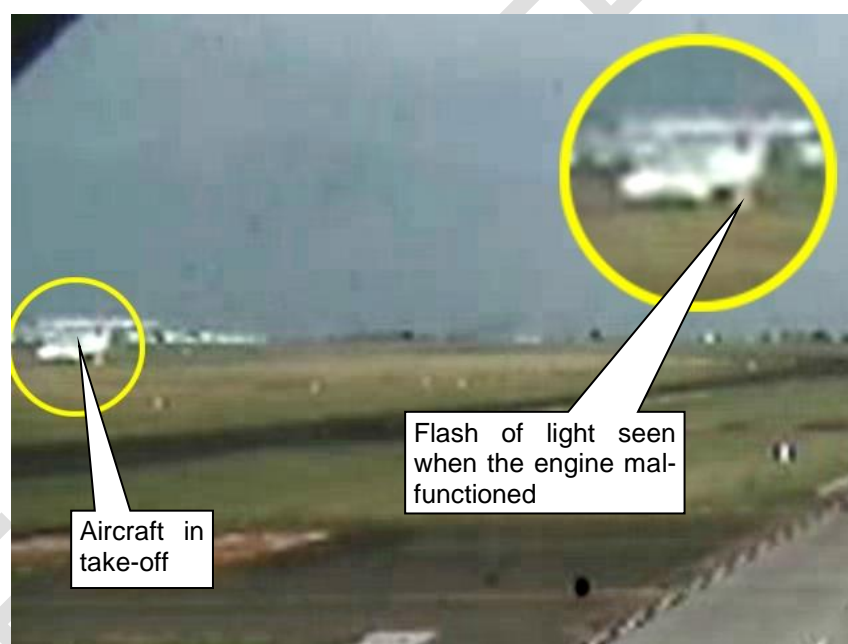
Figure 4: *The moment of the malfunction as recorded by a surveillance camera*

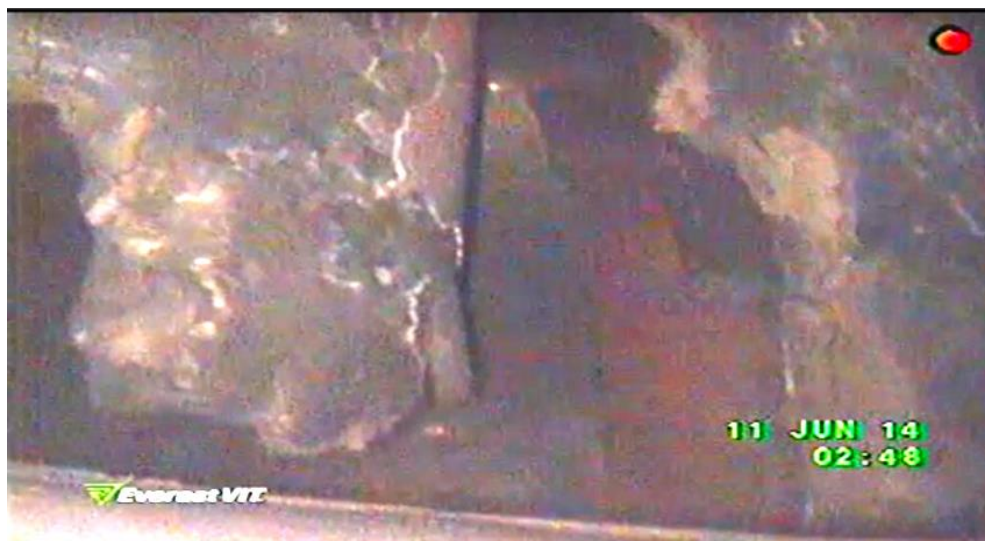
Engine №1 of the aircraft on the left was seriously damaged and had to be replaced.

Figure 6: An image of the damaged high-pressure turbine, taken during the borescopic examination performed on the day after the occurrence.

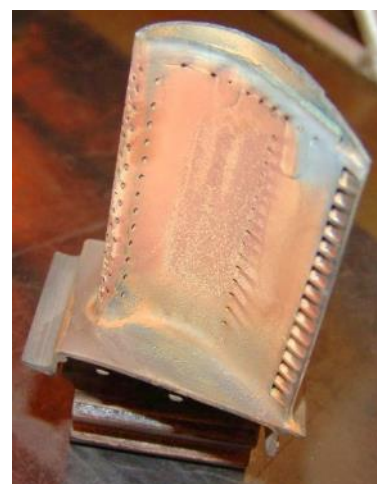
Engine disassembly revealed two HPT blades which had separated in the shank area and exhibit-

Figure 8: CFM56-7B high pressure turbine blade

ed fractographic evidence of fatigue. In both cases the fatigue had started from the internal wall of the cavity. At both HPT blades the area of origin of the fatigue cracking was situated along both the convex and concave wall of the cavity. Oxidation blisters were found near the point of origin of the cracks in the inner surface of the aforesaid cavities.

The malfunction of the engine was triggered by the fatigue fracture of a blade of the rotating part of the high pressure turbine, which took place during take-off in Budapest when the power of the engines was increased. The fracture of one blade soon led to the fracture of several other blades, strong vibration of the high pressure rotating part, engine surge, and finally to massive overheating of the turbine stages and complete engine shutoff. The liberated parts of the blades were broken into small pieces and exited the engine through the tail pipe as tiny fragments.

According to information from the manufacturer of the engine, they were aware of the problem of this kind of breakage of high pressure turbine blades of the affected type at the time of the occurrence, and they had already eliminated it by modifying the construction of the blades.

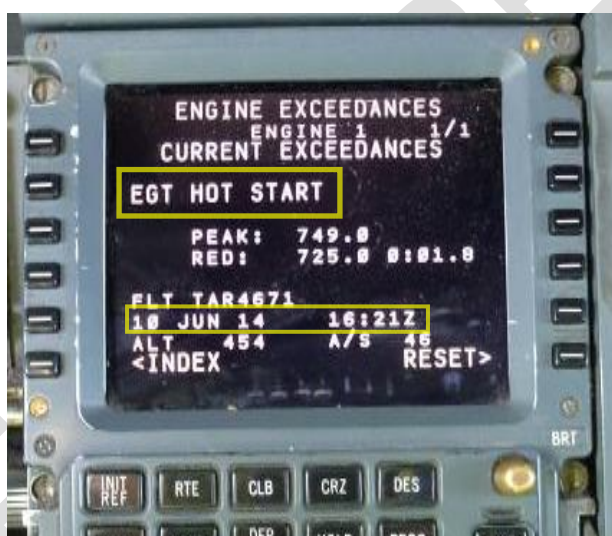
The aircraft was equipped with MCDU. After the occurrence, regarding Engine №1, the system contained the message “EGT HOT START” with the date and time of the interruption of the start, “10 JUN 14 16:21Z”, as shown in Figure 9.

Figure 9 message after the occurrence

According to information from the engine manufacturer (received via NTSB), the content of the message comes from the FADEC device of the affected engine. The message is generated by an increase of the EGT gas temperature over 725 °C combined with a simultaneous low N2 rpm value, regardless of whether the trend of rpm change shows increase or decrease.

According to the IC, an message referring to an engine start irregularity after an event which took place not during engine start may confuse and slow down the investigation of events, as well as the finding and elimination of a possible fault.

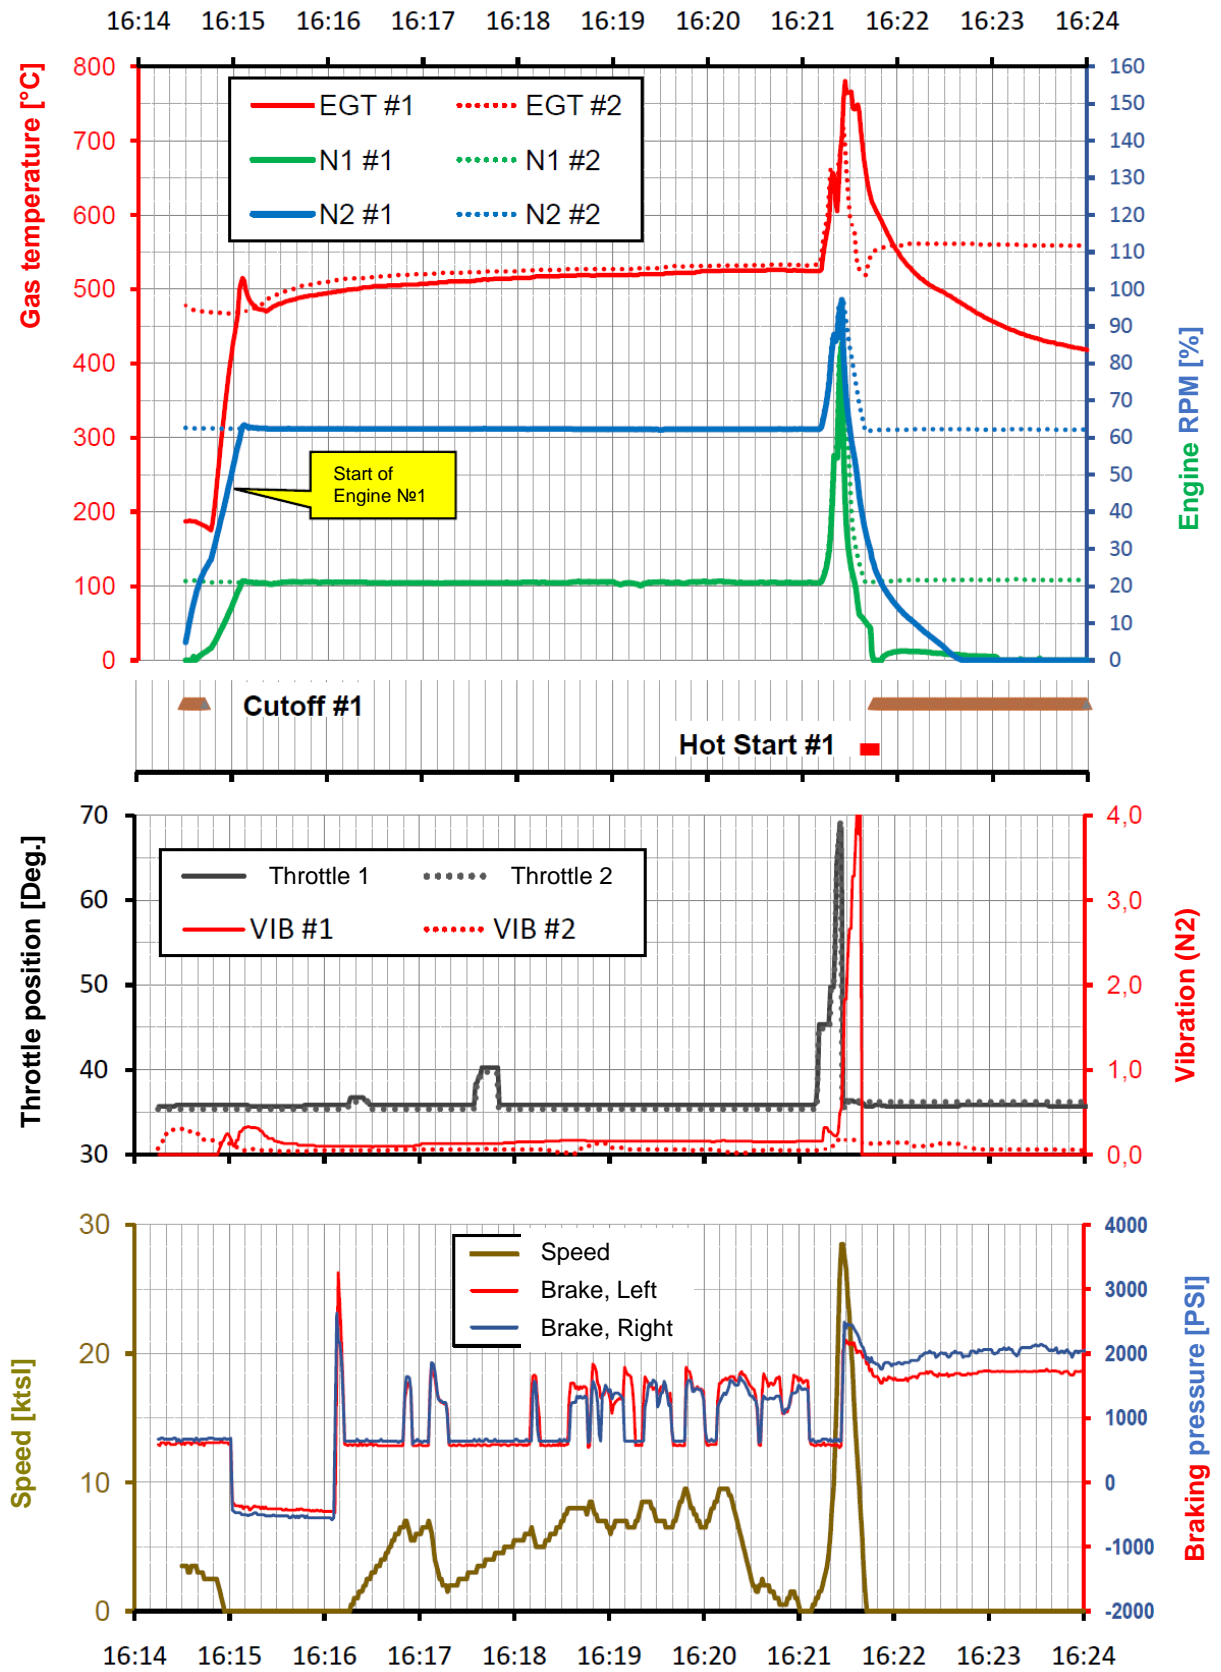
Figure 10: Flight recorder information from engine start till the abortion of the take-off

The flight recorder started recording automatically at 16:14:14 when Engine №2 was started. Until the beginning of the take-off run, the recorded data show the picture of a routine start, from the engine start to taxiing to the runway. When starting take-off (at 16:21:07), the pilots released the wheel brakes, and five seconds later (at 16:21:12) they began to increase engine power by pushing the throttles forward. The rpm values of the engines were still increasing when Engine №1 malfunctioned (at 16:21:25). At that moment, the rpm values (N2) of the high pressure rotating parts of Engines №1 and №2 were 86% and 88%, respectively, and the respective rpm values (N1) of the low pressure rotating parts were 97% and 98%, and the temperatures of exhaust gas were 705°C and 707°C, respectively. Hearing the noise accompanied to the malfunction, the pilots began to withdraw the throttles of the engines which reached the idle position at 16:21:27-28. At 16:21:28, i.e. three seconds after the noise, the wheel brakes were already working full blast. The aircraft stopped at the runway at 16:21:43, after 15 seconds of deceleration.

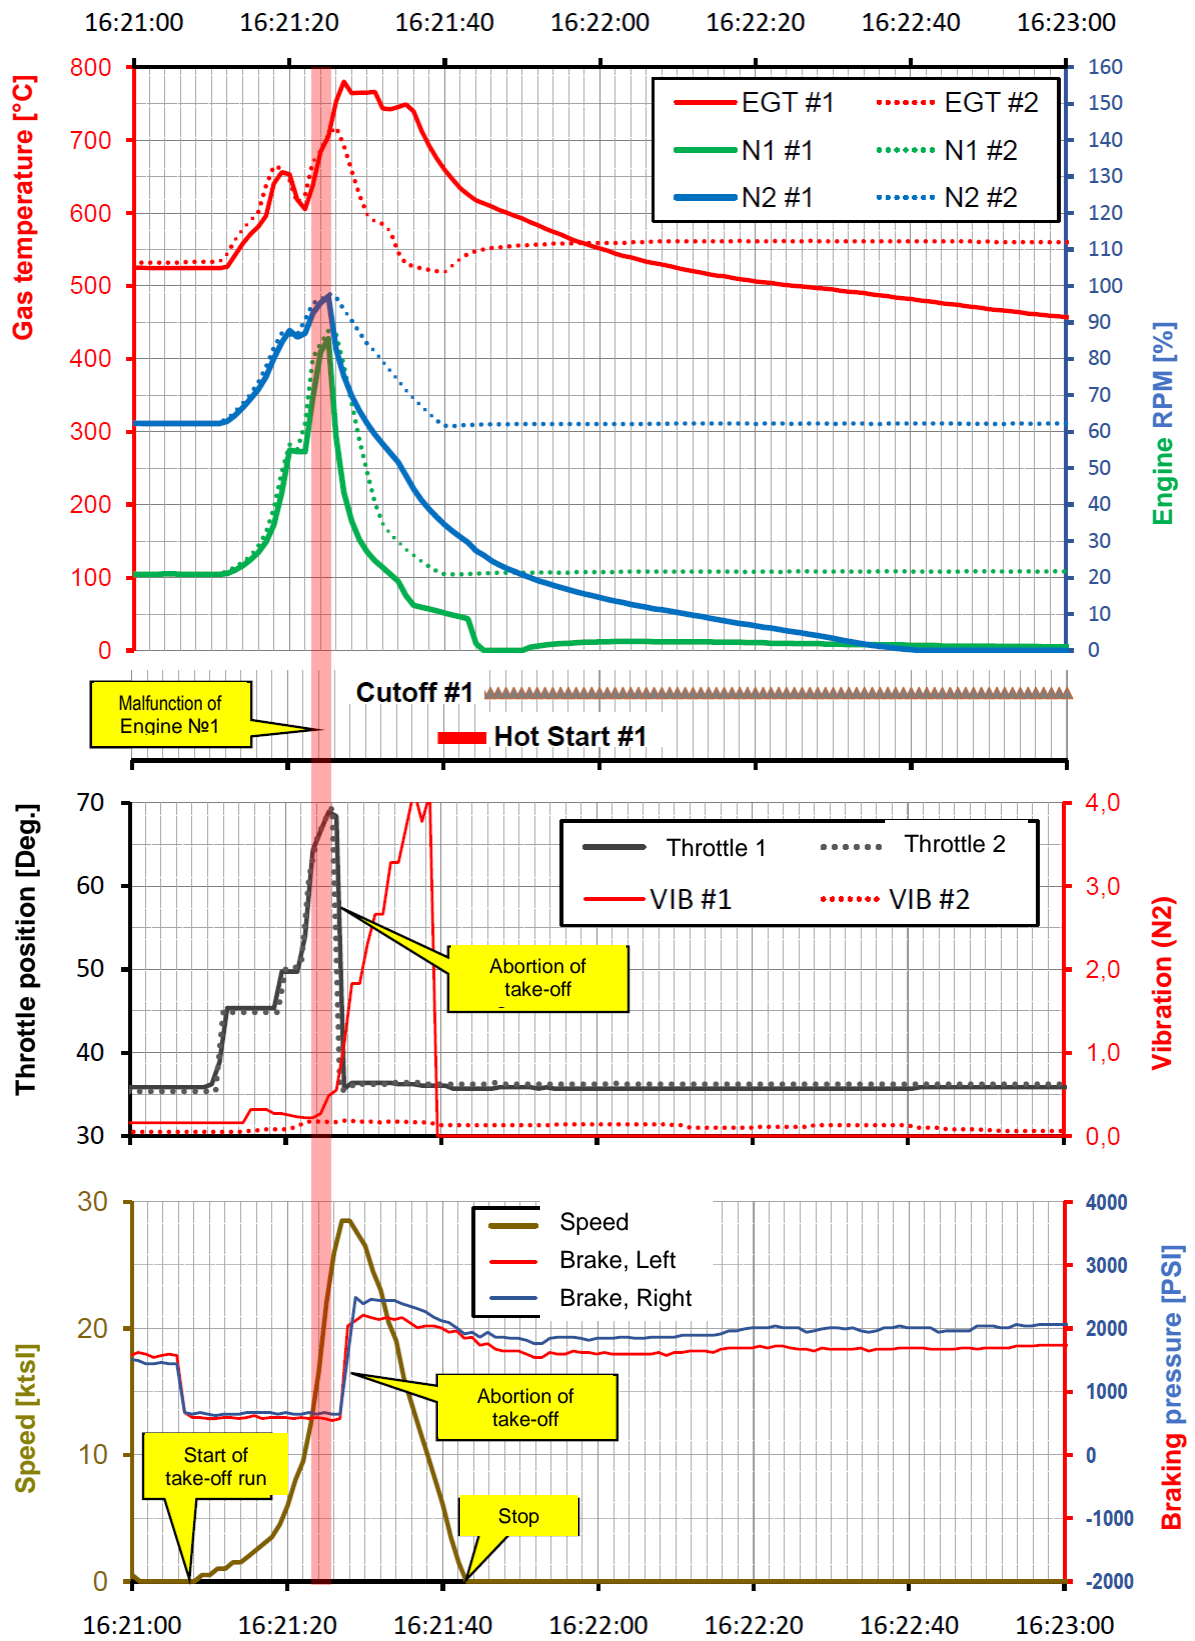
Figure 11: Flight recorder information from the start of take-off till the abortion of the take-off

The thrust of Engine №2 (right side) began to decrease as an effect of releasing the throttle, and reached its idle value at 16:21:40. The rpm of the high pressure rotating part of the malfunctioned engine began to decrease at 16:21:25, i.e. already before the throttles were used, and it fell below the idle value in five seconds (at 16:21:30). The low pressure rotating part, which has fairly higher moment of inertia, took three more seconds (16:21:33) to decelerate below its idle value. The temperature of the exhaust gas from Engine №1 increased two more seconds after the malfunction had occurred, and it reached 780°C at 16:21:27. Then it remained above 725°C for 10 seconds (until 16:21:37), while the rpm value of the high pressure rotating part of Engine №1 decreased to 41%. The fault message “EGT HOT START” appeared at 16:21:40, and lasted till 16:21:46, i.e. for six seconds. The pilots shut Engine №1 off, using the cutout switch, at 16:21:45.

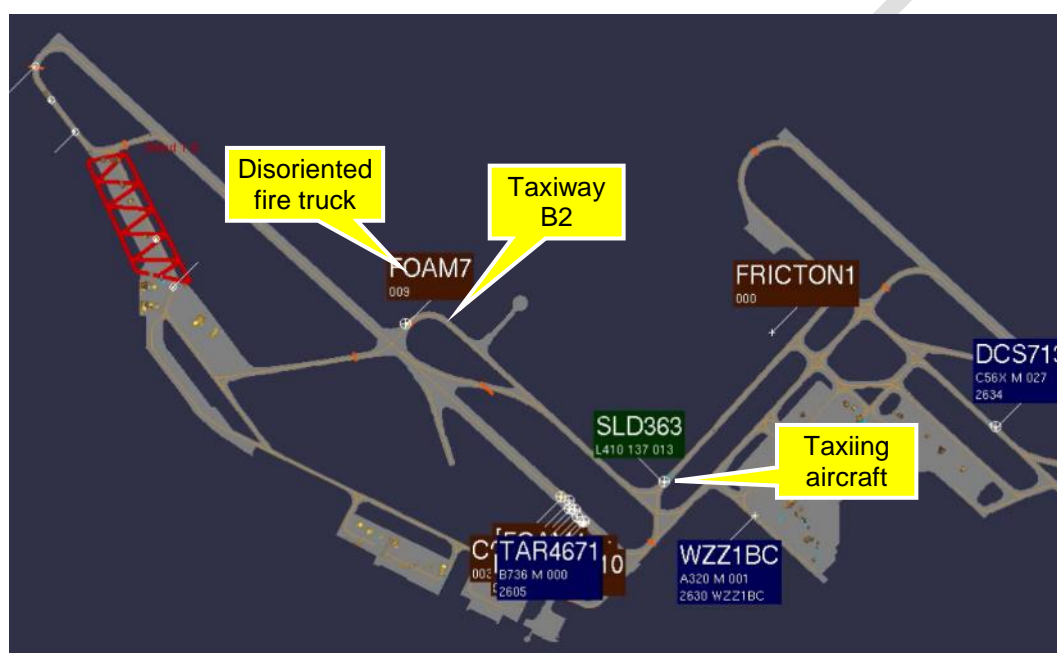
- One of the fire trucks (Foam 2) was not available due to repair;
- A fire truck (Foam 7) was only ready to go with 15-minute delay due to difficulty to start.
- The same fire truck entered Taxiway B2 without clearance, and conflicted with an aircraft (SLD363) taxiing in the opposite direction.
- Vehicles (Tender 1 and Attack 2) with capabilities not complying with the ICAO standards were also needed to secure the aircraft.
- The self-protection (ground-spraying) system of certain fire vehicles could only work with forced operation but, due to lack of adequate number of operating personnel, it would have been difficult to use in case of necessity.

Figure 12: Deployment of airport services as recorded by the A-SMGCS system

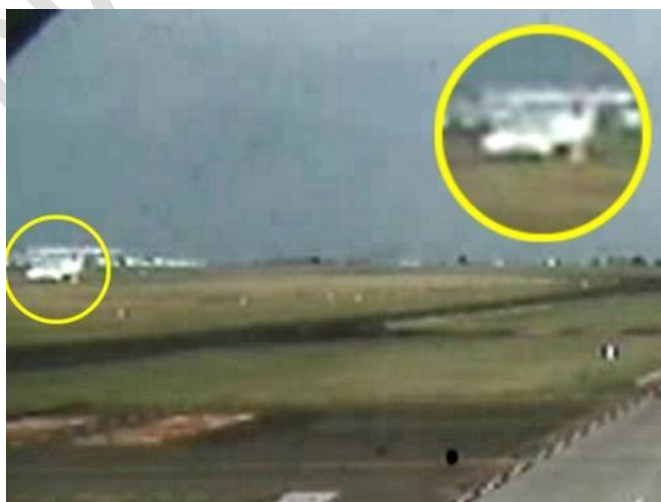
The moment of the malfunction. A bright flash can be seen behind the engine.
