MINISTRY FOR
INNOVATION AND TECHNOLOGY
TRANSPORTATION SAFETY
BUREAU OF HUNGARY

FINAL REPORT
2014-401-4P
SERIOUS INCIDENT
BUDAPEST - LHBP
27 September 2014
Airbus A320
D-AIPH

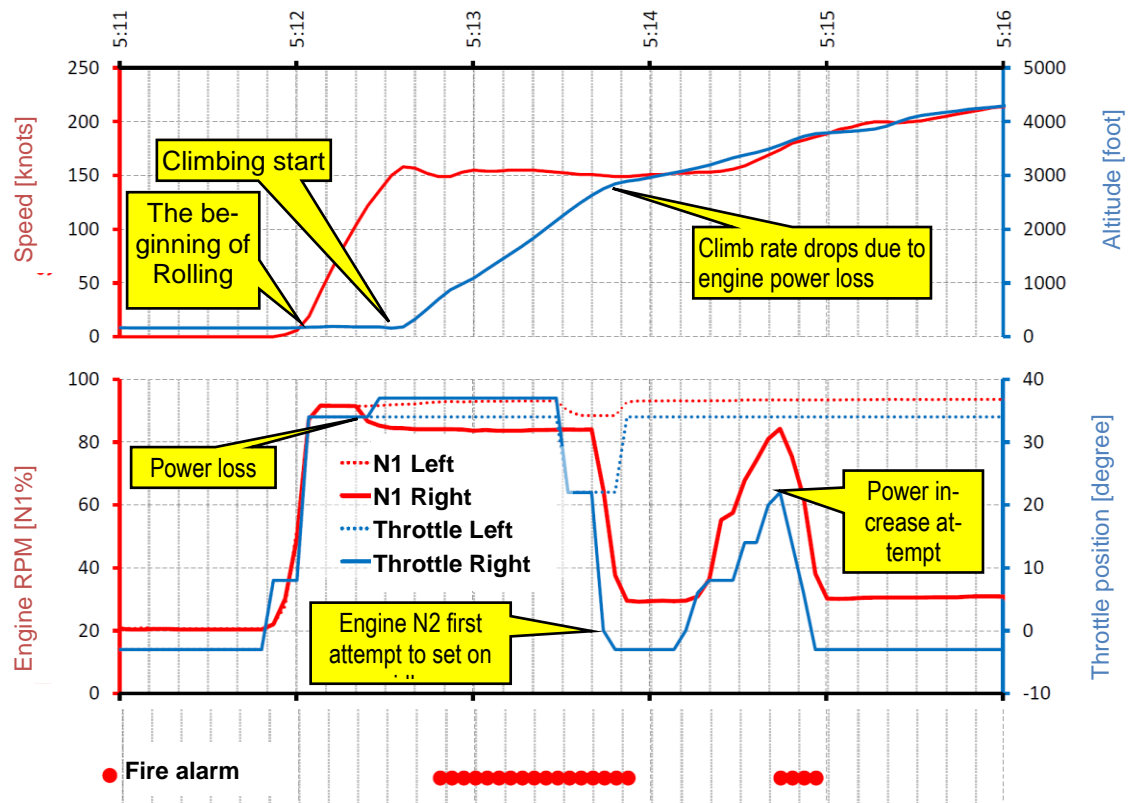
Figure 2: Major flight and engine data during the take-off and climb phase

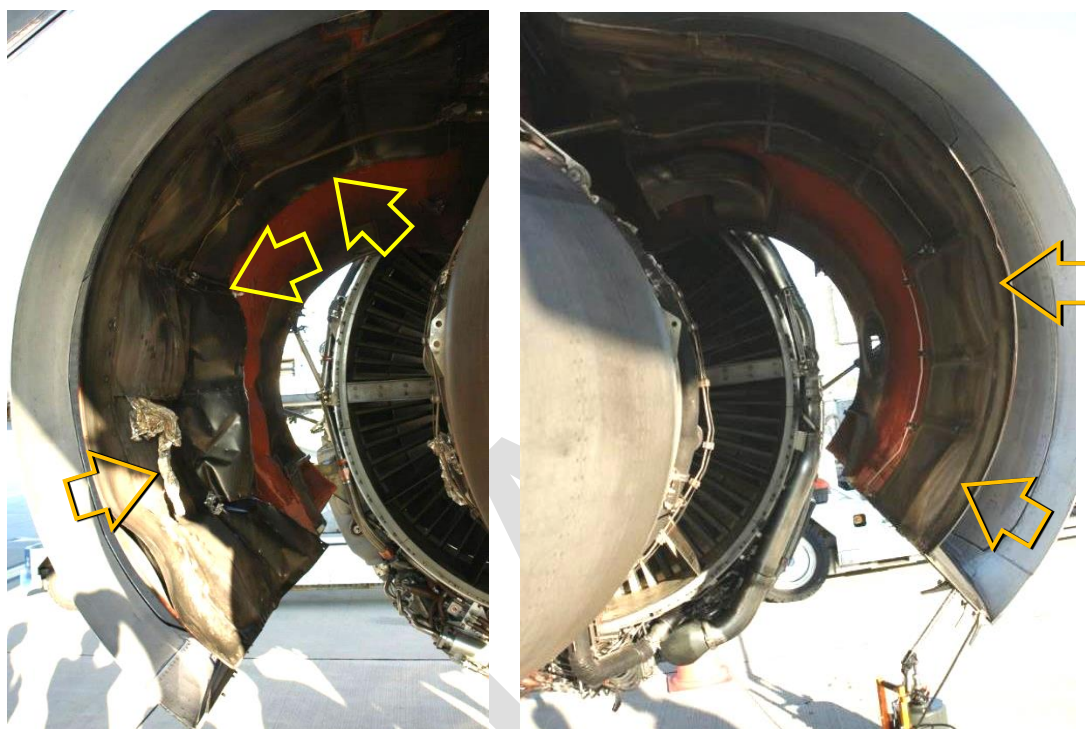
The right hand side engine (Engine №2) and the nacelle built in together with the thrust reverser was damaged.

Figure 7: The left and right side of the damaged engine from backside view with open thrust reverser

The damaged engine and certain elements of the nacelle and thrust reverser were replaced at the Budapest base of Lufthansa Technik and were shipped to Hamburg base of Lufthansa Technik for further inspection and repair. The material testing at Lufthansa Technik laboratory concluded the pipeline breakage was caused by fatigue crack which was initiated from a mechanical and heat stressed welding suture.

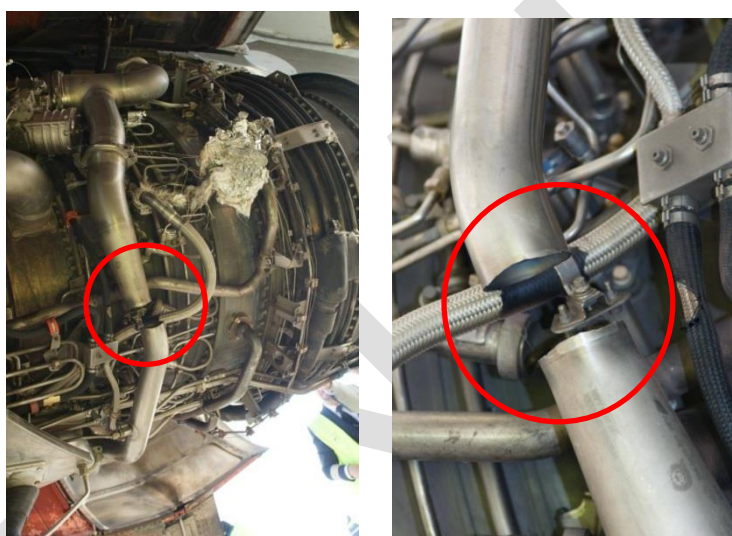
The failed part supplies the bleed air to the pneumatic system from the engine compressor stage. The high-pressure hot air pipeline directly connected to the compressor house with a screw bond then follows the nacelle curve reaching the high-pressure valve housing manifold section, tightened with a clamp. Regarding the pipeline the nacelle curve shape was developed with bending, where the pipe diameter was needed to be increased, it was solved with welding technology by the manufacturer.

The affected piece of pipeline forwards the bleed air during the low-speed operation of the engine into the high-pressure air valve, which valve steadily approaches its closed position proportionally with the increase of RPM. In its fully closed position the sufficient air pressure is supplied to the pneumatic system from another lower pressure compressor stage bleed-air. In the closed position of the valve the compressor pressure remains the same inside the thin-walled tube section, which causes a substantial stress in the long run.

sed stress during the take-off caused the breakage of the pipeline on the affected aircraft.

Figure 8: *The broken pipeline in the installation area*

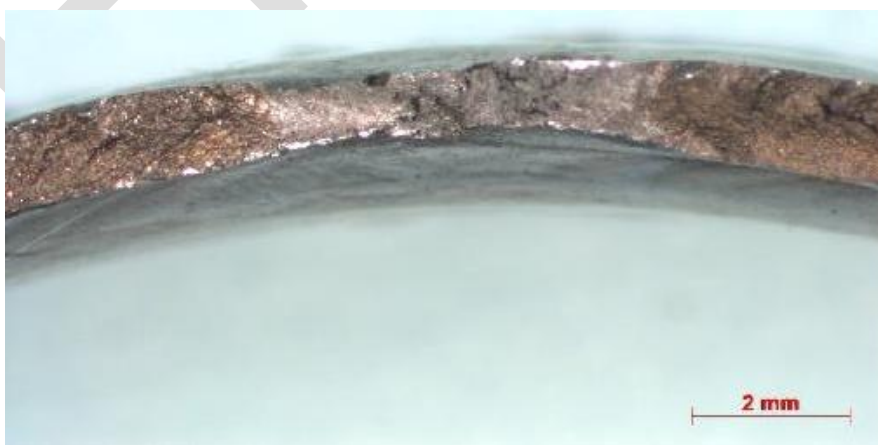
Figure 9: *Evidence of the cracked surface of the pipeline caused by fatigue*

The investigation conducted by Lufthansa Technik could not identify the direct cause of the fatigue initiated pipeline crack but suspected the below facts or combination of those to be the reason:

- physical stress during installation and operation,
- changing the crystalline structure of the material due to the welding process,
- surface roughening treatment prior to the welding result,
- environmental effects: hot air, air pollution, de-icing fluid.

Fatigue crack emerged on the thin-walled pipeline which leads the high-pressure air from the engine to the pneumatic system at the welded seam due to combined effect of metalworking, mounting and operation. The continuous widespread over the time eventually weakened the structure so that during the take-off it could no longer bear the load and broke. Since the pipe break occurred between the air flow valve and the compressor stage of the engine, the high-pressure and high-temperature air with excessive force flowed freely into the engine nacelle. The fracture had negative impact on the engine due to the increased air bleed from the compressor, which caused the sudden drop of the RPM. The strong outflow of the hot air overheated and damaged the inner side of the nacelle. The rapid rise of the temperature activated the engine fire alarm system. When the crew reduced the engine thrust power, the hot air flow decreased and the fire warning signal stopped. When thereafter the crew tried to raise the thrust power, the increased flow of the hot air once more activated the fire alarm signal.

- After the take-off at the initial climb phase the welding of the №2 engine high pressure bleed air pipeline broke up.
- The exhausting high pressure hot air damaged the engine nacelle and activated the fire alarm system.
- The fracture of the pipeline was caused by fatigue crack, which was initiated from a welding seam equally exposed to mechanical and thermal stresses.

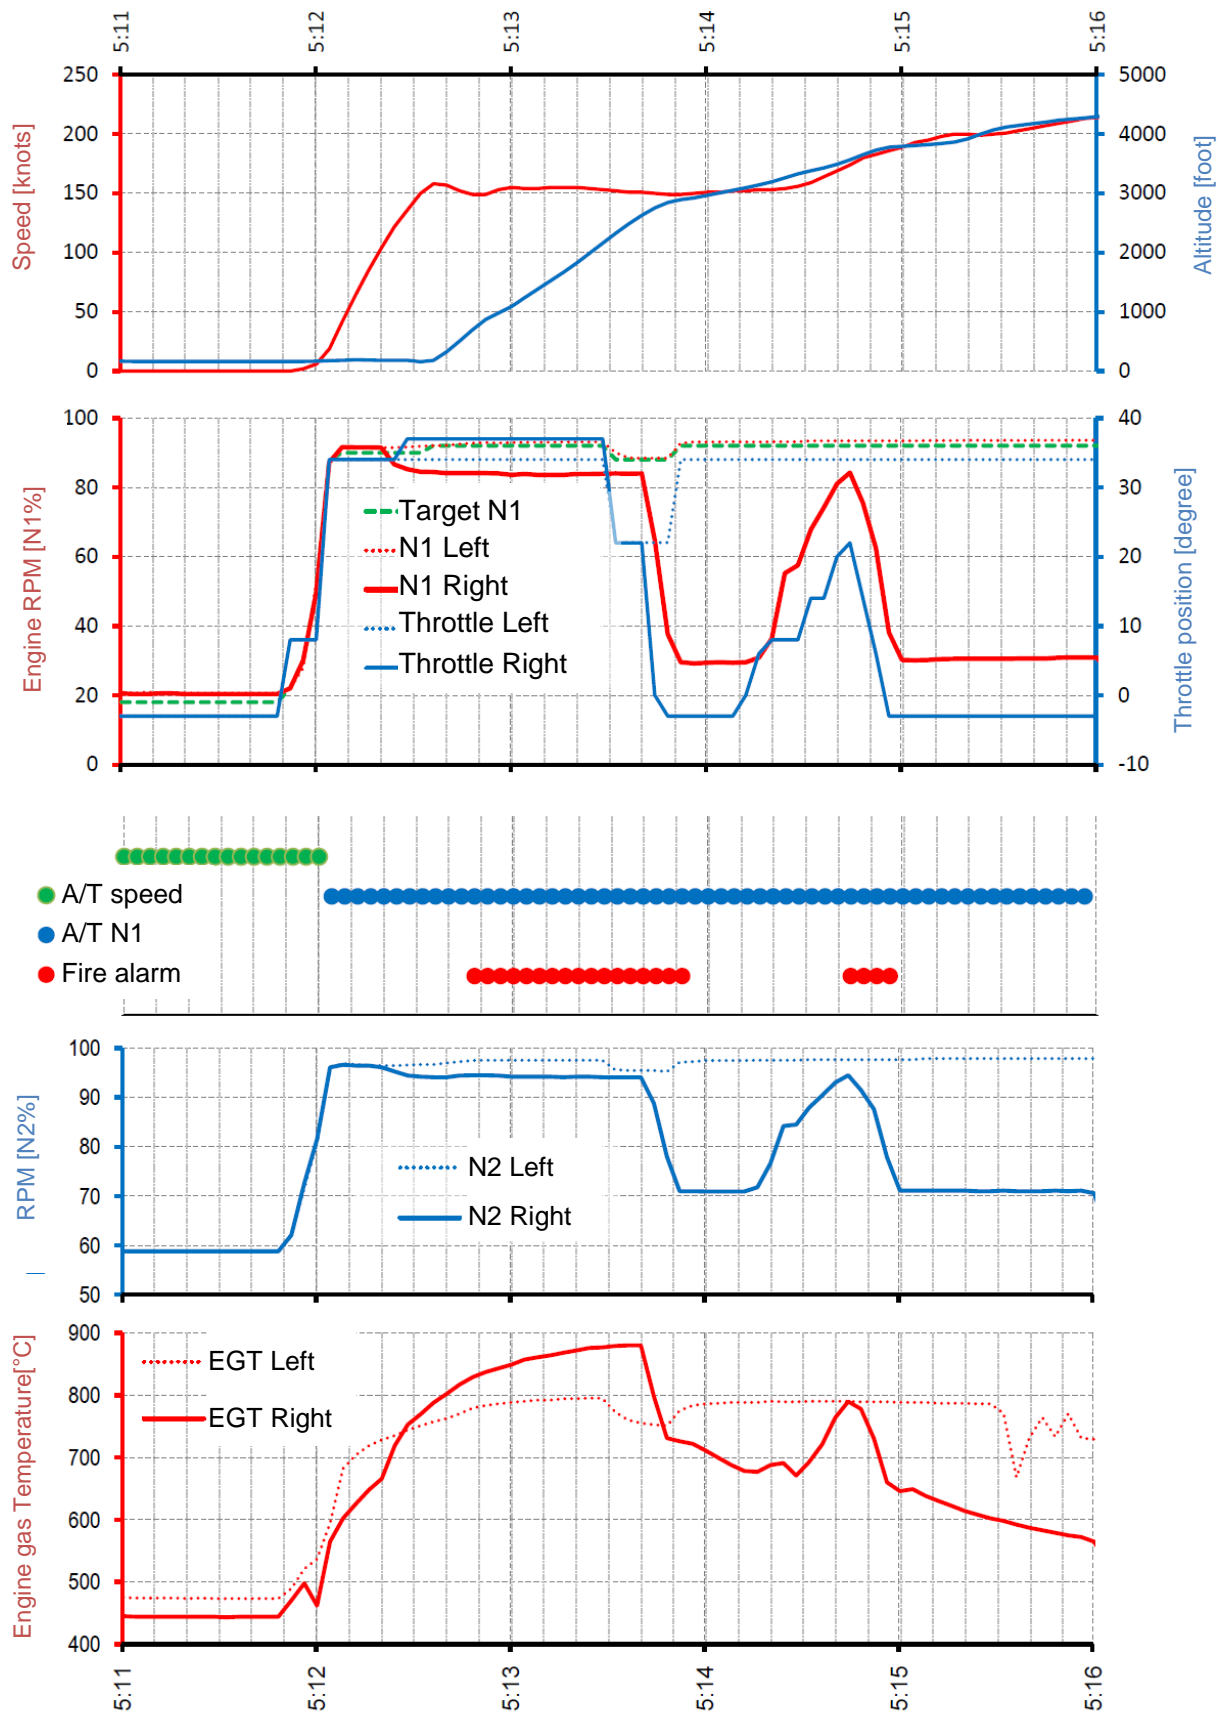
Figure 11: Major flying parameters and engine data during the minutes of failure
