MINISTRY FOR
INNOVATION AND TECHNOLOGY
TRANSPORTATION SAFETY BUREAU

FINAL REPORT

2015-011-4P

Airbus A320-214

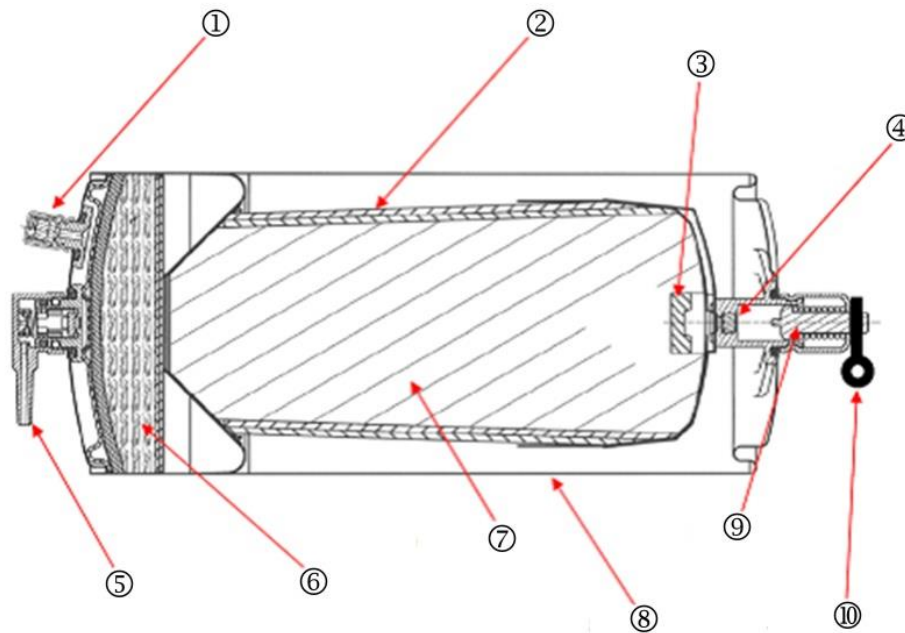
Figure 4: Internal layout of the chemical oxygen generator

In the case of the malfunctioned oxygen generators formally investigated by B/E Aerospace, the primary pellet, which should initiate the chemical reaction, showed the burn mark caused by the heat energy of the pyrotechnic primer, but, due to insufficient intensity, such heat energy failed to propagate in the chemical core. The reaction stopped, that is why no oxygen gas was generated.

Analysis of the chemical core found that up to 64% of the tin fuel had oxidized. The presence of tin oxide was found during analysis of elemental tin.

The inspection found that, in the case of tin oxidation up to 50%, the self-sustaining chemical reaction started both in the primary pellet and in the top layer of the chemical core, with simultaneous oxygen generation. The process of oxygen generation was incomplete in cases of tin oxidation of 60% or above.

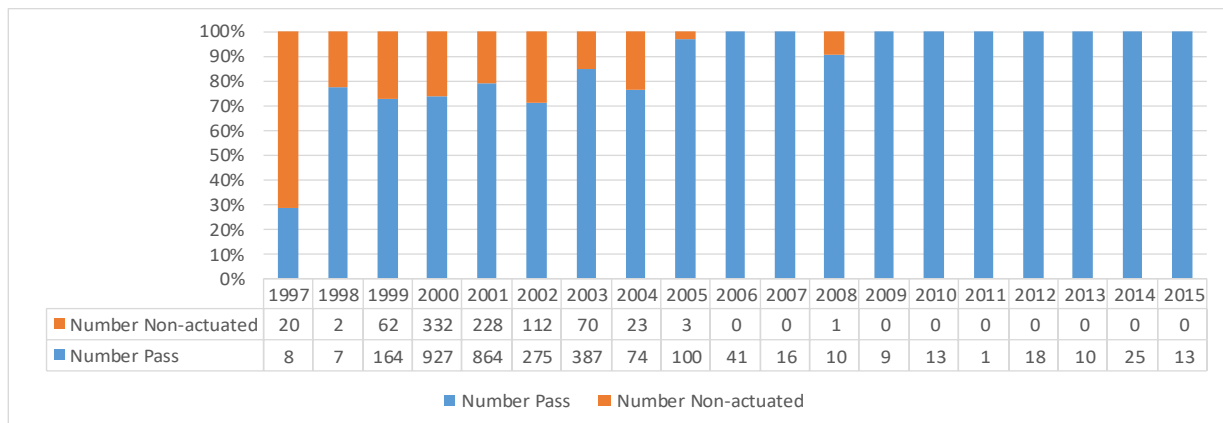
B/E Aerospace inspected serviceability of 3815 oxygen generators with Part Number: 117042-XX manufactured between 1997 and 2015; the results of their study are shown in the diagram below:

The diagram shows that there were lots of unserviceable units among the oxygen generators manufactured between 1997 and 2004, while almost 100 % of the units manufactured between 2005 and 2015 were serviceable.

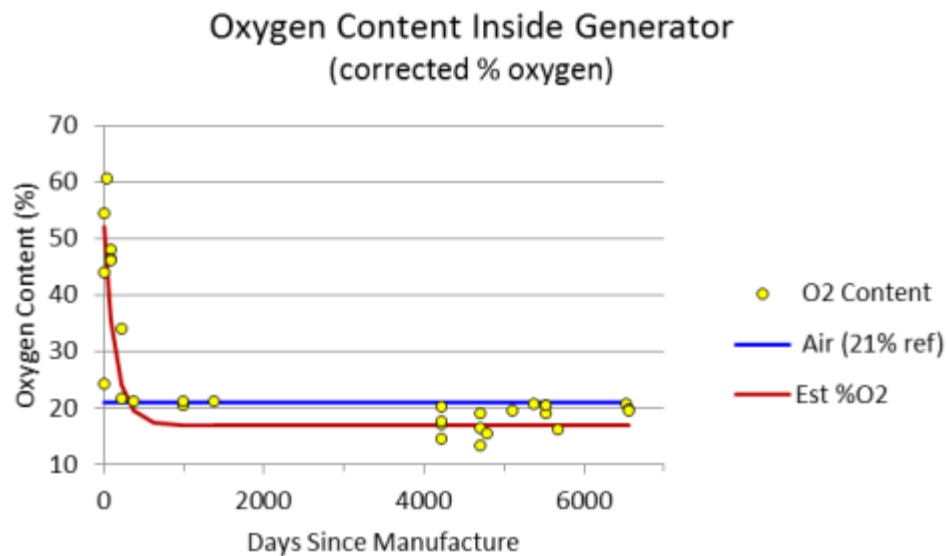
Figure 5: Changes in Oxygen content inside the generator with time

Measurements performed by B/E Aerospace show that the concentration of oxygen gas inside the generator at the typical atmosphere ranges between 40% to 60% oxygen as the generator is produced.

This value decreased to 21% within one year since the manufacturing date. The oxygen concentration in older generators (those generators 13 years of age and older) was less than 21% and averaged around 17 % to 18%. Figure 5 shows the process of the change.

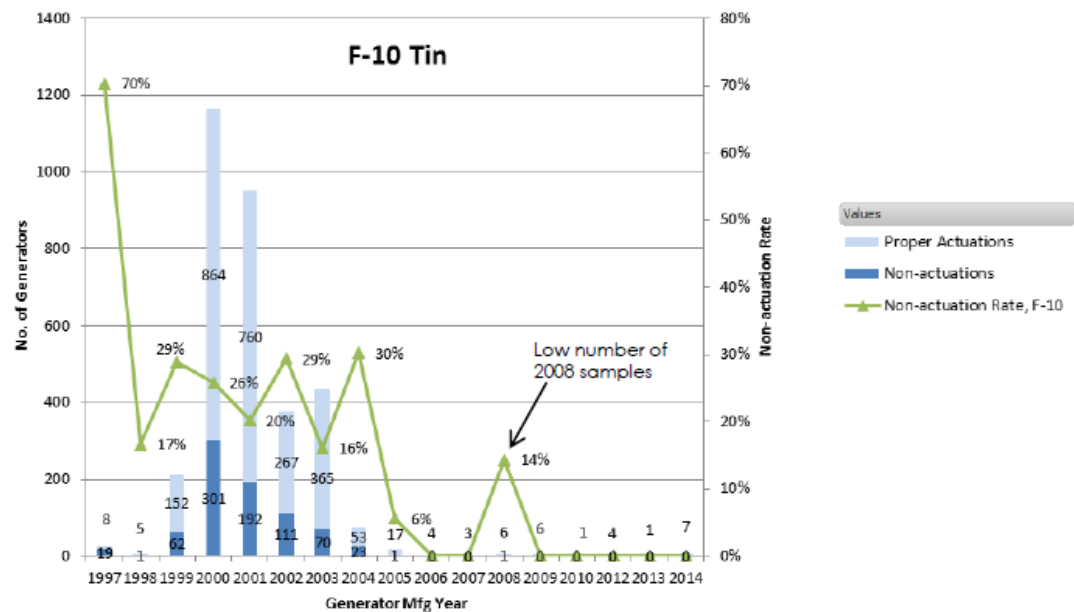
Figure 6: Test result with F-10 tin

Figures 6 and 7 indicate the number of generators which failed to activate in dark blue. The figures demonstrate that the two grades of tin powder used in manufacturing show significant differences. Almost all of the malfunctioned generators were made with grade F-10 tin, while

1. the generators manufactured earlier are more likely to be unserviceable, regardless of the tin grade used;
2. the generators made with grade F-10 tin are more likely to be unserviceable.
