MINISTRY FOR  
INNOVATION AND TECHNOLOGY  
TRANSPORTATION SAFETY BUREAU

# FINAL REPORT

2015-157-4P

R-26 SU Góbé

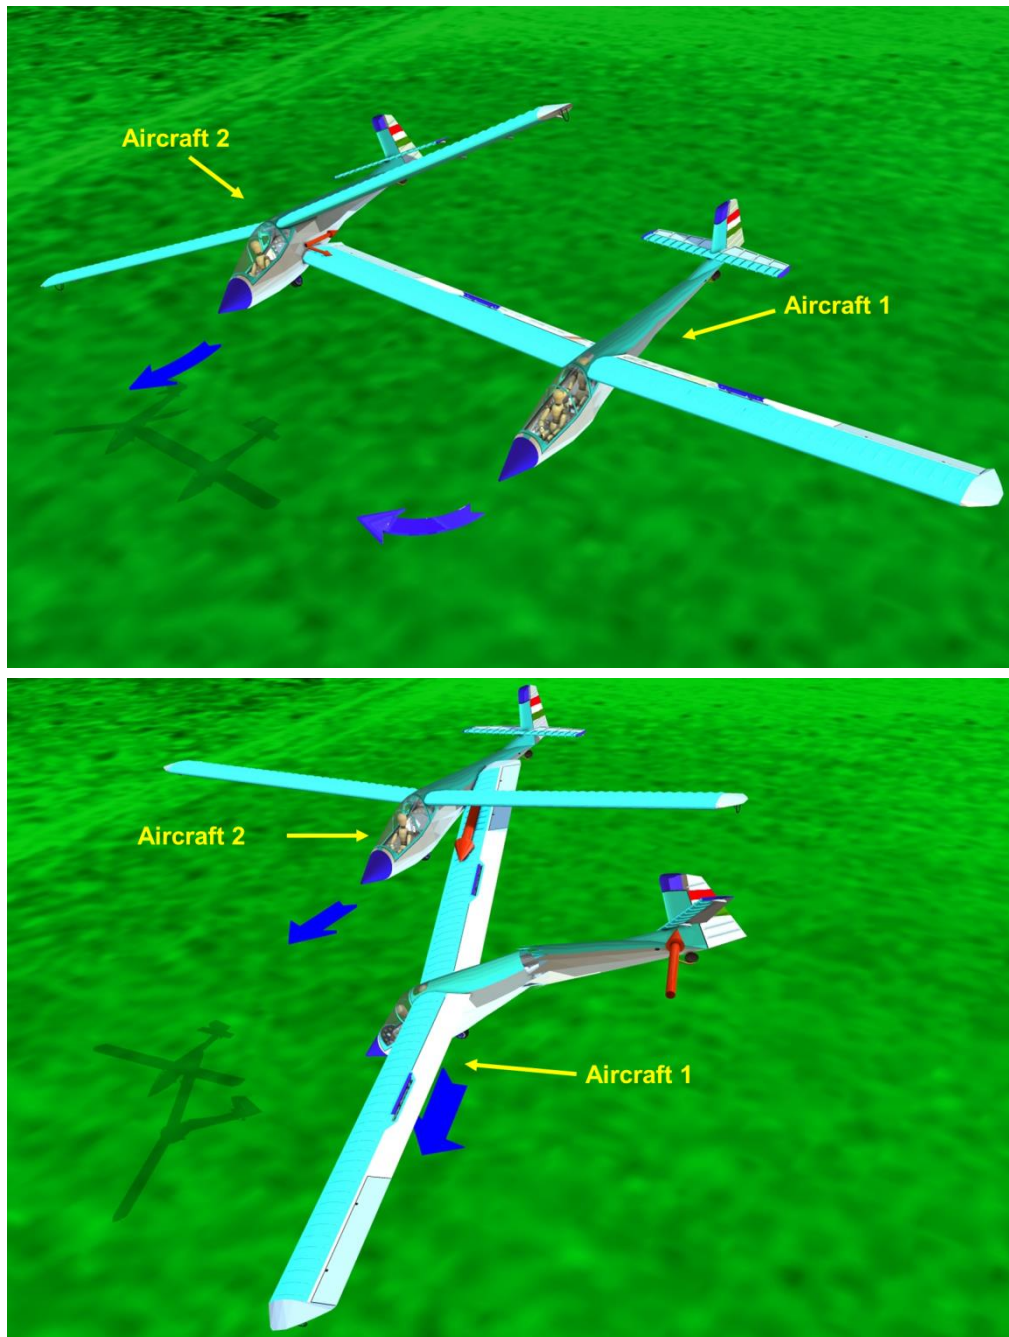
Figure 3: Start of the collision (above) end of the collision (below)

At the point of the collision (Figure 3), the two aircraft were in a side-by-side position because Aircraft 1 had caught up with Aircraft 2 which was turning onto the final approach path. The right wing tip of Aircraft 1 penetrated the fuselage of Aircraft 2 behind the flight cabin, tearing the canvas cover and badly damaging the metal structure of the fuselage. The student pilot in Aircraft 2 perceived that something irregular had happened, but he did not become aware that his aircraft had collided with another aircraft.

The impact made Aircraft 1 turn in front of and below the other sailplane, as a result of which its right wing tip went on slitting the fuselage structure of Aircraft 2 in the direction of the horizontal stabilizer. Now the pilot in Aircraft 2 saw the nose and the canopy of Aircraft 1 for a short time, but he could not find out about its spatial position and motion. The fuselage structure of Aircraft 1 cracked about 1 metre from the line of the wing trailing edge towards the horizontal stabilizers, as a result of which the aircraft became uncontrollable.

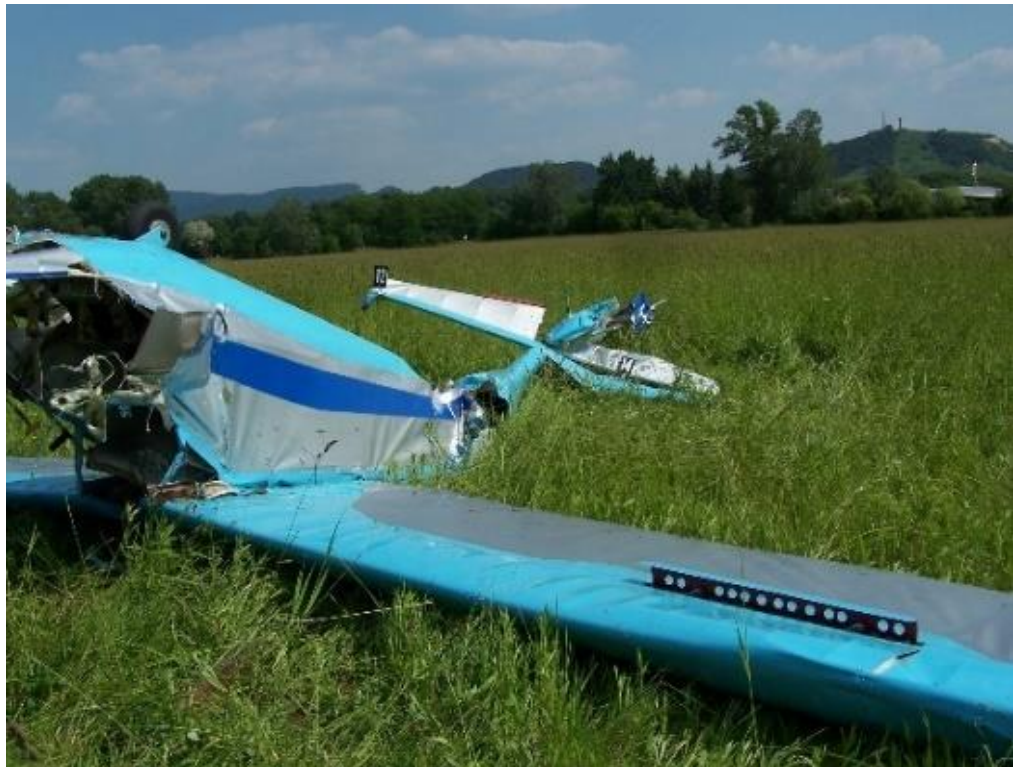
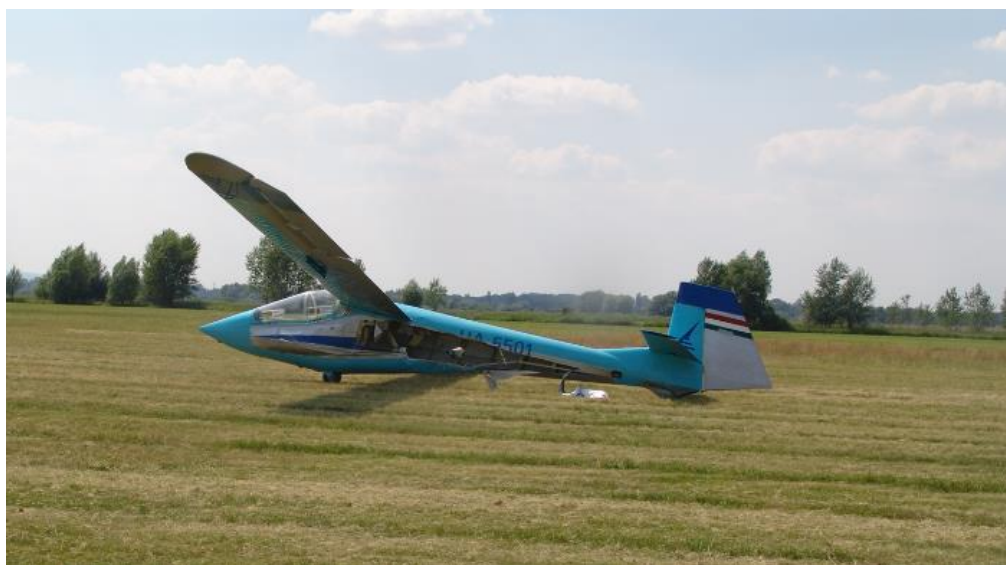
**Figure 4: Aircraft 1 (above) and Aircraft 2 (below)**

The uncontrollable Aircraft 1 began to fall almost vertically after the collision, and its tail turned 180° around its longitudinal axis in the meantime. The sailplane crashed to ground in upside down position and came to rest in that position as well.

Aircraft 2 was significantly damaged in the accident.

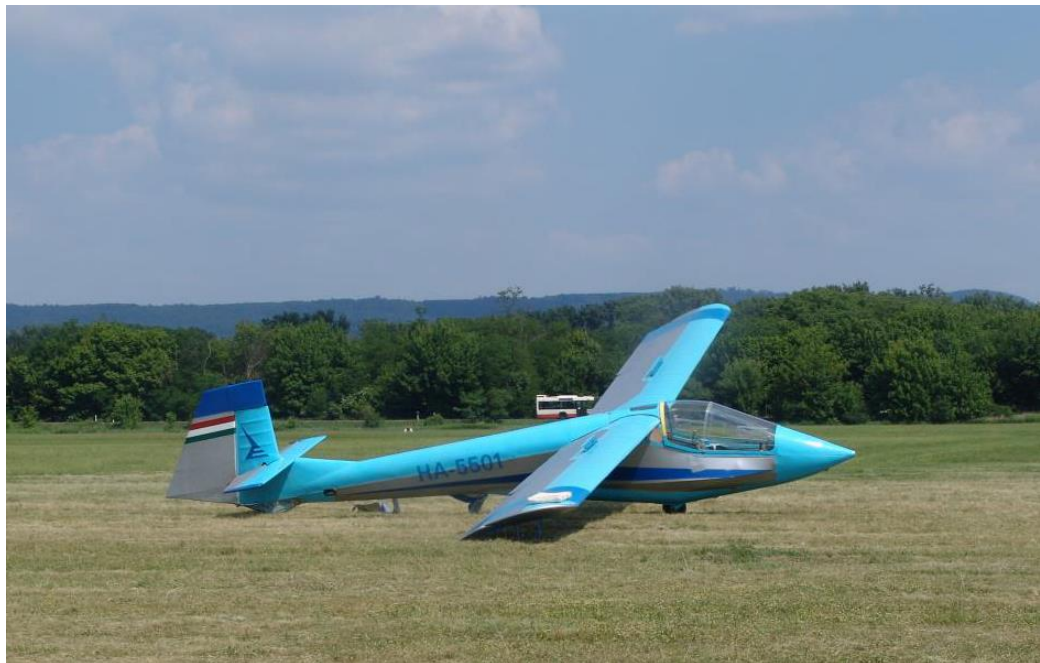
**Figure 6: The blue sky and Aircraft 2 (sailplane HA-5501) after landing**

There were a few cumulus clouds in the sky at the time of the accident, and the aircraft were painted the same colour combination as the colours of the sky blended into their surroundings in the given light conditions (Figure 6). The possibility of their visual detection became questionable in that situation.

In the opinion of the IC, the blue and silver painting of both aircraft involved in the occurrence worked as effective camouflage in the given meteorological conditions.

**Transportation Safety Bureau recommends the owners or operators of those sailplanes the colour of which tend to blend into the background to affix markings providing good visibility on such aircraft without influencing airworthiness. It is advisable to place high visibility marking on parts of wing surfaces, on the vertical stabiliser and/or on the nose part of the fuselage, applying markings in orange or orange and red or other contrasting colour, in sizes which facilitate detection from greater distances.**

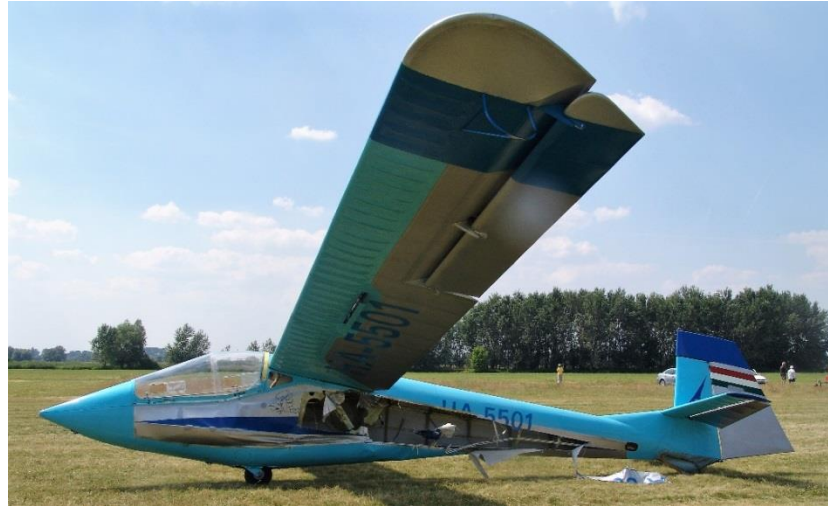
Aircraft 2 remained controllable after the collision and landed safely. The starting point of the collision was found at the left-hand side of the fuselage, above the boat-shaped part, near the centre of gravity. It suggested that the right wing tip of the other aircraft had stabbed the fuselage at this point. Geometry of the damage caused by the impact suggests that the right wing of the other aircraft penetrated from the starting point rearward, in the direction of the stabilisers, tearing apart the body frames and other structural elements, together with the canvas cover.

As regards Aircraft 2, inspection of its full surface showed that only the damage located at the left hand side could be related to the collision. The damage to the fuselage began and was the deepest under the wing and became gradually slighter towards the rear part of the fuselage (Figure 7).

**Figure 7: Damage to Aircraft 2**

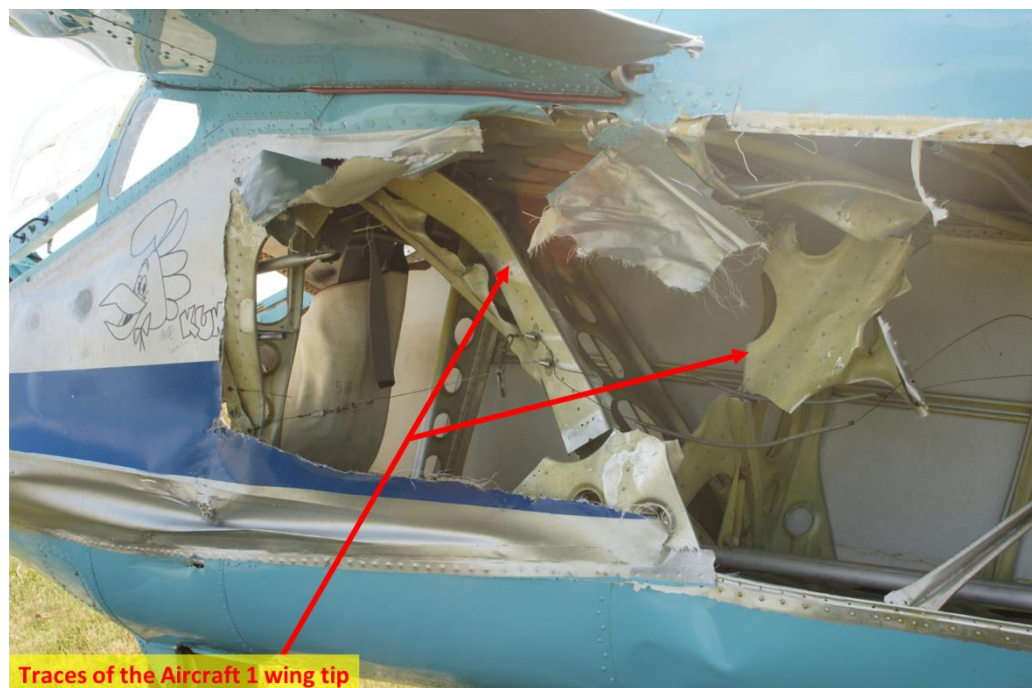
The nature of the damage hints to an object stabbed into the structure of the fuselage and leaving the fuselage by moving towards the rear end of the aircraft (Figure 8).

**Figure 8: Damage to the fuselage of Aircraft 2**

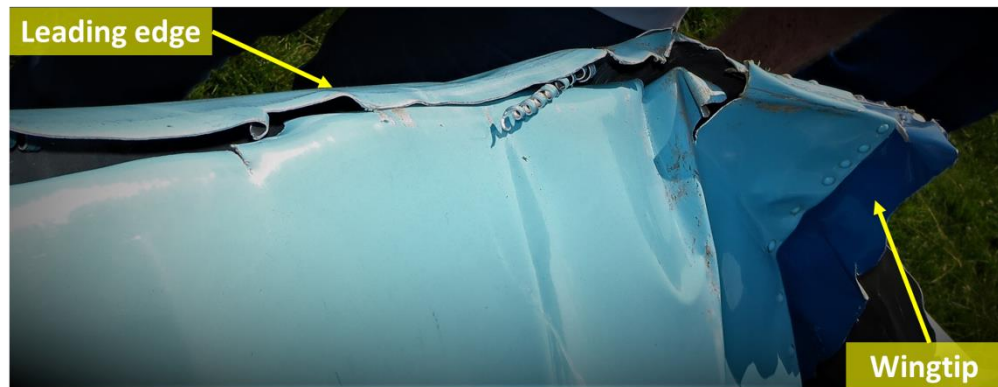
damages identified by the IC along the leading edge of the right wing of Aircraft 1 (Figure 9) could not have been caused by the impact with the ground, and the IC found the matching (“mirror”) marks of damage in the fuselage of Aircraft 2. One of the marks was a chipping type damage caused by a hard and sharp object (Figure 9).

**Figure 9: Leading edge of the right wing of Aircraft 1**

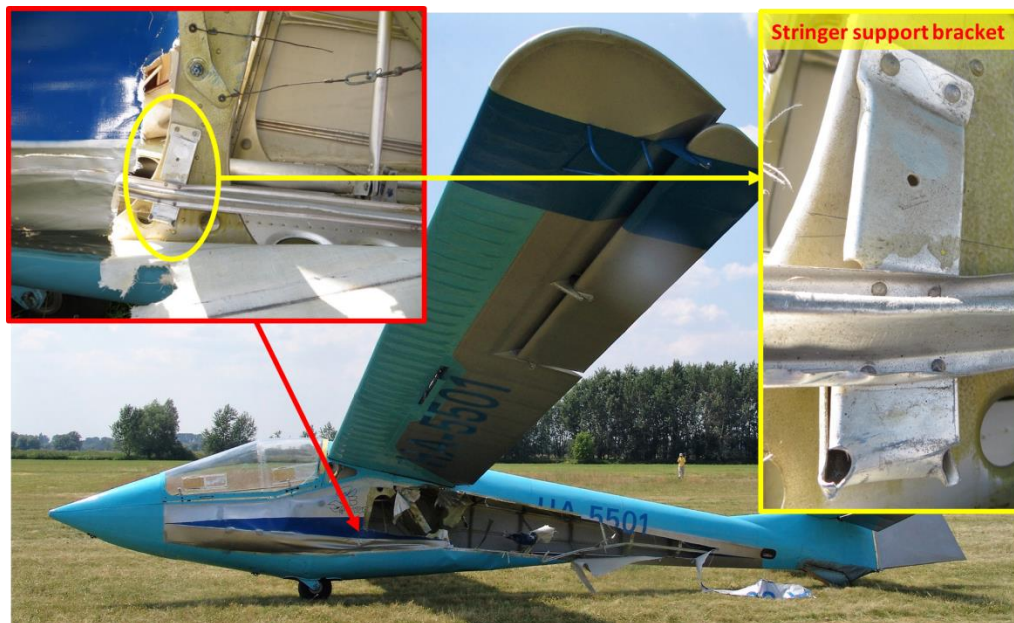
The IC found the bracket of a stringer, which had caused the chipping type damage, in the initial section of the damage near the centre of gravity of Aircraft 2 (Figure 10:). After dismounting it from the aircraft, and matching it with the damaged part of the right wing of Aircraft 1, the IC clearly identified it as the object that had caused the damage (Figure 11).

**Figure 10: Bracket of the stringer, Aircraft 2**

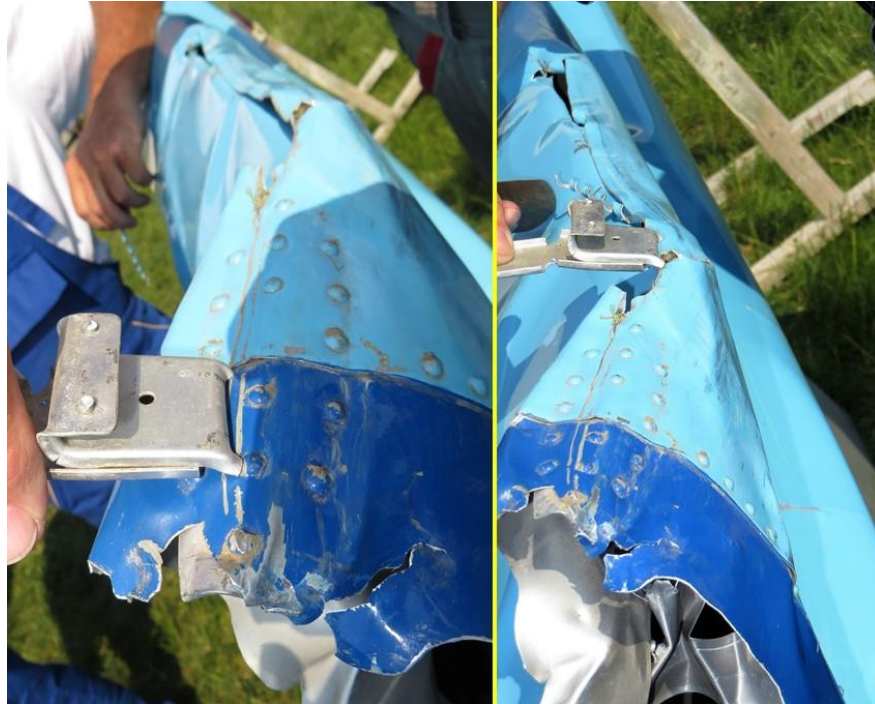
**Figure 11: Identification of damage along the leading edge of Aircraft 1, using the bracket of a stringer dismantled from Aircraft 2**
