MINISTRY FOR  
INNOVATION AND TECHNOLOGY  
TRANSPORTATION SAFETY BUREAU

# FINAL REPORT

Accident

Pipistrel Virus

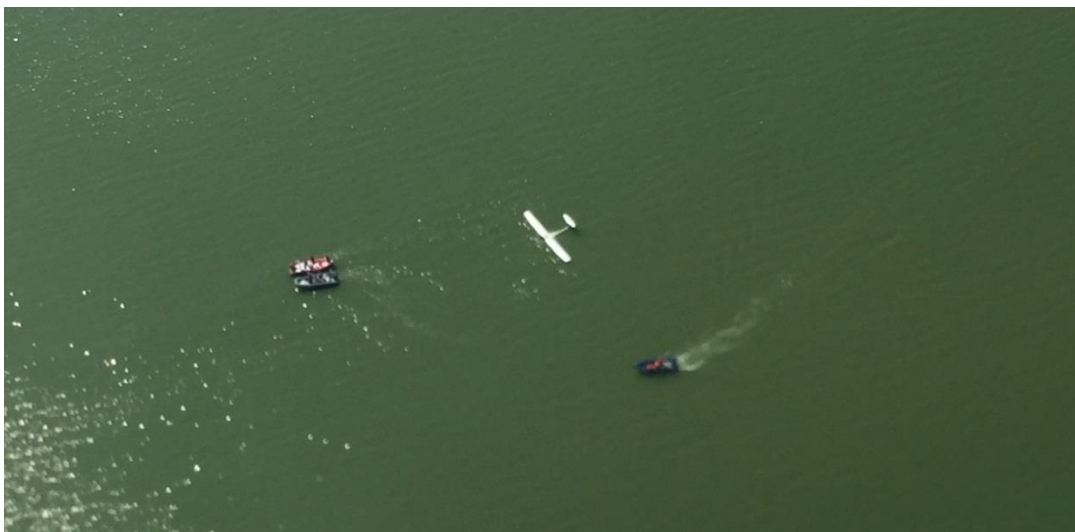
**Figure 2: The aircraft after ditching**  
(Source of the photo: Hungarian Air Ambulance Nonprofit Ltd.)

After the aircraft descended into the water, the pilot and his passenger left it on their own, and then, clinging to the wings of the floating aircraft, they waited for the boats to come to their rescue. The boats arriving to the floating aircraft began to tow it to the shore. Upon arrival, the water police unit recorded the geographical coordinates of the location, and took over the technical rescuing of the aircraft (Section 6, Annex 1). The aircraft was towed to the free beach at Balatonberény, where the IC began its inspection.

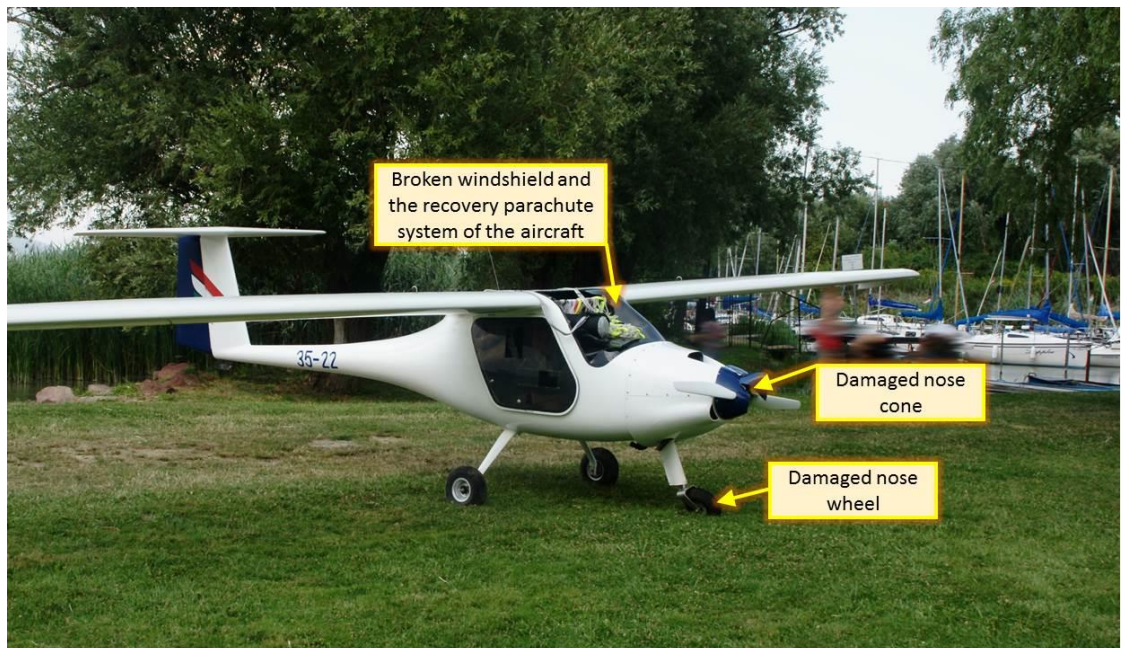
It was found during the inspection of the scene that the windshield, nose cone and nose wheel of the aircraft had been damaged (Figure **Hiba! A hivatkozási forrás nem alálható.**).

**Figure Hiba! A hivatkozási forrás nem található.: Damages of the aircraft after its rescue from the lake (photo taken at Balatonberény Beach)**

According to the pilot's statement, the extra air pressure generated by the propelling rocket after activating the parachute ripped the windshield out, and opened the doors. Then, after the parachute opened, they touched the water "*relatively soon*". According to judgement by the pilot, the aircraft still had a minimal horizontal speed when touching the water surface, that is why the nose cone fractured.

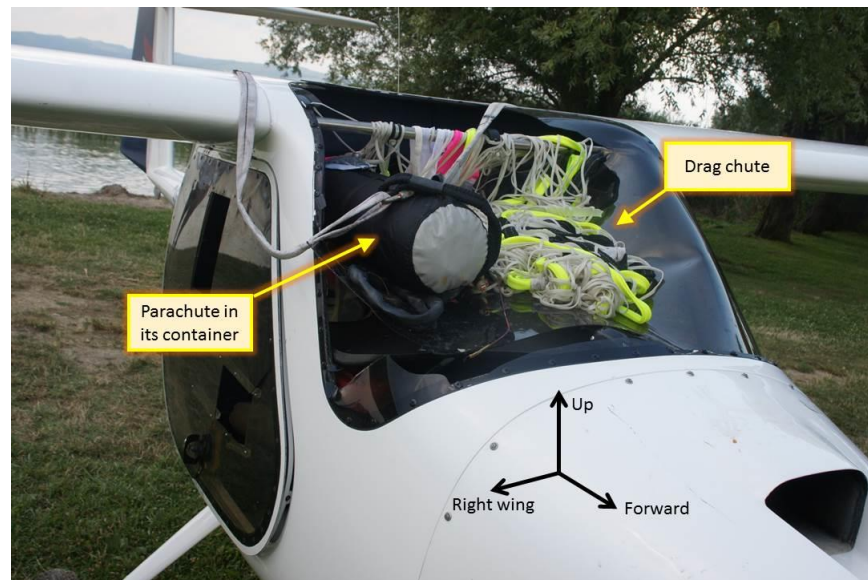
During the investigation, the IC found that only the drag chute of the recovery parachute opened (Figure 3) (the task of the drag chute is to pull the main parachute out of its container). See Section 1.18.5 for a description of the recovery parachute system.

**Figure 3: The main parachute in the container and the drag chute**
