MINISTRY FOR
INNOVATION AND TECHNOLOGY
TRANSPORTATION SAFETY BUREAU

FINAL REPORT

2016-004-4P

Airbus A320-232

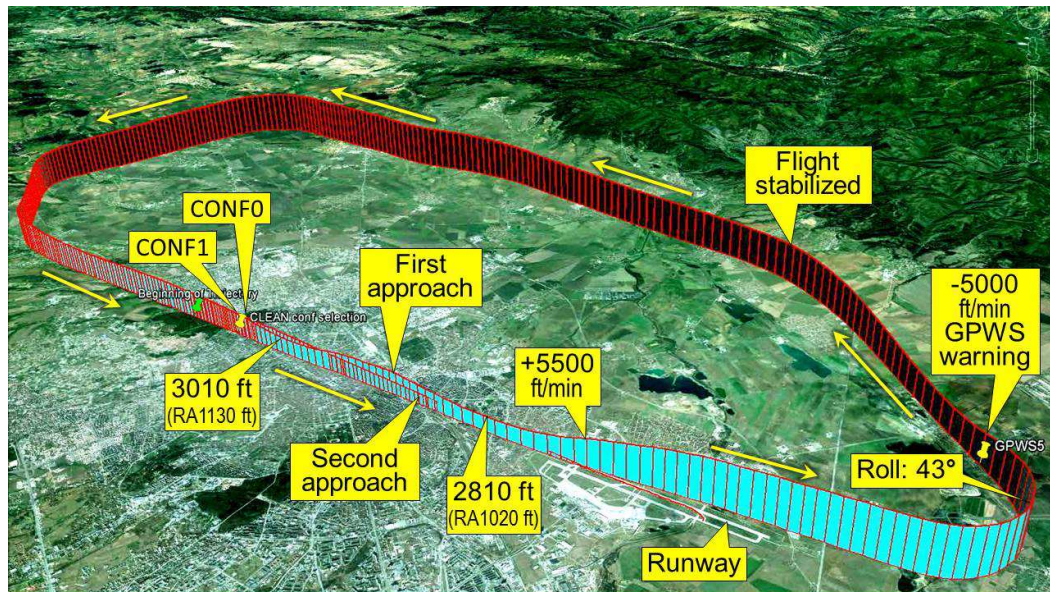
Figure 2: Aircraft trajectory and major events during the approach and go-around (Airbus Report)

As the aircraft was established on the ILS, just below 4000 ft (above sea level), and in CONF2, the PM positioned the flap lever to CONF0 (fully retracted) instead of CONF FULL (fully extended) as instructed by the PF. The PF pushed the sidestick forward (to descent) and put the throttle lever angle (TLA) to TOGA (take-off/go-around) position. The autopilots and the auto thrust were now voluntarily disconnected.

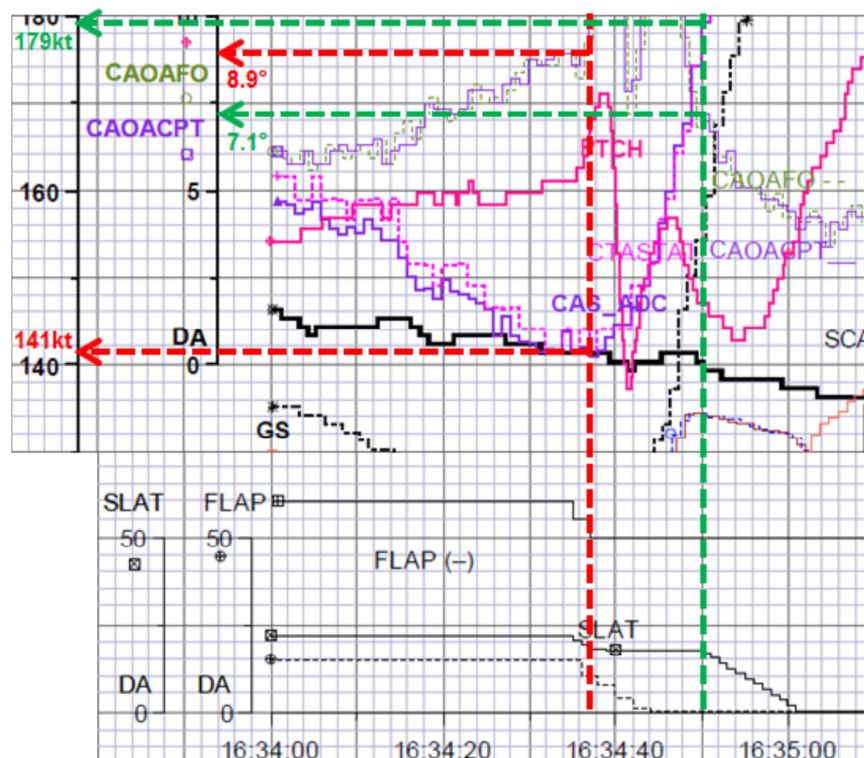
The Alpha/Speed Lock function inhibits slat retraction at high angles-of-attack (alpha) and/or low speeds. If alpha exceeds 8.5° or the airspeed goes below 148 knots, retraction from position 1 to position 0 is inhibited. Inhibition is removed when alpha goes below 7.6° and, when the speed exceeds 154 kt. This protective function is not active if the aircraft is on the ground, and its speed is less than 60 kt., or, during flight if alpha exceeds 8.5° or the airspeed goes below 148 kt, after the flight crew has moved the lever to 0.

Figure 4: Inhibition of retraction of slats (red arrow) and removal of such inhibition (green arrow)
(source: Airbus Report)

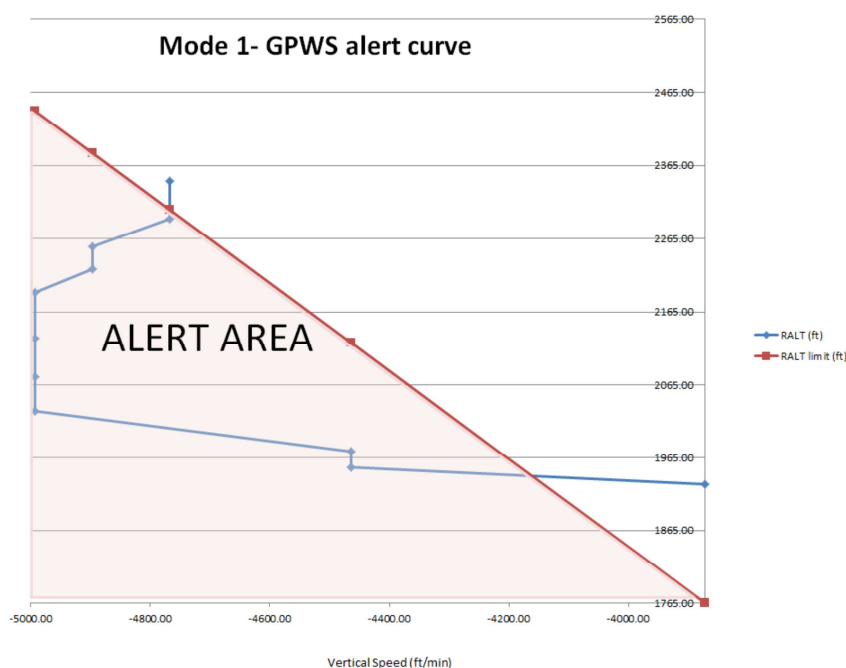
Figure 8: Flight parameters which triggered SINK RATE alert in the case (Airbus Report)

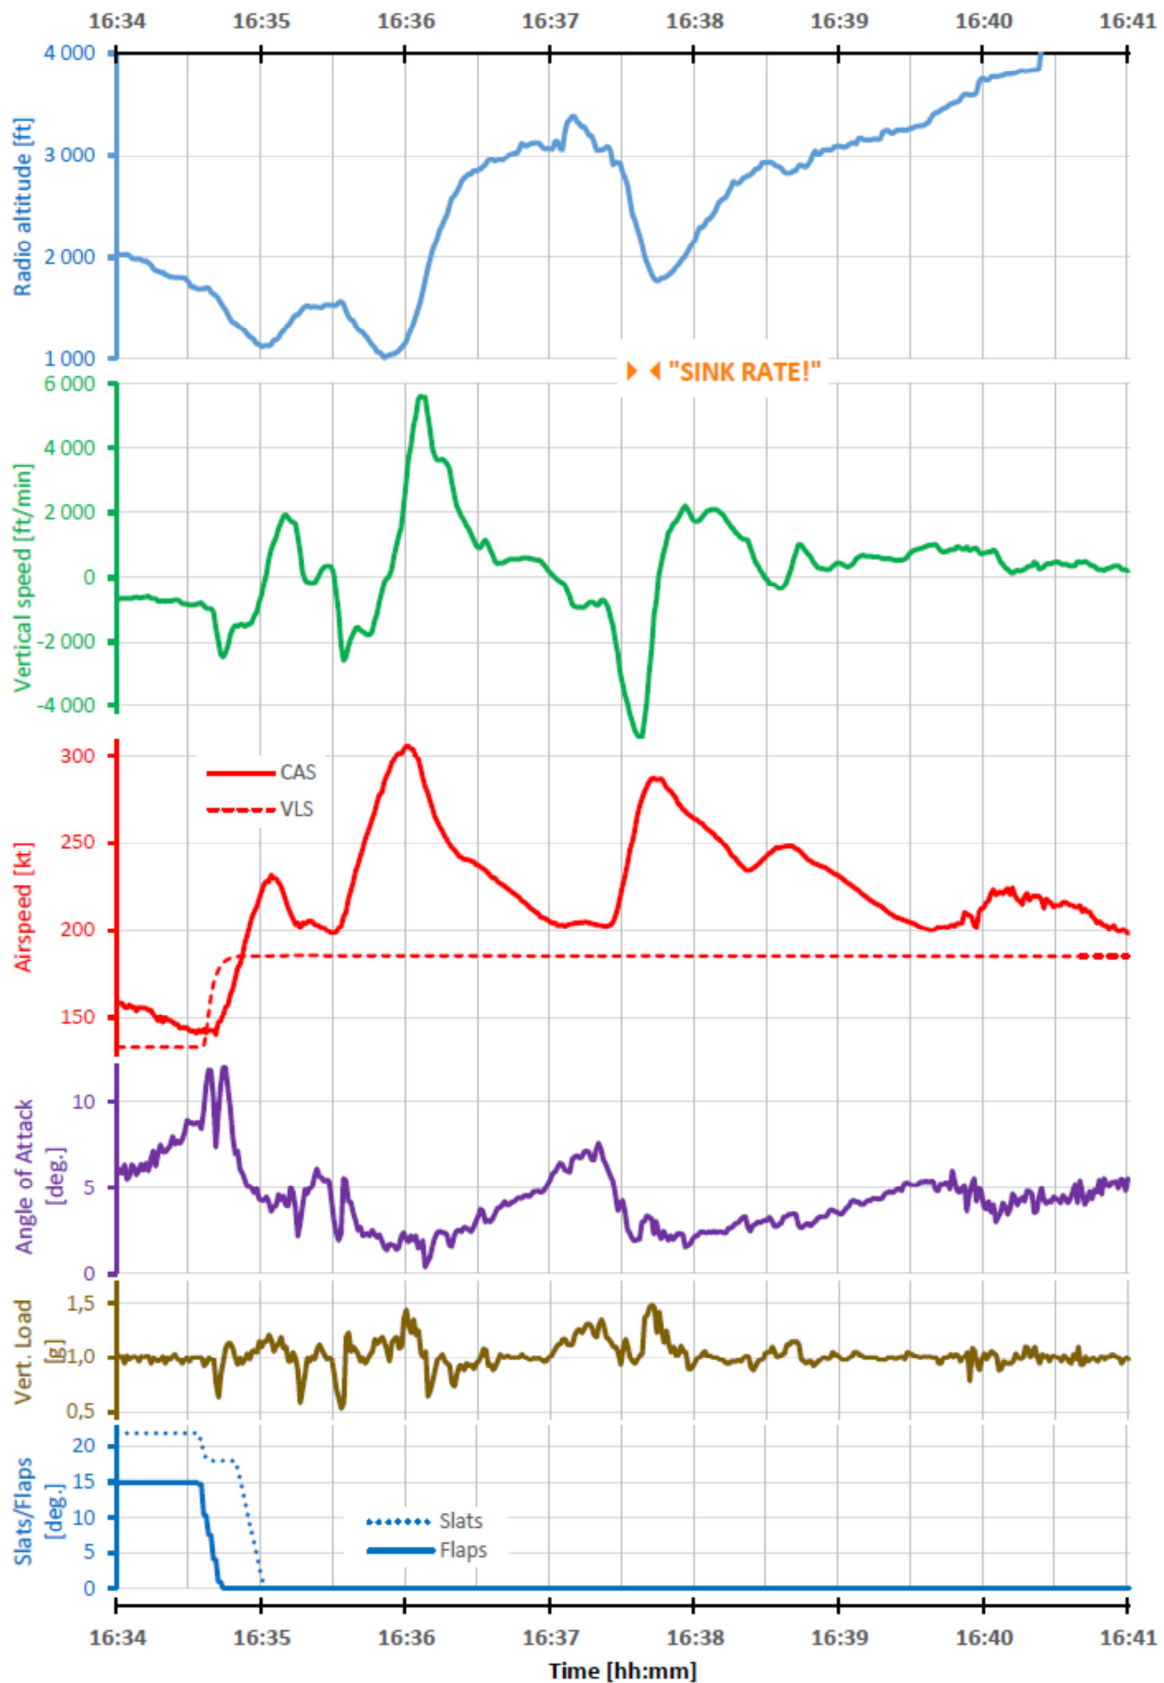
Figure 9: Flight parameters as per data from the QAR (TSB)

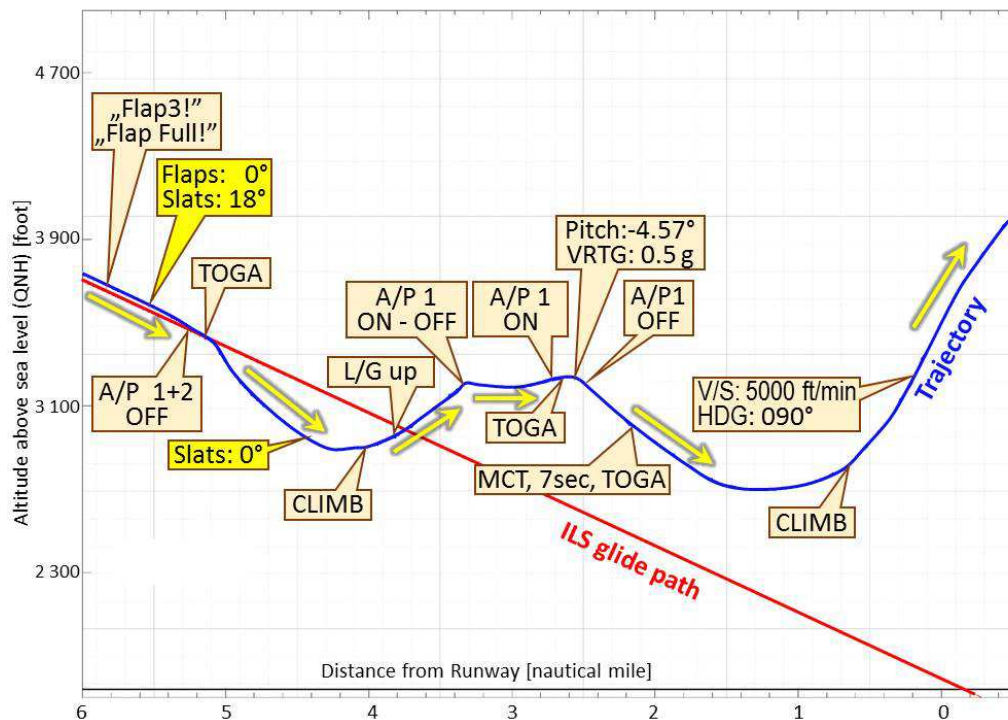
After the instruction to deploy flaps, when the PM set the control lever to CONF0, the PF saw on his instrument that the lowest selectable speed (V_{LS}) value was rapidly growing and reaching a value above the current airspeed. The immediate danger of stalling was eliminated by the action of the protective system of the aircraft which did not allow full retraction of the slats immediately because of low airspeed and high angle of attack. In order to eliminate the problem, the PF disconnected the auto pilots, initiated steeper descent, and then set the thrust levers to maximum thrust (TOGA). Despite the fact that the thrust levers were now in TOGA position, the aircraft control did not switch from approach mode to go-around mode because the CONF0 position of the flaps lever inhibited that process according the AFS logic.

At the cost of a loss of altitude of ca. 500 ft, airspeed reached a safe value of 220 kt, after which the slats were retracted fully. The aircraft started to climb, and PF pulled the thrust back to CLIMB position. The landing gears were retracted. In response to the thrust lever position, the A/THR engaged, and, in accordance with the still active approach mode, it tried to reduce airspeed to Green Dot speed (198 kt). As at this time the current aircraft speed was 230 kt, the A/THR reduced engine thrust (to a level near idle).

Figure 10: Moments of the interruption of the ILS approach, side view (source: BEA)
