MINISTRY FOR
INNOVATION AND TECHNOLOGY
TRANSPORTATION SAFETY BUREAU

FINAL REPORT

2016-037-4

Accident
outside Vértistolna
28 February 2016
Cessna FA152
HA-VOK

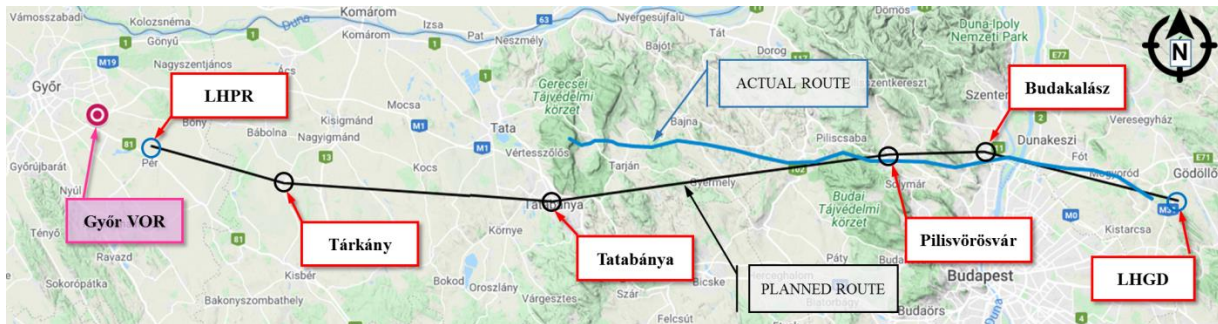
Figure 4: The planned route vs. the actual route of the aircraft

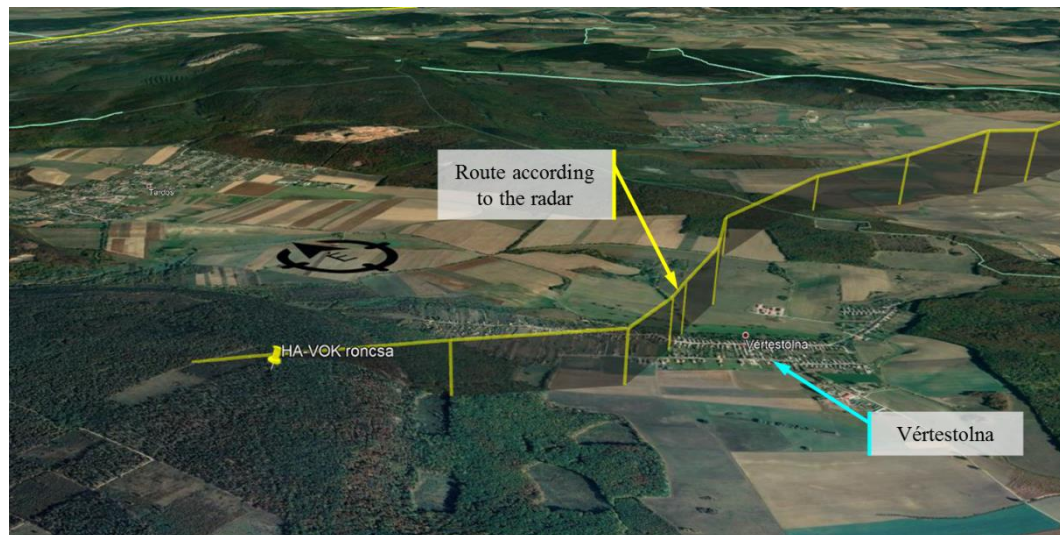
According to radar data, in the last 2 minutes preceding the accident, the flight altitude of the aircraft changed several times from 1800 ft. to values between 1900 ft. and 1600 ft., as well as its speed and direction of flight (Annex 1).

Figure 5: The flight path of the HA-VOK according to radar data

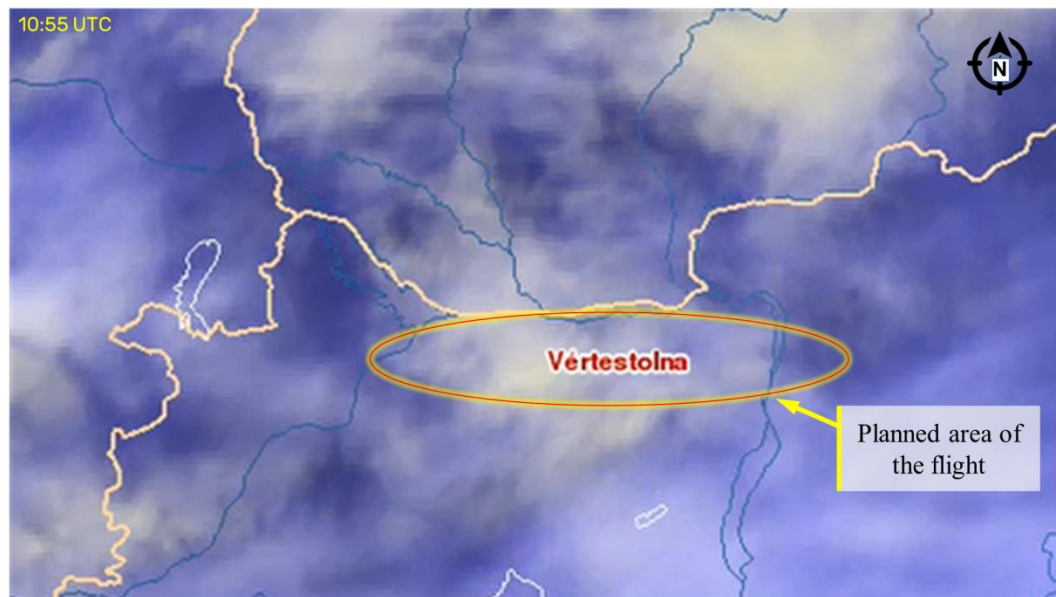
Figure 6: Composite cloud picture (Source: Hungarian Meteorological Service)

At the time of the accident, the top and the eastern side of the affected mountain was certainly in the cloud at the flight altitude of the HA-VOK.

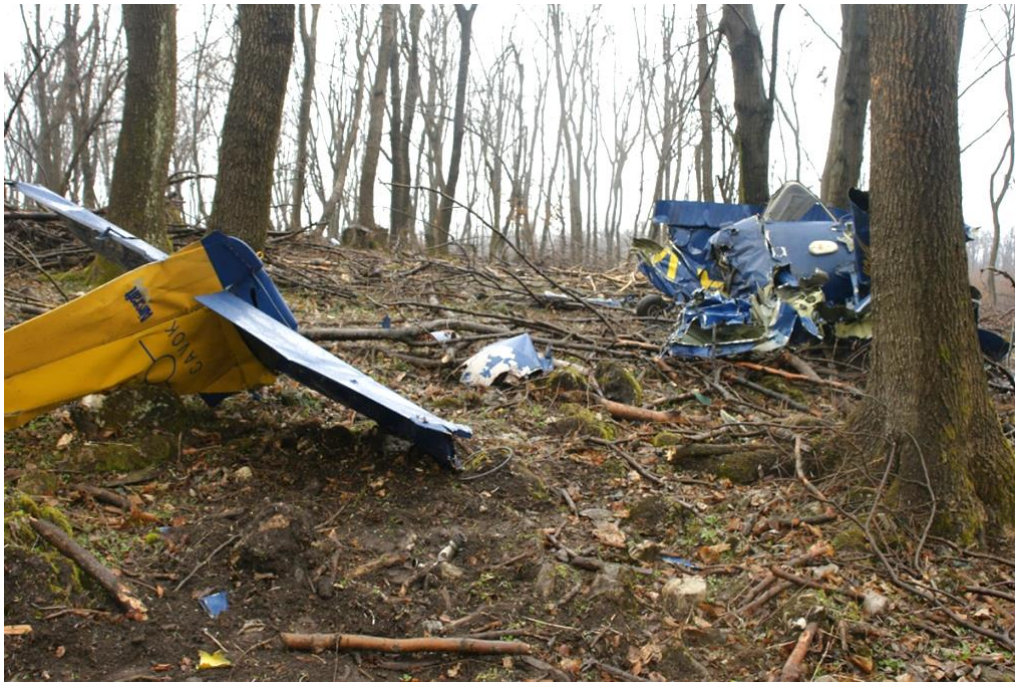
*Figure 7: The wreck of the aircraft with some major structural elements separated
(Photo: TSB)*

The damages to the trees and the pattern of scatter of the separated aircraft parts show that the aircraft moved along an almost fully straight line with no deviation of direction from the point of the first collision to the spot where it came to rest, and that its direction was about 311 degrees (Annex 2).

As a result of the series of collisions, several major structural elements of the aircraft separated from the fuselage (among others, the main landing gears, a piece of the left wing, the LH aileron, the propeller, and the tail part with the vertical and horizontal stabilizers) (Figure 7).

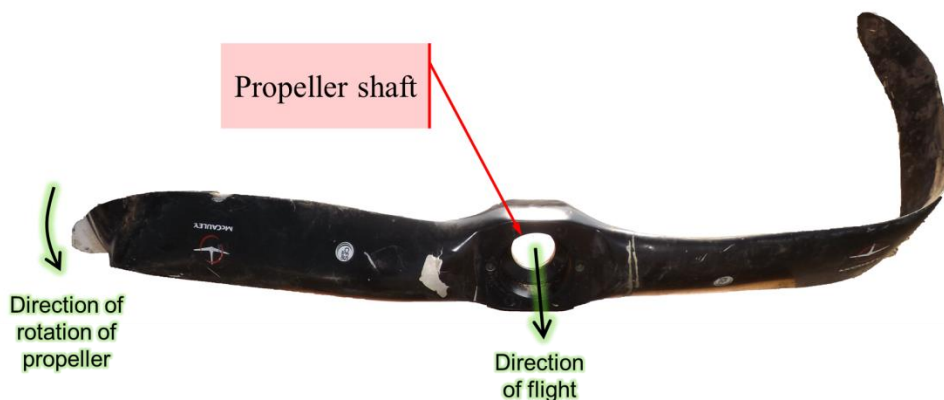
Figure 8: The propeller of the HA-VOK

The investigation of the hub and blades of the propeller found, among others, that the propeller hub separated due to the forces generated by the engine running at high speed and the contacts with the trees (Figure 8).

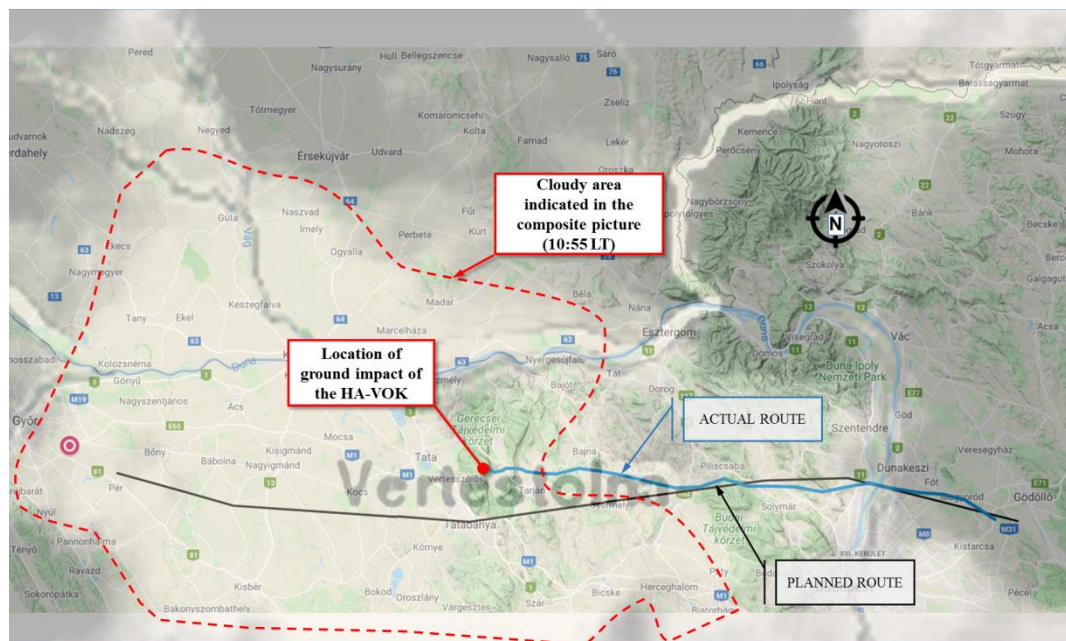
Figure 15: Matching of the composite cloud map and the flight path

According to the IC's position, the Pilot and the Passenger were aware of the weather situation. Therefore, it cannot be excluded that the turning point at Győr also influenced the selection of the route, due to the VOR navigation station which allowed IFR flight as well, based on the instruments installed in the aircraft (1.6.1).
