MINISTRY FOR
INNOVATION AND TECHNOLOGY
TRANSPORTATION SAFETY BUREAU

FINAL REPORT
2016-071-4P
SERIOUS INCIDENT

LHBP
16/03/2016

ATR 72-200
YR-ATI

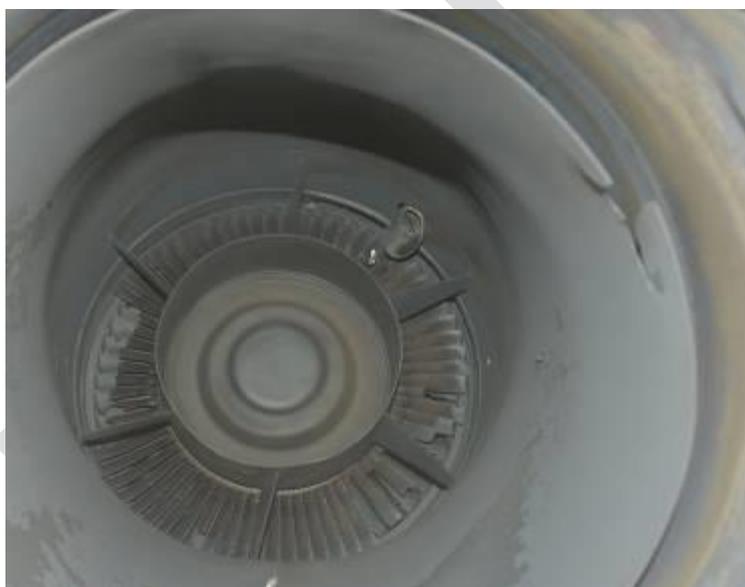
The power turbine stage of the right hand side (№2) engine (Figure 4) and the tail pipe were badly damaged, and the fire caused significant damage to the engine nacelle (Figure 5). Engine failure was contained and no damages have been found outside of the engine nacelle.

Figure 4: engine №2 from the direction of the tail pipe, after landing

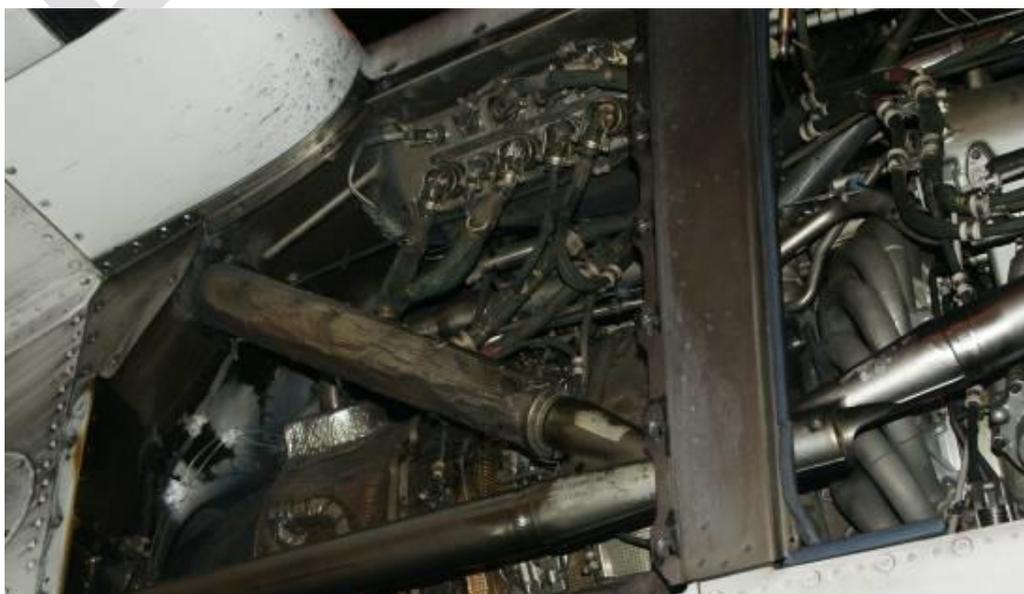
Figure 5: Visible signs of the high temperature in the nacelle of the engine №2

During the incident, the fire alarm system of the engine №2 of the aircraft was activated, smoke flowed into the passenger cabin, and the smoke emitted from the engine №2 was perceived visually in the control tower of the airport. The pilots reduced the power of the malfunctioned engine, but it was only a minute after that they shut it off and started both bottles of the fire extinguishing system of the engine. The fire alarm worked for ten seconds, then it stopped. Damages caused by severe burn were observed both in the engine and its nacelle during the inspection. The burns did not reach beyond the nacelle.

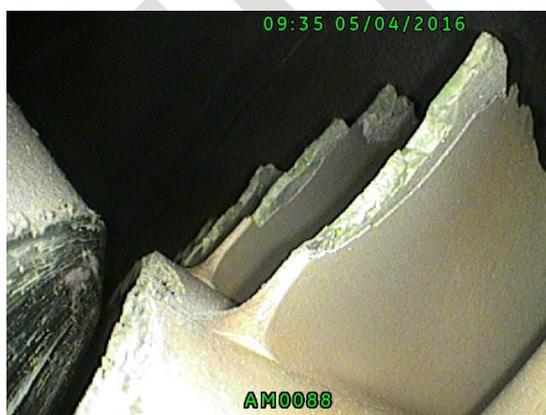
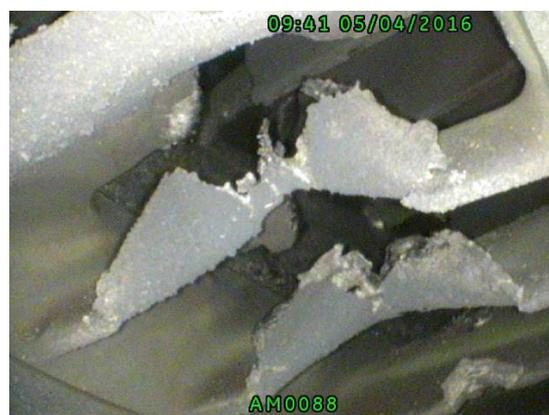
Figures 13 & 14: *Boroscope photos of the low pressure turbine and the power turbine (VAF)*

- The blades of the discs of both stages of the power turbine were badly damaged
- The low-pressure compressor showed no sign of damage caused by ingested foreign object.
- The outside of the engine showed the signs of effects of high temperatures.
- Significant quantity of metal debris was found in the oil system
- Both discs of the power turbine were badly damaged.

- 19 blades of 2nd stage PT were fractured and the rest of the blades were damaged.
- The tail pipe was damaged by partly molten metal debris flowing out.

- Each blade of the 2nd stage PT stator was damaged.
- Each blade of the 1st stage PT rotor assembly fractured. A blade of the rotor assembly broke off near its root, which may have been the point where the engine started to become inoperable.

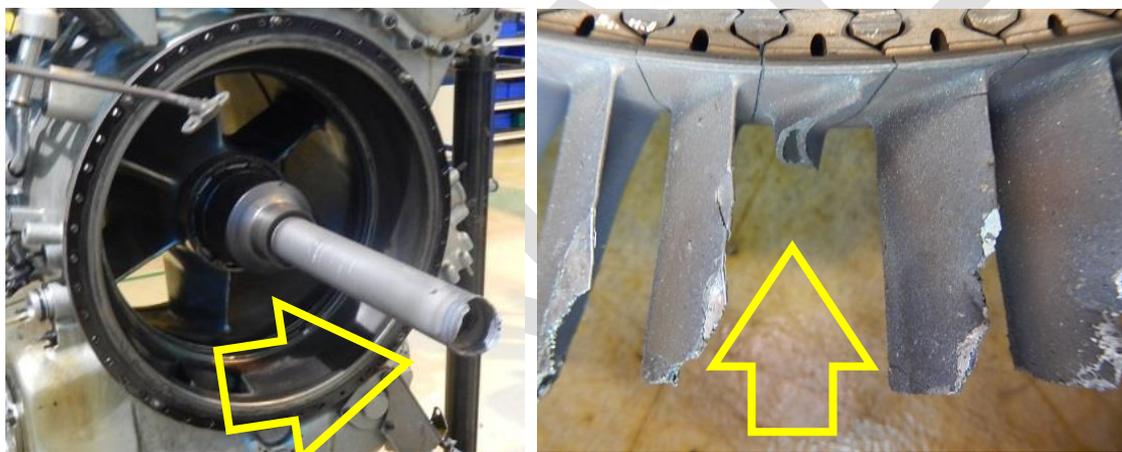
Figures 15 & 16: *The fractured shaft of the power turbine, and the stump of the fractured blade which started the process leading to engine failure (Vector Aerospace France)*

The information acquired during disassembly of the engine show that the process leading to the failure of the engine may have been started by the fracture of a blade in the 1st Stage PT. The rotor assembly became unbalanced, and the vibration evoked by it probably broke the three oil pipes holding the № 6 & 7 bearing housing. The unsupported bearing housing could not keep the shafts in place, and the spilt oil caught fire. As a consequence of the above events, both the low-pressure and the power turbine rotor assemblies were displaced, and were finally damaged, and the shafts fractured. The damages of the compressors are the consequence of the severe damages of the turbine section.

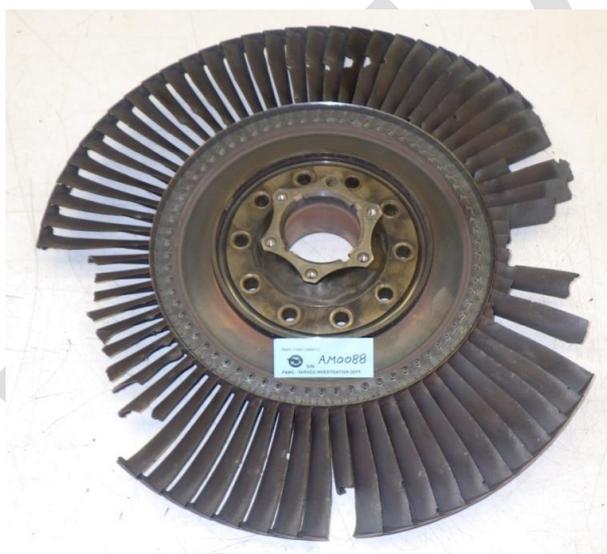
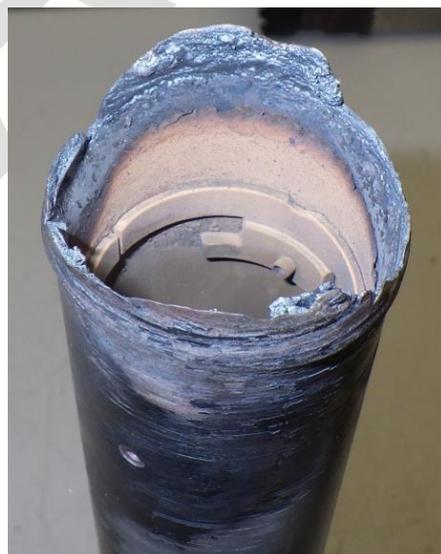
Figures 18 & 19: the rotor assembly and the fractured, molten shaft of power turbine, 2nd stage (PWC)

- The 2nd stage PT stator shows impact damage.
- Several blades of the 2nd stage PT rotor assembly fractured at different heights due to single impact.
- The bearing housing № 6&7 was overheated, deformed, its fastening screws fractured; the oil pipes to it also broke and show burn marks as well.
- The PT shaft melted and fractured at the № 5 bearing area.
- The shaft of the LP turbine also fractured at the № 5 bearing area as an effect of friction with the fractured shaft of the power turbine.

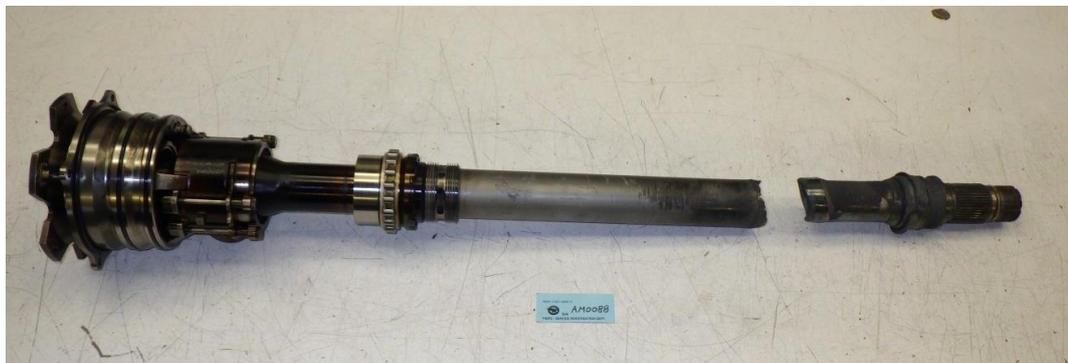
Figure 20: The molten and fractured shaft of the power turbine (Pratt & Whitney Canada)

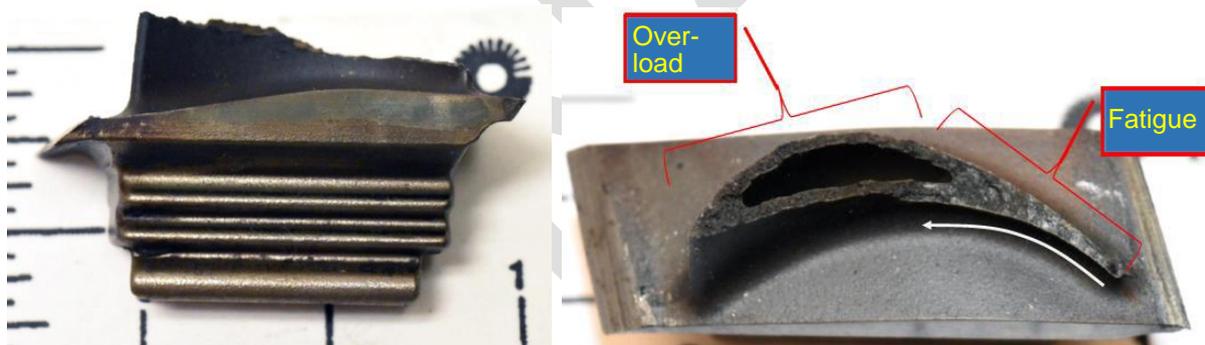
Figures 21 & 22: Root of the fractured PT blade and the fractured surface (Pratt & Whitney Canada)

- A fatigue crack started out from the trailing edge of the blade and spread towards the leading edge (Figures 21 & 22, white arrow), as far as half of the chord length. The remaining part fractured due to overloading.
- The composition of the alloy of the blade meets the relevant requirements.
- The geometrical layout of the trailing edge of the blade shows no anomaly.
- The remainders of other blades of the power turbine showed no fatigue cracks.

The 1st stage PT rotor assembly included both new blades and used ones. The fractured blade was fitted as a new one between two old ones. It cannot be stated that the fatigue crack which led to fracture of the blade would have been due to the vibration generated by loose fastening.

It may be established on the basis of information from the lab test that a fatigue crack started out from the trailing edge of the trailing edge of a blade of the PT1 and its spreading finally led to fracture of the blade. No defect of material or mechanical damage was found around the area where the crack started out. The damage to other stator vanes and rotor blades of the power turbine was a consequence of the first blade fracture. The power turbine became unbalanced, and its intensive vibration caused fractures of the of the oil pipes and screws which fixed bearing housing № 6 & 7, as a result of which the low- and high-pressure power turbine shafts may have contacted and fractured. The fire fuelled by spilt oil led to thermal damage to or deformation of the 1st stage PT stator, the low-pressure turbine, the bearing housing № 6&7, and the oil pipes. The damage to the blades of the high-pressure turbine was due to overheating.

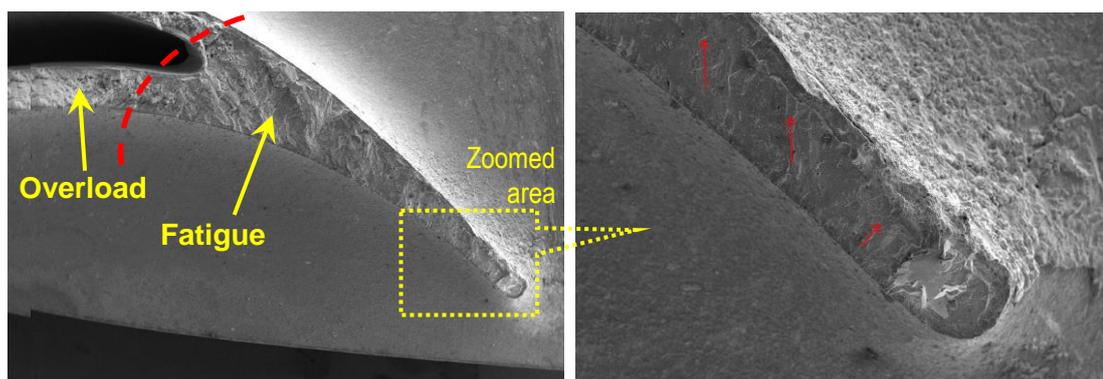
Figure 23: *Electron microscopy image of the fractured surface at the trailing edge of the blade (PWC)*
