MINISTRY FOR  
INNOVATION AND TECHNOLOGY  
TRANSPORTATION SAFETY BUREAU

# FINAL REPORT

2016-158-4

Chain Bridge (Danube River), Budapest, Hungary

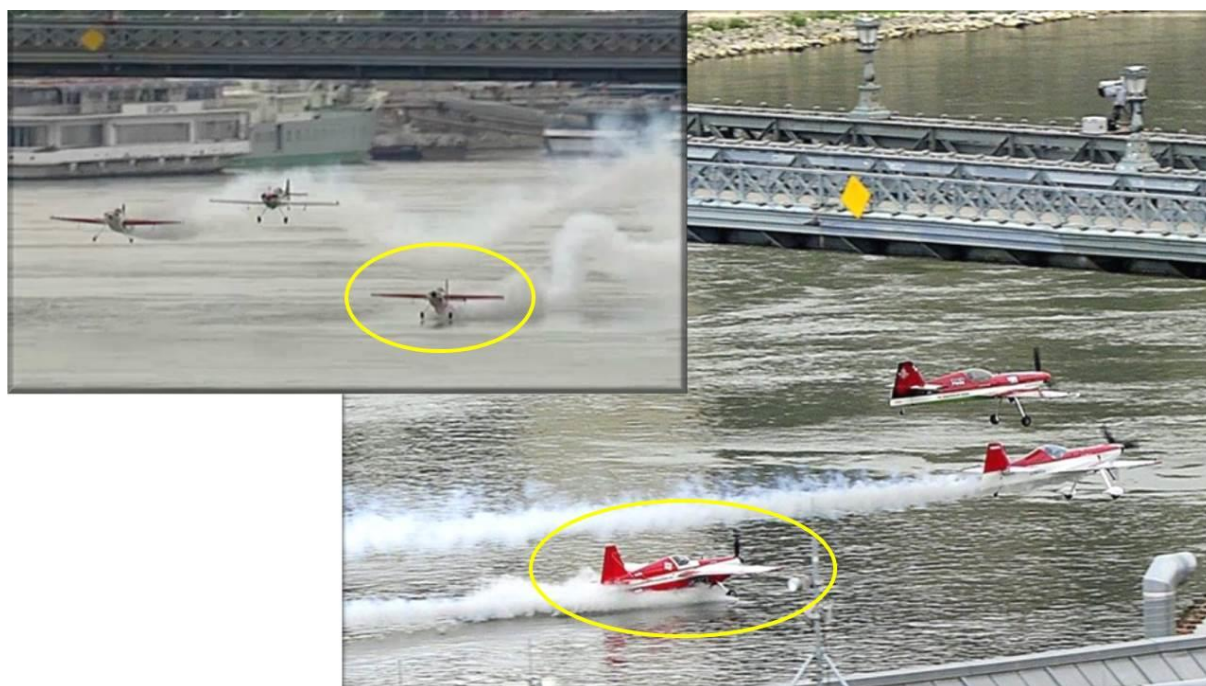
Fig. 2: Photos about the incident, front and side

From the recordings available to the IC, it was found that during a three-plane flight under the Chain Bridge, the left wing suddenly lost altitude just before reaching the bridge. The airplane touched the surface of the Danube with both main landing gear wheels. Thanks to the immediate reaction of the pilot, further descent was stopped. The left wing quickly re-established and held his position in the formation.

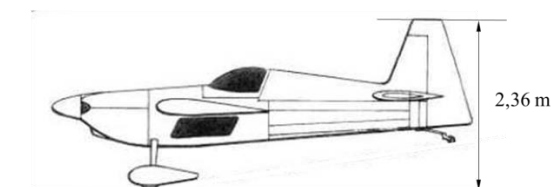
Fig. 4: The height of EDGE 540<sup>1</sup> is 2.36 m (7ft 9")

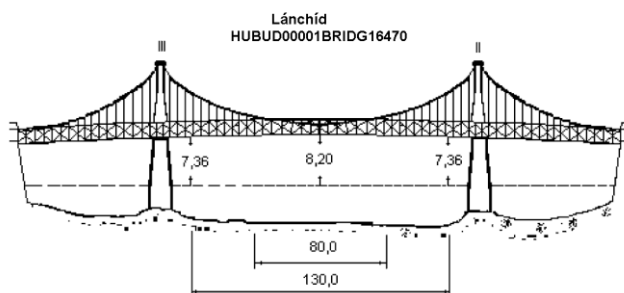
Fig. 5

Chain Bridge, position: N47°29'900", E19°02'645"; marker: 1647 km. The minimum navigation water level (MNWL) under the bridge's central span is 0.8 m. Based on MNWL, there is a 130-m-wide zone with a height of 7.36 m and a narrower, 80-m-wide zone with a height of 8.22 m (see Fig. 5).

the occurrence (which corresponds to a low water level). Therefore the real clearances were as follows: 696 m in the central 80m wide zone and 610 m in the broader 130m wide zone. (MNWL-206= -126 cm; 822-126= 696 cm / 736-126= 610 cm)
