Short summary of the occurrence

On 31 March 2017, the pilot of the type DV-20 Katana (Figure 1) aircraft with registration mark HA-DAL detected loss of engine power during the climb after take-off, so he interrupted his flight task and returned to the airport. An eye-witness saw smoke leave the exhaust pipe of the engine of the aircraft during landing. Landing was performed safely, and none of the people on board was injured, and the aircraft was not damaged either. Smoking stopped upon stopping of the engine.

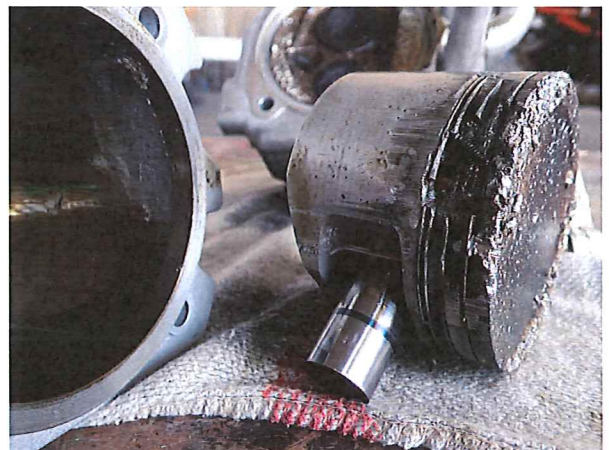
At the posterior inspection, the IC found that both compression rings as well as the oil control ring broke in Cylinder 1 of the engine of the type Rotax 912 S3. The piston shows burn marks at the ring grooves, and it even burnt through in an area of a few square millimetres at the groove for the oil control ring. The piston surface contacting with the combustion chamber shows the signs of damage caused by loose pieces of metal, and there is aluminium (missing from the material of the damaged piston) smeared on the cylinder walls (Figure 2).

Figure 2: The damaged piston

- According to the manufacturer's inspection of the damaged engine, the damage symptoms at the piston of cylinders are the result of knocking combustion.

Compression in Cylinder 1 decreased due to piston ring fractures and to burn of the piston, which led to power loss and vibration of the engine. Particles of the fractured parts caused additional mechanical damages within the rotating engine. The fume of the oil leaking into and burning in the combustion chamber left through the exhaust pipe, which the witness saw, too.

According to information available to the IC, the aircraft involved in the occurrence was typically used for the training of student pilots. As a result, it may have been occurred that its engine was used – for shorter or longer periods – outside the optimum parameters specified by the manufacturer in the Service Letter № SL-912-016R1. This could have been caused by possible switched-on state of carburettor heating during a take-off following a go-around, and/or improper propeller pitch setting in various phases of the flight. A situation where the engine was operated at engine speed over 5500 rpm during climb following take-off may have occurred during student pilots' independent flights. The IC's position is that the breakdown of the engine was the result of a longer process during which the pistons and cylinders of the engine might have been exposed to mechanical and thermal loads in excess of the design values occasionally. The piston melted and burnt through at the piston ring groove due to excessive heat load which might have occurred during operation, and the compression rings fractured.

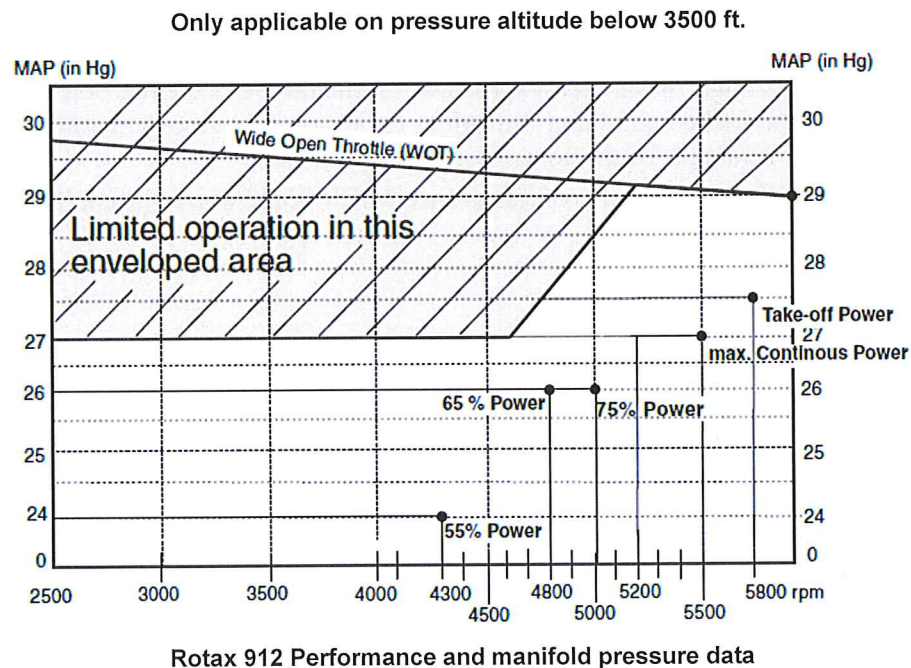
- Continuous use of engine speed below 5200 rpm with WOT should be avoided, and, at pressure altitudes below 3500 ft., continuous use of engine speed below 5200 rpm must follow the graph below (Figure 3):

Figure 3: Operating range below 3500 ft. (Source: Service Letter SL-912-016R1)
