FINAL REPORT

2017-186-4

Accident

Schleicher K-7

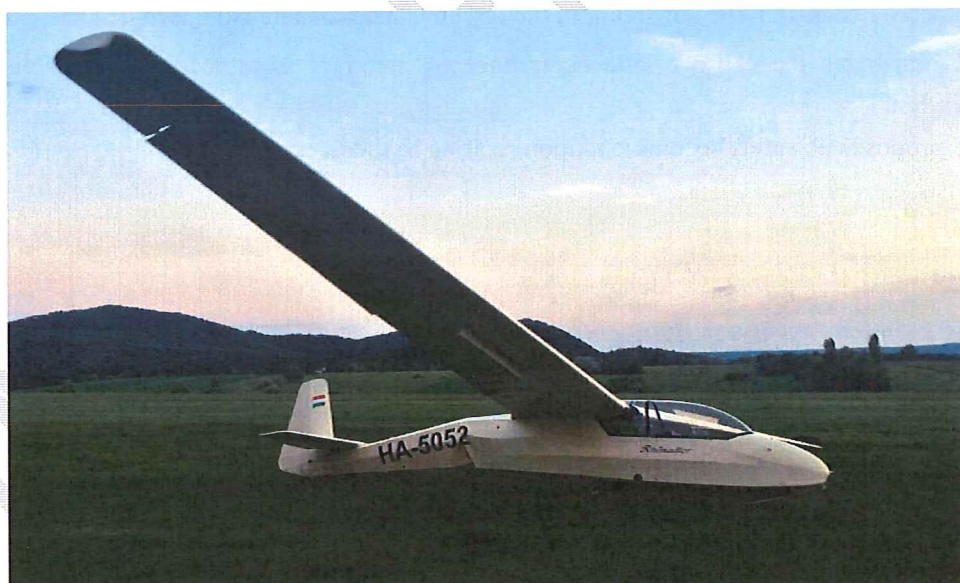
On 20 May 2017, the Flight Instructor and his Student Pilot took off for a training task in a type K-7 sailplane. It is known from witness statements that the Flight Instructor flew with the Student Pilot because of the strong wind and turbulence. After about an hour of flight, the Flight Instructor and the Student Pilot approached the fourth turning point to Runway 33 of Farkashegy Airport in order to land. On completion of the fourth turn, the flight altitude of the aircraft was a little higher than usual, about 250 metres relative to the location of the take-off. The two people who had been on board at the time of the occurrence stated unanimously that the aircraft had been flown by the Flight Instructor. During the final approach, the Flight Instructor applied full spoilers, flying at 90 km/h indicated airspeed, so that he can stop the aircraft as close to the start point as possible. Due to a combination of strong wind, approach speed and fully extended spoilers, they approached the runway at a steeper angle than the usual landing approach profile. When starting the landing manoeuvre, at an altitude of 15 to 20 metres above ground level, Flight Instructor found the speed of the aircraft slow in the given circumstances, so he attempted to increase speed by retracting the spoilers and simultaneously starting a speed-gaining manoeuvre (pitch down). During the manoeuvre, the Flight Instructor realised that the airspeed of the aircraft did not grow while descent was invariably intensive. In that new situation, at an altitude of about 3 metres, the Flight Instructor tried to reduce the intensity of descent by pulling the control stick backwards. Subsequently, the main landing gear of the aircraft crashed to the ground at high vertical speed. The Student Pilot occupying the front seat suffered a vertebral fracture and the fuselage of the aircraft was damaged significantly due to the impact.

Figure 2: The aircraft involved in the occurrence, after landing

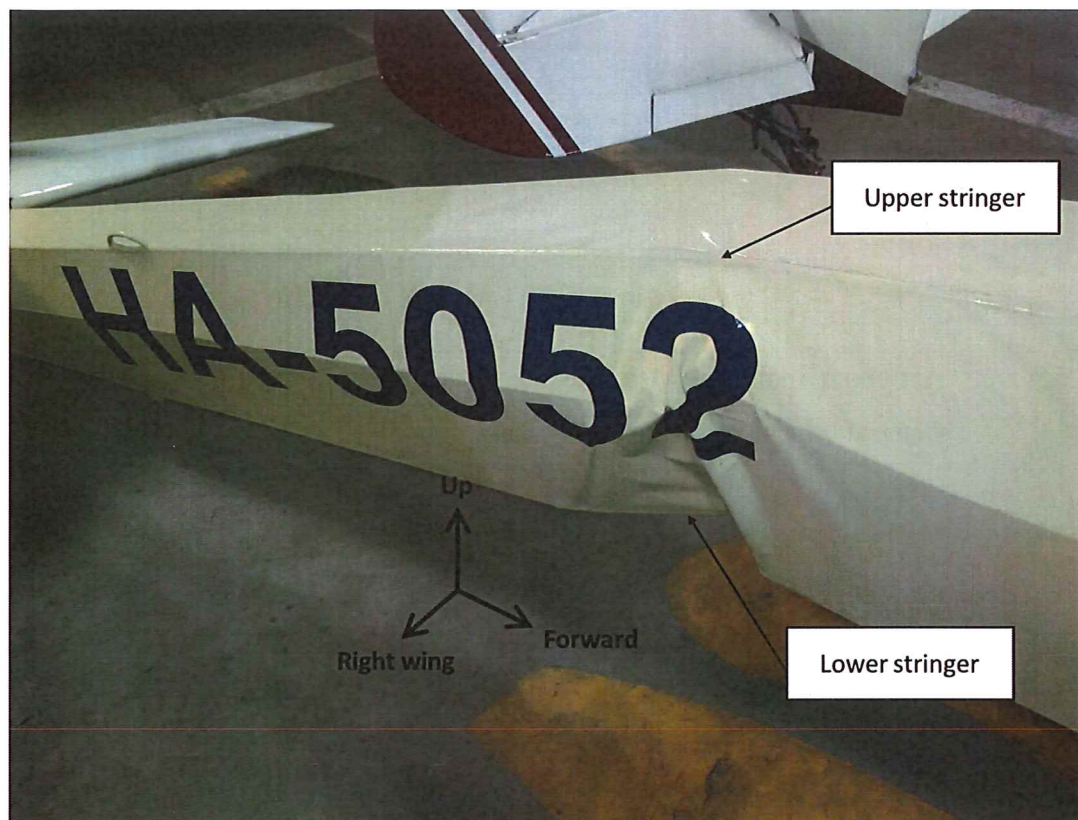
According to information from the flight safety organisation contracted with the owner of the aircraft, the damage to the aircraft has been assessed (by X-ray and endoscopy methods) since the occurrence. The wings were not damaged: the connections, as well as the wooden structure remained intact. The lower stringer of the fuselage web bent between two joints, which led to arc-shaped bending of 3 upper stringers (Figure 3).

Figure 3: Damaged fuselage of the aircraft

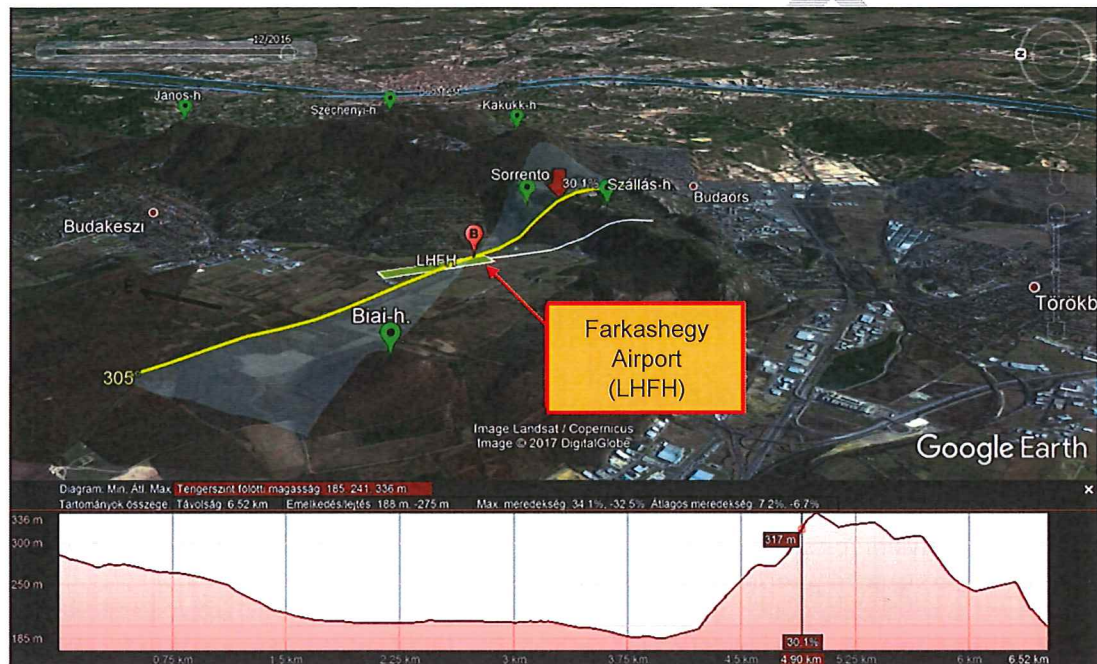
The occurrence took place at daytime, in good visibility conditions. In the afternoon of the day of the occurrence, the NW wind freshened in the area after a noticeable intrusion of cold air in the lower atmosphere, and it became stormy (15 to 20 m/s) by the time of the occurrence, according to data recorded by the meteorological station at Jánoshegy. The wind blew the mountain ridge almost perpendicularly, from directions ranging from 280° to 305°. The angles of the slopes near Farkashegy Airport are 20° to 30°.

Figure 4: Vertical section view of the terrain as seen from Farkashegy Airport; direction of view: 305°

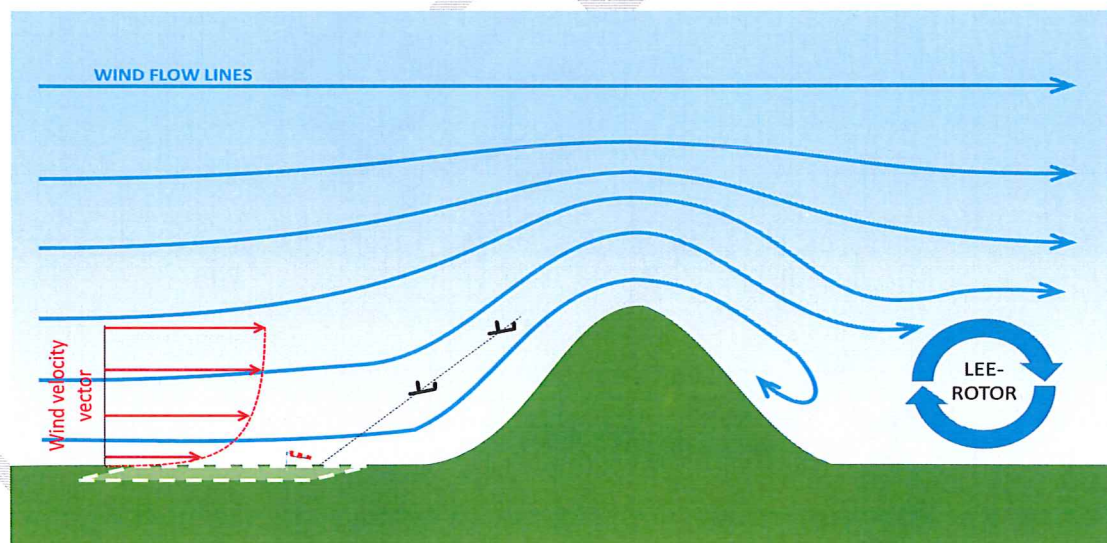
In the opinion of the IC, it is definitely important to maintain the flight crew's situation awareness during the operation of aircraft. Situation awareness highly depends on the availability of the pilot's attention, the level of stress associated to the situation, and the mental load imposed by the activity being performed. Partial or full loss of the capacity of situational awareness may lead to decision problems which in turn may result in errors. The position of the IC is that the Flight Instructor's striving to land close to the start place, the approach angle steeper than usual, the lower-than-expected speed of the aircraft and the turbulent weather imposed great load on the Flight Instructor. As a result of increased mental load, the Flight Instructor did not pay sufficient attention to other environmental parameters (e.g. wind gradient) associated to flight. The position of the IC is that when the Flight Instructor realised that the speed of the aircraft was slower than expected and the rate of descent exceeded the usual value, he intervened. However, that intervention took place at an altitude where retraction of the spoilers and the speed-gaining manoeuvre was insufficient due to the wind gradient.

Figure 5: Vertical gradient of the wind at the windward side of the mountain and the airflow behind the mountain¹

The IC concluded during the investigation that the cause of the occurrence was that the Flight Instructor did not take into account adequately the vertical gradient of the wind speed and the turbulence associated to the given wind conditions.

Flight Safety Organisation, Hungarian Aeronautical Association proposes in connection with the occurrence, as a safety recommendation, that, in order to avoid similar cases, the operating and training organisation should remind the crews of the aircraft of specific features of flying in conditions of intensive turbulence before flights to be performed in similar weather conditions; with special attention to the aerodynamic aspects of turbulence and to the appropriate procedure of eliminating its adverse effects.
