MINISTRY FOR
INNOVATION AND TECHNOLOGY
TRANSPORTATION SAFETY BUREAU

FINAL REPORT

2017-371-4

Bellanca 8GCBC

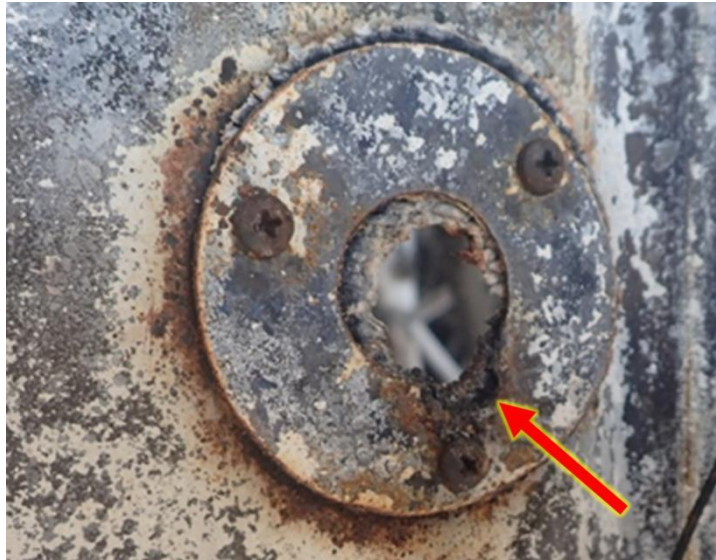
Figure 2: Location of the cable passage in the firewall

Marks of electrical discharge at the passage of the high power cable through the firewall (the area indicated by the red arrow in Figure 2).

The IC inspected the passage of the high power cable through the firewall where marks of electrical discharge can be seen (Figure 2), and a mark of melting can be seen on this cable in the plane of the firewall (Figure 3). This cable (Nr.99 in Figure 10) is powered when the main switch of the aircraft is ON, i.e. this discharge must have been generated before the pilot shut off the electrical system of the aircraft, using the main switch, through the Master Solenoid (Figure 10).

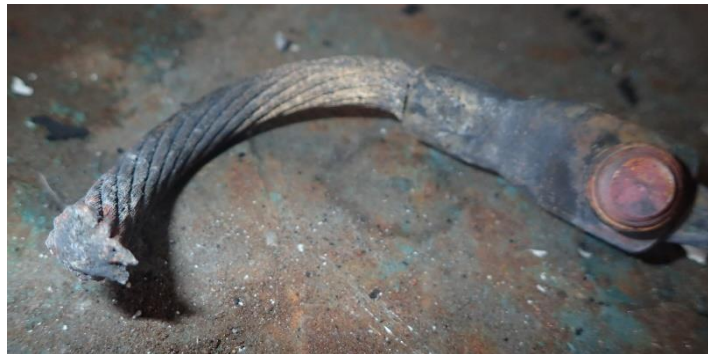
Figure 3: The cable which melted at the passage

Figure 3 shows the cable led through the firewall (cable Nr.99 in Figure 10); the cable melted in the plane of the firewall (see detailed description of the electricity system of the aircraft in Chapter 1.18.1).

This cable is always energised when the master switch of the aircraft is on.

On the basis of the Starter Solenoid position of the type 7GCBC airplane, the IC placed the melted piece of the cable (Figure 3) of the airplane with registration mark HA-KYL on the firewall, positioning it at the place of the Starter Solenoid (Figure 9, the cable indicated as Nr.99). The experiment showed that the high voltage cable melted in the plane of the firewall.

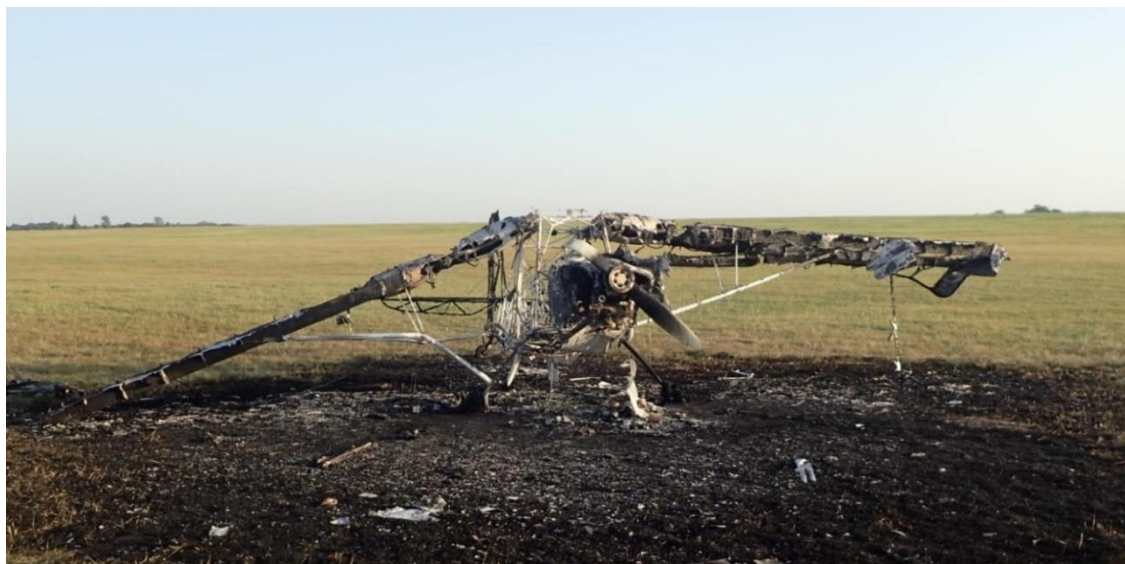
Figure 4: The aircraft with registration mark HA-KYL after the accident

During the accident, the fire started in the engine compartment of the aircraft and simultaneously in the cockpit as well, and then it spread to the fuel system of the aircraft (see Chapter 1.14 for detailed description).

Due to the burning of fuel, the aircraft burnt out within very short time, ca. 2 to 3 minutes (Figure 4).

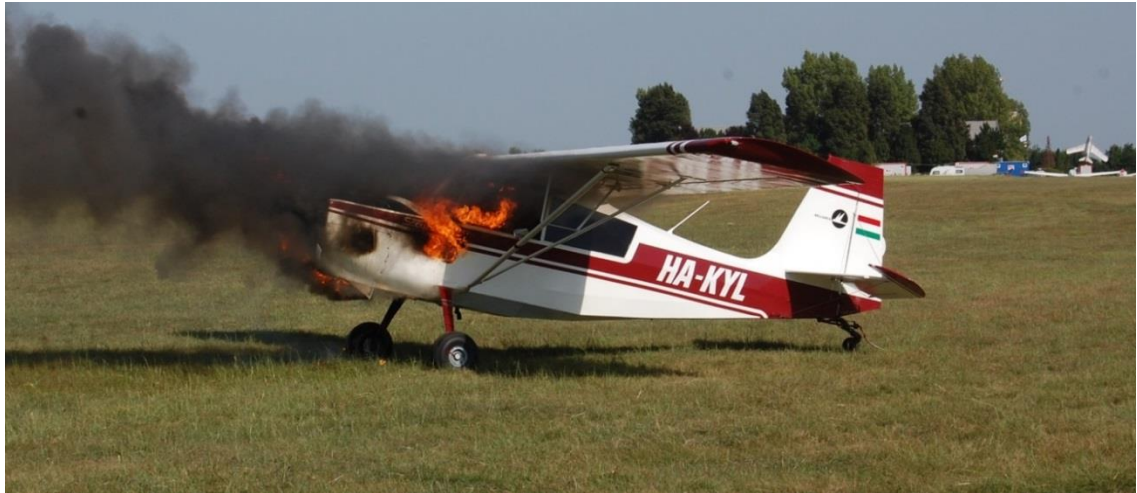
Figure 5: Spread of the fire along the fuel pipe in the direction of the wing tank

Figure 5 shows the engine compartment on fire, and also the spread of the flames along the fuel pipe running along the windshield frame to the wing tank.

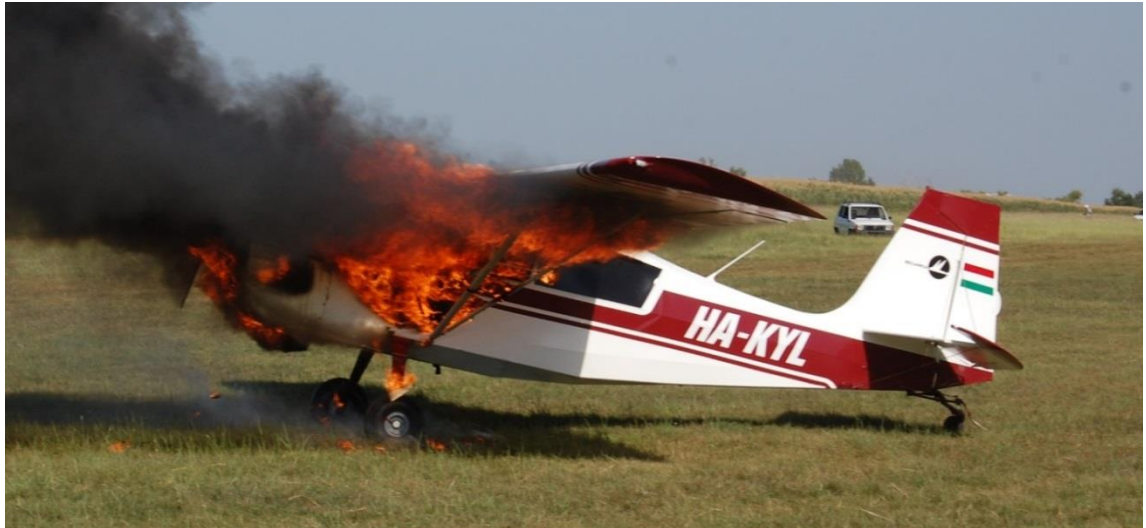
Figure 6: The front section of fuel tank melted, and fuel spread along the bottom surface of the tank

In figure 6, the fire had already reached the tank, melted its front section, then fuel flowed along the bottom surface of the wing and spread the flames wide under the wing.

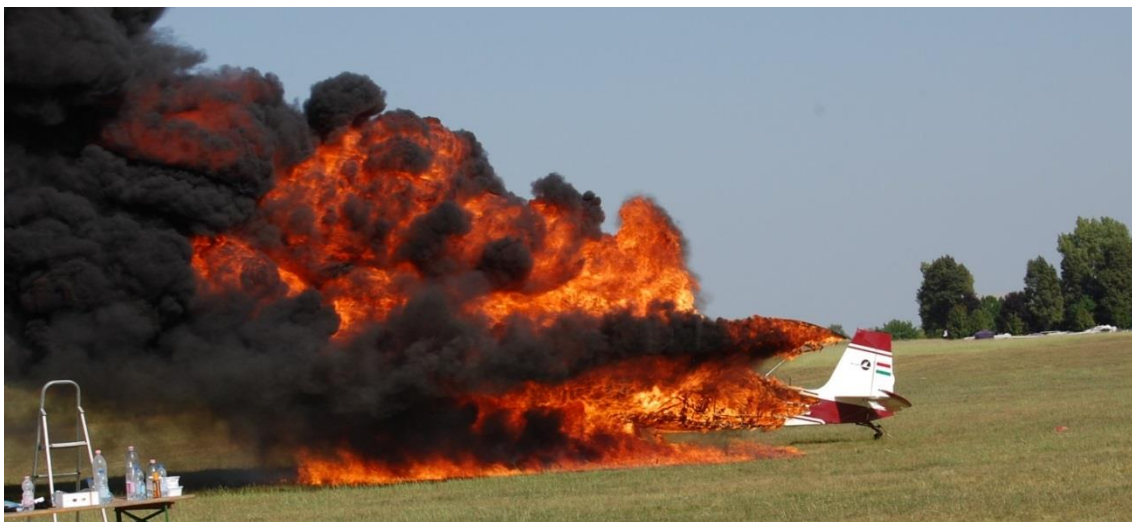
Figure 7: The fuel spilt from the fuel tank to the ground where it spread out

Figure 7 shows that more and more fuel spilt from the fuel tank, it could not hold and burn on the lower surface of the wing but flowed down to the ground and spread there. The burning fuel led the flames to the ground, and the spreading fire set the rest of the aircraft on fire as well.

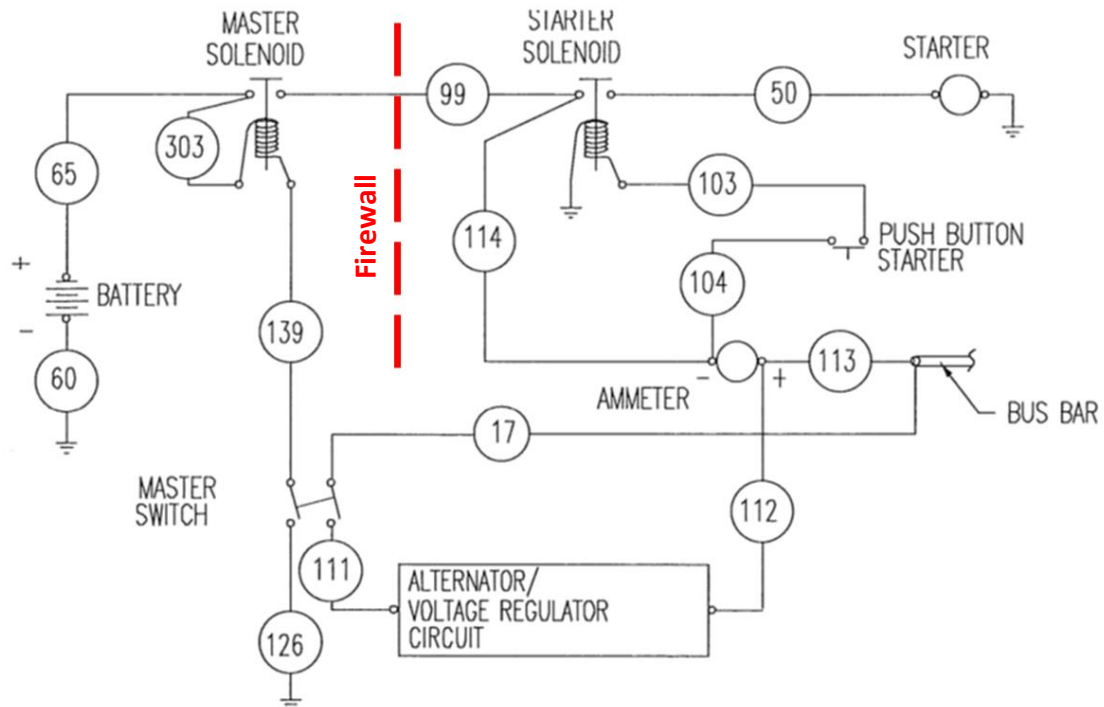
Figure 10 (Source: SL 418)

According to the factory design seen in Figure 10, the battery and the Master Solenoid are installed behind the cockpit, in the tail of the airplane. A high power cable (Nr.99 in Figure 10) runs from the Master Solenoid to the Starter Solenoid which is situated in the engine compartment of the airplane. The Starter Solenoid and the Starter are also connected by a high power cable (Nr.50 in Figure 10). The plane of the firewall is indicated by a red dashed line in Figures 10 and 11.

Due to large current consumption of the starter, the circuits of the cables Nr.65, Nr.99 and Nr.50 cannot be protected with fuses, for the sake of reliable operation of the starter. Accordingly, in the case of a possible short circuit to the frame, the two poles of the battery are shorted through the high power cable, and the amperage of the current flowing through the cables will be the maximum amperage of the battery. The high power cables will heat, glow, and melt due to high amperage of the current flowing through them. The melting temperature of copper cable is 1085°C (1985°F).

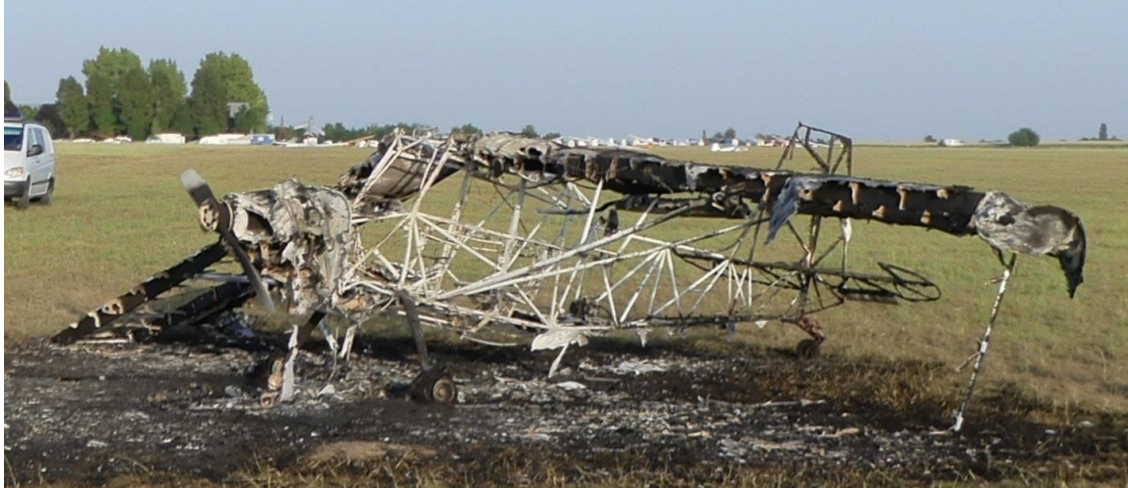
Figure 14: The wreck of the aircraft with reg. mark HA-KYL at the time of the investigation of the scene

The IC found the aircraft in burnt-out state when arriving to investigate the scene of the accident (Figures 4 and 14).

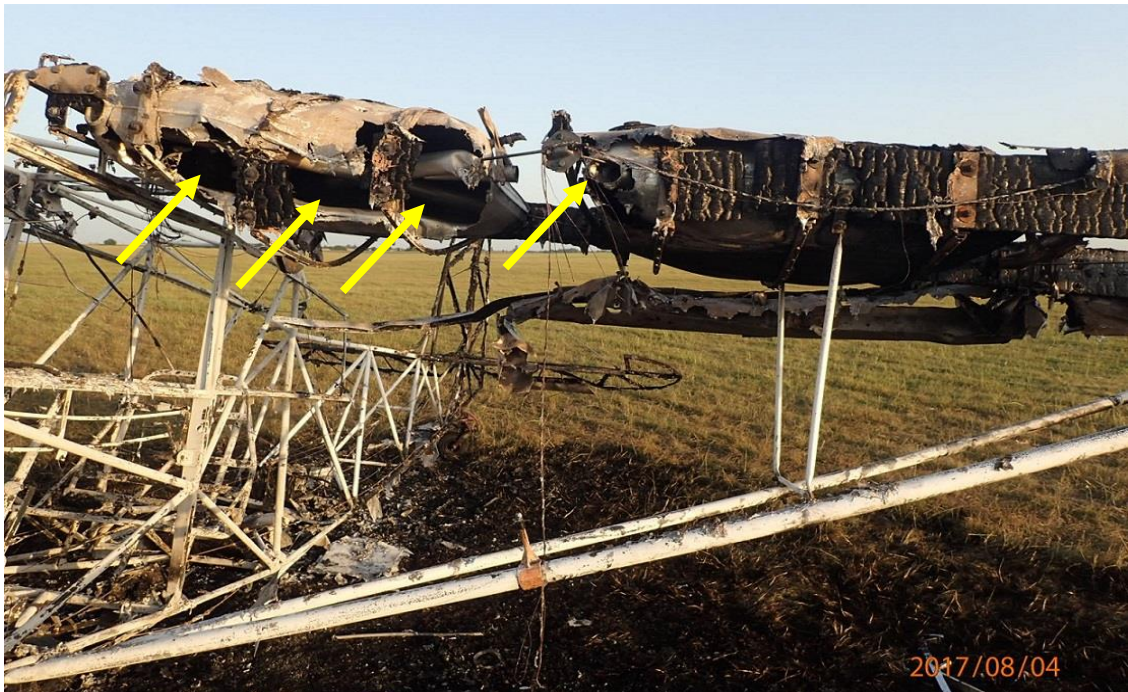
Figure 15: The molten fuel tank

As an effect of the fire, the openings in the fuel tanks became larger and larger (see locations indicated by yellow arrows in Figure 15), letting more and more fuel spill from the tanks. The spilt fuel could not stick to the bottom surface of the wings any more but flowed down to the ground where it spread, guiding the flames all along, and set the rest of the aircraft on fire (Figure 7).

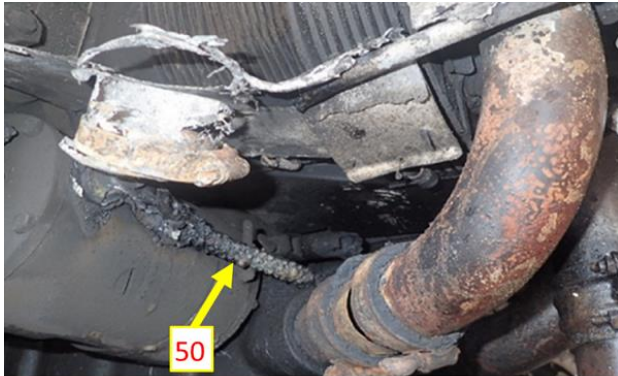
Figure 16: end of cable Nr.50 at the starter

The IC viewed the high power cable (Nr.50 in Figure 10) at the starter and at the firewall (Figures 16 and 17). The insulation was molten on the wire at the end of the cable which is at the starter, while the insulation was fully burnt off the wire and the wire was discoloured at the other end which is at the firewall.

This suggests that the starter end of the cable Nr.50 was exposed to much lower temperatures than its firewall end, i.e. the melting of the cable was not due to engine fire.

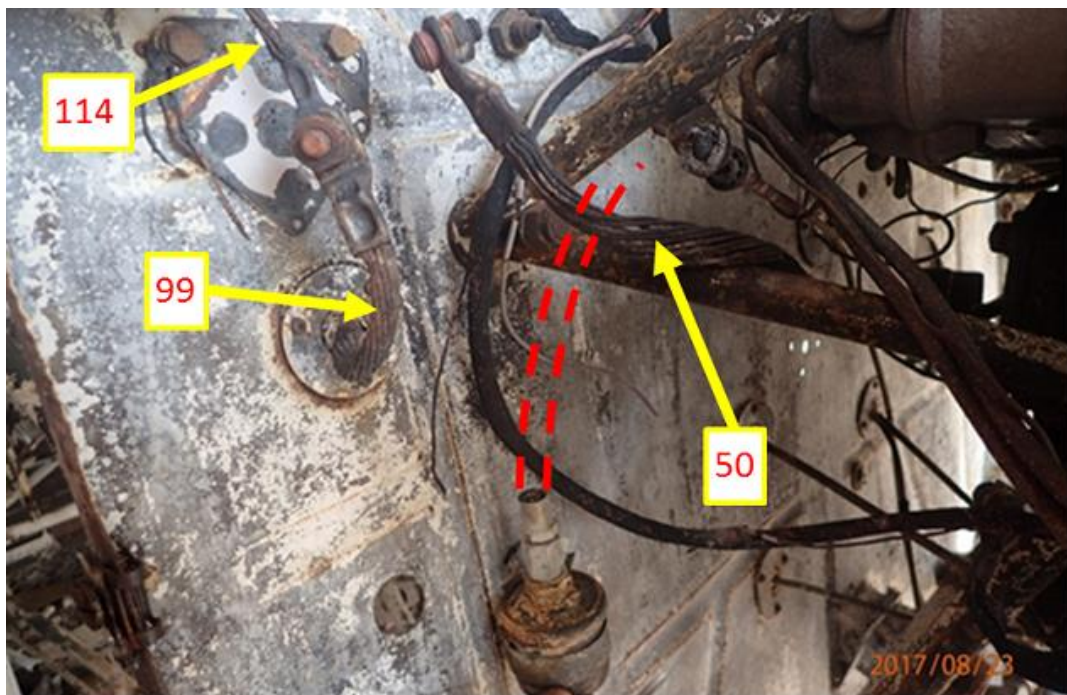
Figure 18: The firewall seen from the engine compartment (with the cables Nr.99 and Nr.50 in place)

The melting temperature of copper is 1085°C (1985°F); the cable Nr.99 reached that temperature at the passage through the firewall. Thermal conductivity of copper is very good, so it began to glow quickly in both directions from the passage: toward the engine compartment as well as the cabin.

Figure 18 also shows that the firewall did not burn through, the fire did not penetrate it, but two fires started independently: one at the engine compartment side, and the other at the cockpit side of the firewall.

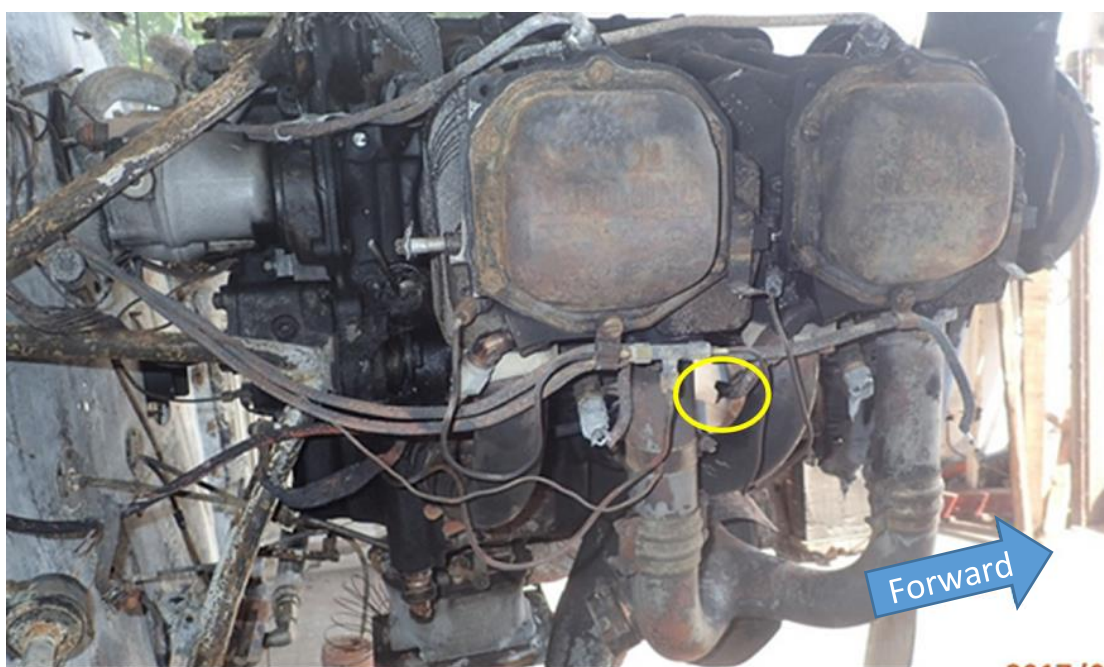
Figure 19: The right-hand side cylinders and exhaust system of the boxer engine

The position of the IC is that the cable Nr.50 was heated up through the Starter Solenoid by the heated and melted cable Nr.99. The insulation of the glowing hot cable Nr.99 burnt (Figure 18), and then, after the aluminium housing of the Starter Solenoid melted, the cable moved downward due to gravity. Hanging on the cable Nr.114 attached to it, the cable Nr.99 moved in the direction of the engine (Figure 17). The moving cable Nr.99 hit the flexible rubber hose of the oil pressure transmitter (red dashed line in Figure 18), melted it, and the oil spraying from the rubber hose caught fire by self-ignition when contacting the hot exhaust system. The flames arising at the exhaust throat melted the cylinder head oil return pipe (the pipe highlighted with a yellow circle in Figure 19) at the right front cylinder of the boxer engine, and the leaking oil also supplied the fire.

The composite engine housing caught fire and burnt as a consequence of the burning of the lubricating oil.
