## Short summary of the occurrence

The type CESSNA 310 aircraft with registration mark HA-EAB performed belly landing (gear-up landing) inadvertently when practicing an emergency situation at Pécs-Pogány Airport (LHPP) because the flight crew had forgotten to extend the landing gears. The aircraft was badly damaged in the incident, but no one was injured. According to the Investigating Committee (hereinafter: the “IC”) of Transportation safety Bureau, Hungary, the serious incident was caused by deviation from requirements of the Flight Manual, and by inadequate supervision of the Student Pilot’s activity during landing. The IC found no circumstance which would warrant a safety recommendation.

<b>Occurrence category:</b>	Serious incident			
<b>Date of occurrence:</b>	06 Oct 2017, 14:04LT <sup>1</sup>			
<b>Location of occurrence:</b>	Pécs-Pogány Airport (LHPP)			
<b>Type and registration of aircraft:</b>	Cessna 310Q, HA-EAB			
<b>Year of manufacture, serial number:</b>	1972, 310Q0490			
<b>Number and type of engine(s):</b>	2 pcs, Continental IO-470-VO			
<b>Purpose of flight:</b>	Non-commercial (training)			
<b>People</b>		<b>Crew</b>	<b>Passenger</b>	<b>Other</b>
	<b>Number:</b>

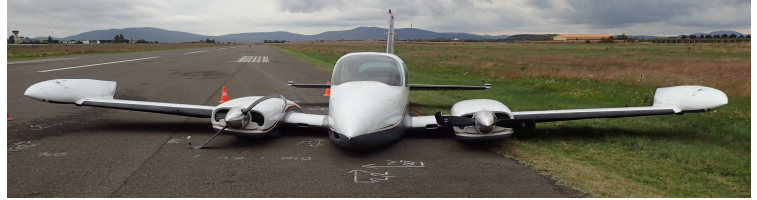
The aircraft touched down in the middle of the paved Runway 16, slightly to the left of the centreline of the runway. From there, it slid ca. 260 metres and came to rest near the LH side edge of the runway. The propellers as well as the antenna installed at the bottom of the fuselage were destroyed by ground impact. The plates at the bottom of the fuselage were damaged.

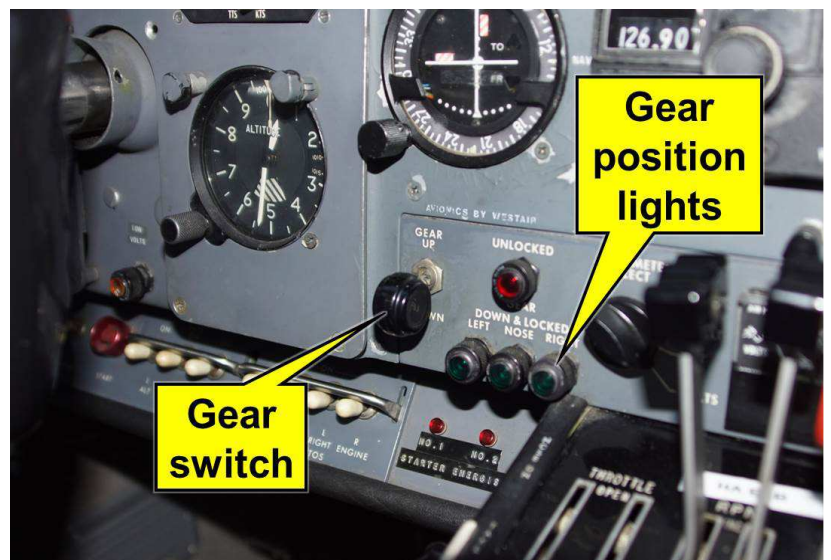
Cessna 310 is a twin-engine, low-wing aircraft, made fully of metal. Its 194 kW, six-cylinder, petrol injection, and opposed-cylinder engines move 2-blade variable pitch propellers. Its landing gears with steerable nose wheel are electrically retractable and extendible. The switch for control of landing gear movements has three positions (top down): gear up, neutral, gear down. The landing gear control switch and the green lights indicating the extended and locked position of the landing gears are located in the lower left part of the central instrument panel. The intermittent tone (provided by the landing gear warning horn) triggers in the cockpit if any of the landing gears is not in down and locked position while the flaps are extended by more than 15 degrees or while pressure in the manifold of any of the engines falls below 40.6 kPa. Should the electrical system fail, the landing gears can also be moved manually, using the hand crank located at the side of the LH side pilot seat.

According to the position of the IC, the immediate cause of the serious incident was that the Student Pilot failed to extend the landing gears because he switched the landing gear switch from GEAR UP to neutral, and neither of the pilots checked the signal of the lights indicating the extended and locked position of the landing gears. Such human errors were facilitated by the mental load increased by the practice flight and by multitasking (practicing of an emergency situation, and the Student Pilot's foot fatigue). According to the IC, the small size of the landing gear switch contributed to the occurrence, because it hinders visual checking of the position of the switch. The IC found no circumstance which would warrant a safety recommendation.
