Synopsis

The 74-year-old pilot in a PA-46 Malibu Mirage, registered as N3975C, encountered visibility below minima on approach to Nyíregyháza Airport, his primary destination and decided to divert to his alternate Debrecen Airport where he landed gear up with 10 degrees of flaps. Neither of the two occupants was injured in the event. The Hungarian Transportation Safety Bureau's Investigating Committee (hereafter referred to as IC) has attributed the cause of this serious incident to human factors and found no grounds to issue a safety recommendation.

Occurrence category		Serious incident			
Date of occurrence		05 Dec 2017, 16:35LT ¹			
Location of occurrence		Debrecen Airport (LHDC)			
Type and registration of aircraft		Piper PA 46-350P, N3975C			
Year of manufacture, serial number		2007, 4636419			
Type and number of engines		Single engine, P&W PT6A-35			
Purpose of flight		Non-commercial (private, cross-country)			
People	Number	Crew		Passenger	
		Injured		Other	
		1	1	0	
		None	-	-	
Damage to property		Aircraft: substantially damaged 3rd party damage: none			
License and ratings of PIC²		PPL(A) ³ , IR(A) ⁴ , NVFR ⁵ , SEP(Land) ⁶ - (EASA) ⁷ PPL, Single Engine Land, Instrument A

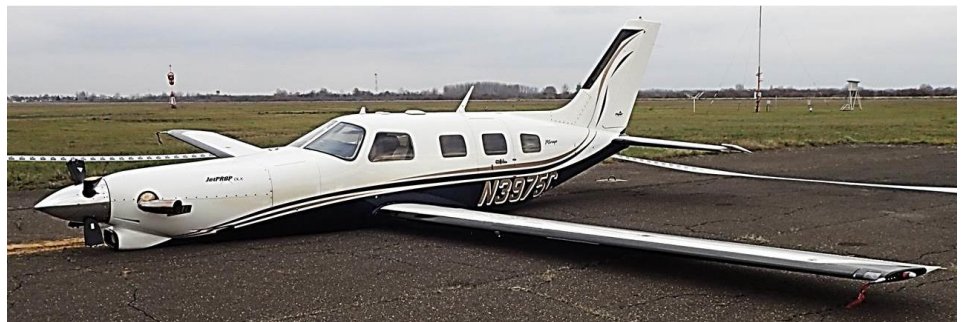
The aircraft skidded to a halt right of the centreline ca. 400 metres from the threshold. During the skid the underside of the fuselage was damaged and all four Hartzell propeller blades, still spinning, shredded off the hub in full length. The landing gear lever was found in DOWN position during site inspection, but it cannot be determined with certainty whether it was set in the DOWN position before or after the incident. No parts of the landing gear showed any scrape wear against the tarmac or any signs indicating a partially open position. The landing gear was up and locked when the fuselage was jacked up and loaded on a trailer for transport. At a later date when a supplementary inspection was carried out, the landing gear was found unlocked, as in an initial phase of extension. When the aircraft was jacked up again for testing, the landing gear gradually extended by gravity. Subsequent extensive landing gear testing revealed no system malfunction whatsoever; all drive and control elements were found in sound working order.

Figure 2 – The aircraft on the next day

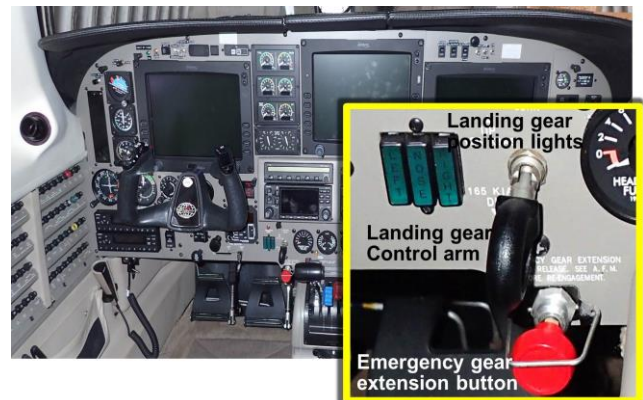
Figure 4 – Landing gear controls in the cockpit

Landing gear control lights in their dimmed position as shown in *Figure 4* are considerably dimmer than in daylight setting and may not be bright enough for easy perception. The pilot also admits in retrospect that being accustomed to this, he missed to pick up when the landing gear lights did not come on during approach.
