Short summary of the occurrence

Occurrence class:		Accident			
Date of occurrence:		15 December 2017, 14:30LT ¹			
Location of occurrence:		Jakabszállás Airport (LHJK)			
Type and registration of aircraft:		Cessna 172N, HA-SJY			
Year of manufacture, serial number:		1977, 17268609			
Type and number of engines:		1 piece, Lycoming O-320-H2AD			
Purpose of flight:		Non-commercial (private, local)			
People		Crew	Passenger	Other	
	Number:	1	3	0	
	Injured:	None	None	---	
Damage to property:		Aircraft: Significantly damaged			
Licence and ratings of PIC:		PPL(A) ² , SEP(Land) ³ ,			
Age and citizenship of PIC:		58 years old, Hungarian, male			
Flight experience of PIC:		Total	On the type	Last 90 days	Last 7 days
	Flying hours:	284	more than 61	6	0
Sources of information:		Report, on-site investigation, photographs interviews with the pilot and witnesses, meteorological data

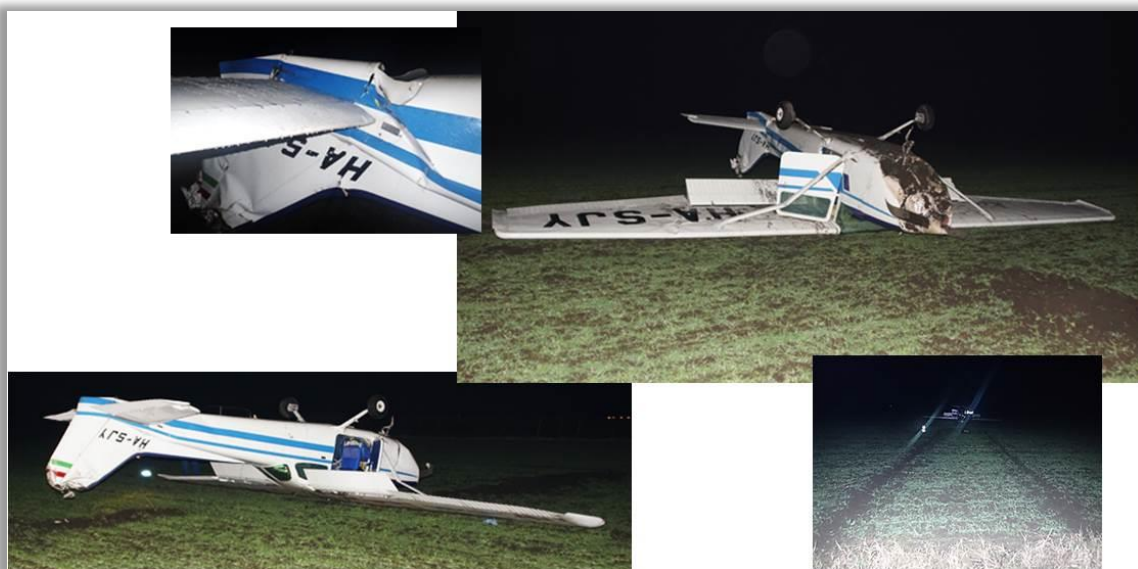
When the IC arrived at the scene, the aircraft was approximately 116 metres downstream of the 32L (grassy) runway threshold, about 30 m from the edge of the airport, lying on its back in the ploughland, de-energized, but with no sign of disassembly. As a result of the slip on the loose, wet ground and the tipping over, the aircraft was badly damaged. The damages to the propeller showed that the engine had been running and the propeller rotating in the course of the accident. The propeller, the nose, and the vertical stabilizer were also damaged. The tail section bent, the left wing took the form of a wave, and its support fractured. The IC found that the flap control lever was open to 10°, and the flaps were open to a greater extent than that.

Figure 2: The aircraft at the scene following the accident (Source: TSB)

On the basis of the data obtained, the aviation meteorological information available on the day of the occurrence provided information on the expected predominantly cloudy weather, and embedded showers/thunderstorms, including wind-related changes. However, according to information of the IC, the pilot did not obtain detailed information from aviation meteorological sources about the meteorological conditions influencing his flight prior to take-off. He performed his take-off and flight on the basis of the momentary weather he had observed. Returning to the airport, he perceived a deterioration of the weather and a "dark cloud" before the fourth turn of the traffic pattern of runway 14. However, he did not anticipate any possible changes in the direction or strength of the wind from any of the above signs. He performed landing according to the supposed unaltered wind direction and wind speed. However, the direction and strength of the wind had changed in the meantime, due to the prevailing weather front and the embedded thunderstorm. As a result, the pilot carried out the landing in a strong, slightly pushy tail wind. According to the IC, the unexpectedly worsening weather conditions and then the higher-than-normal speed over the runway and the excessively approached end of the runway increased the Pilot's mental loads. In this precarious situation, given the circumstances, the Pilot chose the solution that seemed appropriate for him: the go-around. However, the intensity of ascent from the ground was no longer sufficient, so the main landing gears of the aircraft get caught in at the edge of the adjacent agricultural land which was 20 to 25 cm higher than the runway. As a result, the aircraft descended back to the loose, wet soil. Despite the running engine, the sunken main landing gears further decelerated the aircraft until the nose landing gear touched down. The force of the remaining speed of the aircraft caused the nose landing gear

sinking into the soil to break. After all, its remaining kinetic energy proved to be enough for it to tip over the nose and come to rest on its back.

According to the Pilot, he had closed the flaps when starting the go-around. At the scene of the occurrence, the flap control lever was at 10° and the flaps of the aircraft were extended to a larger extent than that. The IC's position is that the Pilot, in line with his account, probably started to retract the flaps, but they were not fully retracted because of the shortage of time. The IC is of the opinion that the flaps left extended contributed to the lower-intensity ascent of the aircraft, and thus potentially to the final outcome of the accident as well.
