TRANSPORTATION SAFETY BUREAU

FINAL REPORT

Travel Service a.s., Boeing 737-8K5, OK-TVP
Budapest Liszt Ferenc International Airport (LHBP),
23 March 2018

2018-128-4

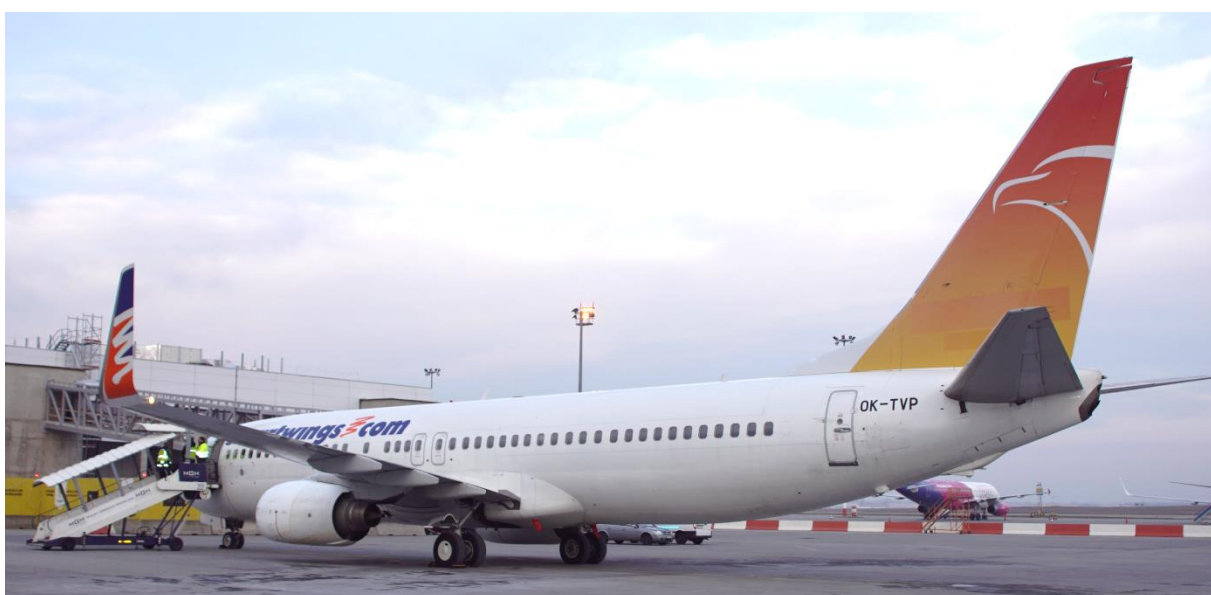
Figure 1: The aircraft involved in the occurrence, after the scene was changed

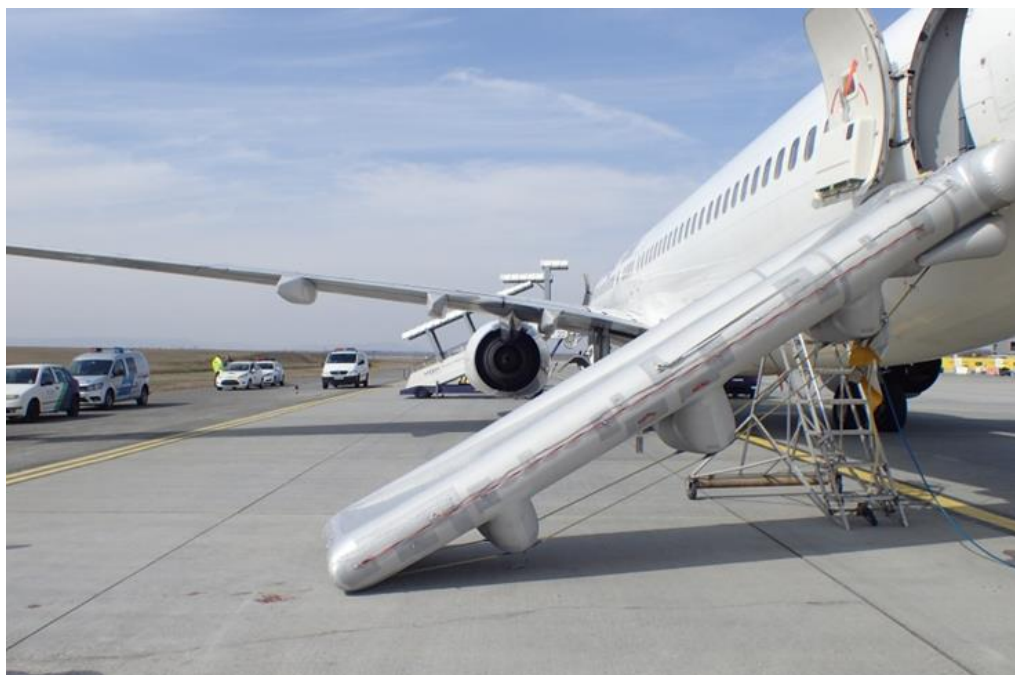
As shown in *Figure 5*: the slide is in line with the direct jet blast of the left engine.

Figure 5: The reconstructed scene

The circumstances of the accident are unclear, but the IC's opinion is that the injury of the passenger could have been caused by the floating of the evacuation slide, caused by the jet blast of the engine and/or by an accidental push from another passenger. During the investigation, the IC received no additional information that would confirm or exclude either of these possibilities.

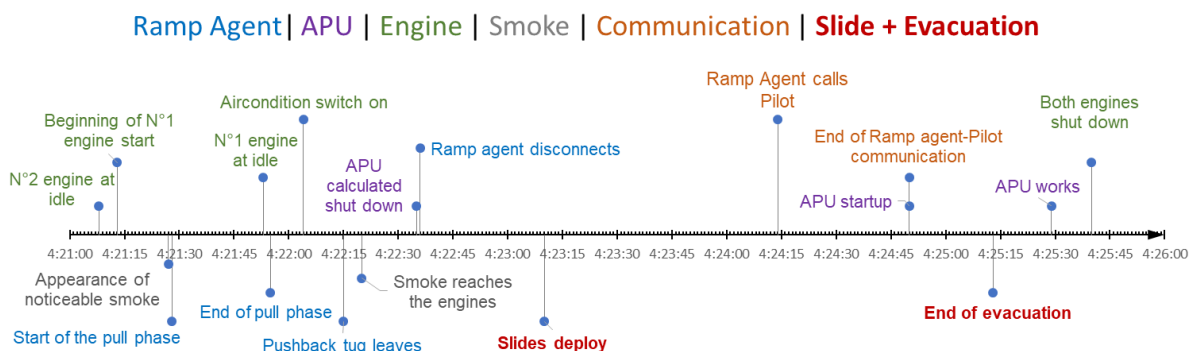
Figure 8: Timeline related to the Ramp agent

- the appearance of the smoke and the start of the pull part of the push-back procedure roughly happened at the same time (04:21:27), while medium dense smoke was already flowing towards the right engine (N°2) of the aircraft, which had been running for about 20 seconds,
- approximately 26 seconds passed between the start of the pull part of the push-back procedure (4:21:28) and the full stop of the aircraft (4:21:54),
- the generators being switched on and the characteristic sound of the air conditioning system being switched on can be recognized on the audio recordings (04:22:04),
- after the full stop the tug gets disconnected as the final phase of the pushback, and then the tug leaves the aircraft (04:22:17) when more dense smoke appears,

- large amount of smoke reaches the running engines with the already operational air conditioning system resulting in smoke entering the cabin (04:22:20),
