MINISTRY FOR  
INNOVATION AND TECHNOLOGY  
TRANSPORTATION SAFETY BUREAU

# FINAL REPORT

2018-322-4

Magnus eFusion

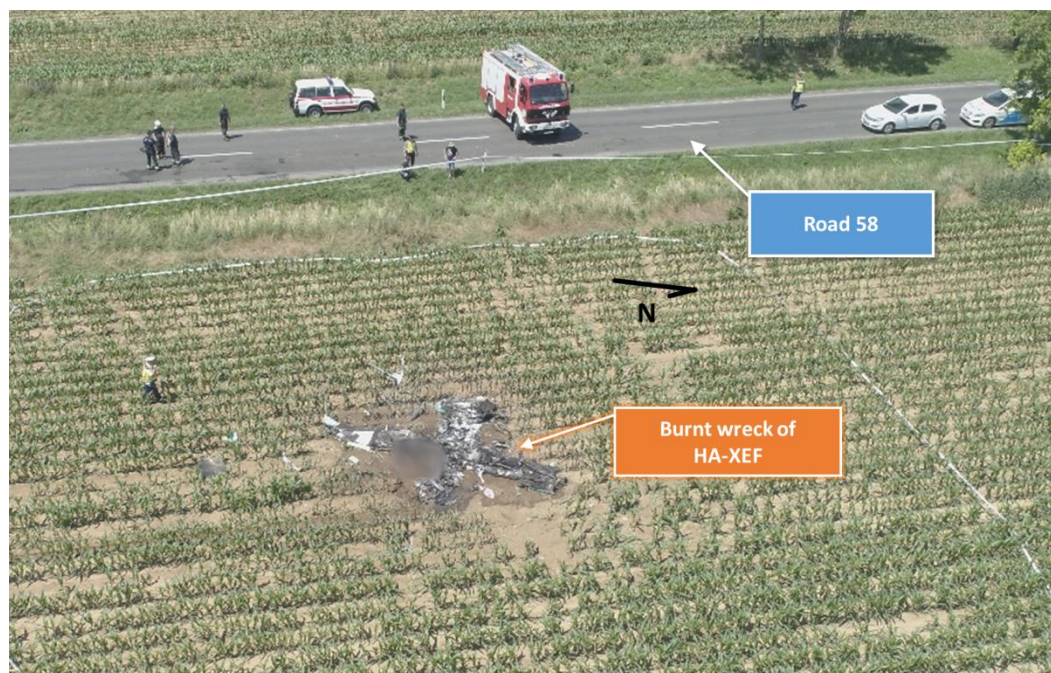
Figure 3: The scene of the accident (Source of photo: Police)

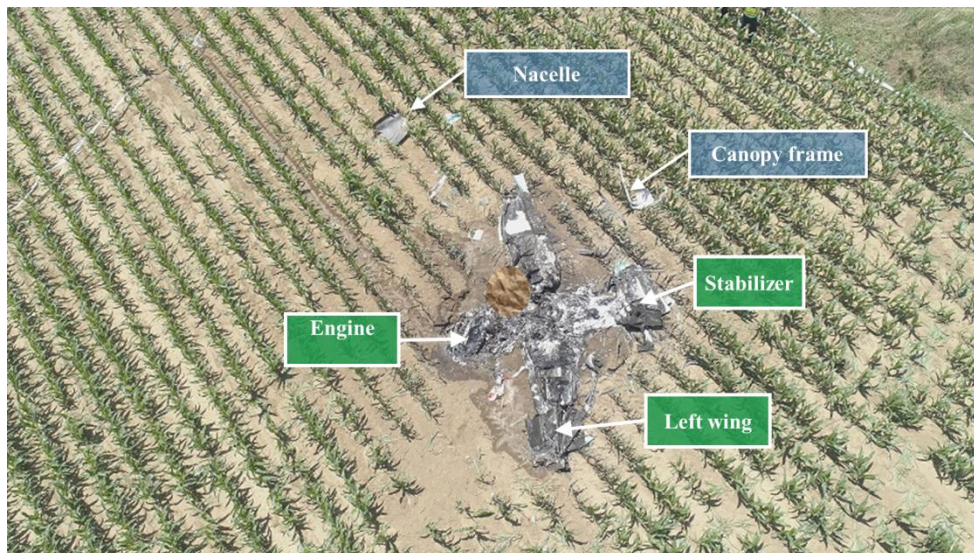
The wreck of the aircraft was found on the spot with geographical coordinates N45.97551° E018.23002°, approx. 1.8 km of Pécs-Pogány Airport, approx. 4.8 km of the point of the second turn of the specified traffic circuit. The situation of the wreck and its damages suggest that the aircraft impacted the ground at large vertical speed, at a small angle, and with its wings in almost horizontal position. The positions of the parts parting upon impact and the impact marks in the ground suggest that the aircraft had been rotating to the right around its vertical axis (see *Figure 6*). The aircraft caught fire upon ground impact, and then the fire spread to the airframe made of composite.

Figure 6: The burnt wreck of the aircraft

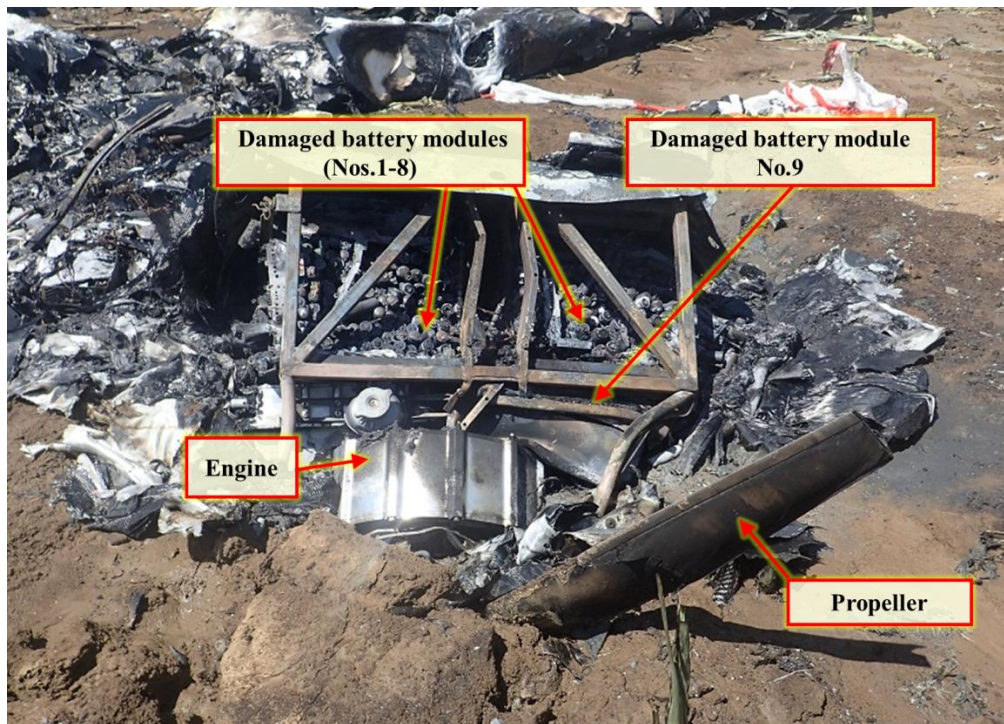
The position of the IC is that in consequence of the impact following the fall the 9 battery modules of the aircraft were damaged to such extent (see Figure 7) that short circuit and overtemperature may have occurred in their cell units. Due to the damage, the heat increase in the cells was too fast to be compensated by the heat exchange with their environment, which was even worsened by the short circuit causing strong current. A fire started during that irreversible process, and rapid spread of the fire was supported by the composite airframe of the aircraft which was fully burnt in the fire. The fire was so intense that those parts of the aircraft which had not departed during the ground impact and were found as part of the wreck were either fully burnt or showed marks of intense fire.

Those parts which separated and spread upon the ground impact (nacelle, a piece of the canopy, a broken piece of the Plexiglas of the canopy) show no sign of in-flight internal fire, smoke or overheating.

Figure 7: Location of the start of the fire

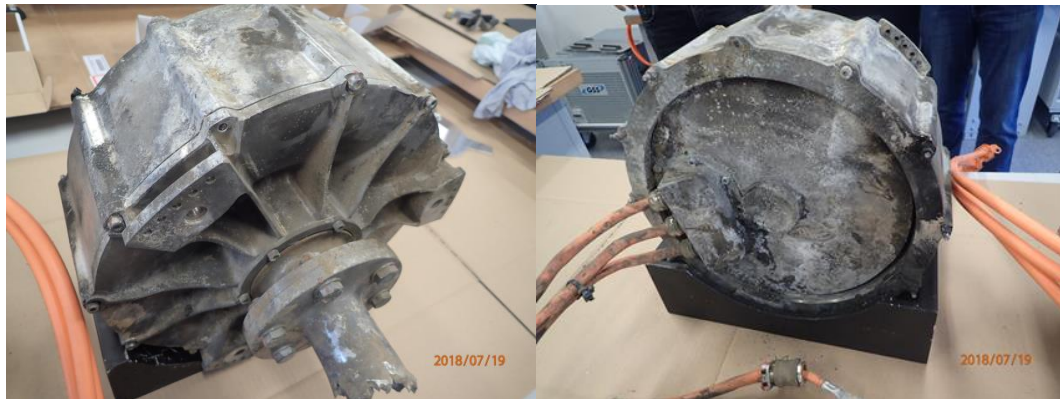
- After disassembling the motor we could not observe any sign (mechanical, electrical or thermal) at the electric machine side which could be the reason of operational malfunction,
- The damages of the motor clearly appear due to mechanical impact and subsequent external fire.

*Figure 8: The electric motor of the aircraft (front view and rear view)*

The damages of the engine were clearly due to mechanical impact and subsequent external fire. (1.16.2)

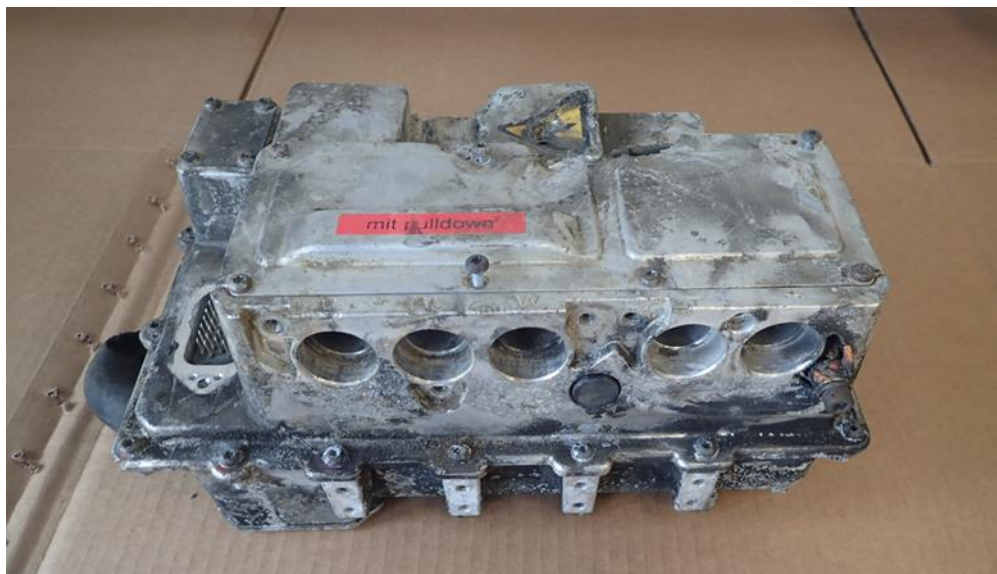
- Based on observations/measurements, no short-circuit occurred inside the inverter which could cause the immediate stop and blocking the motor rotation.
- The heat, which melted the grey material and detached the parts inside the inverter, was coming from an external heat source.
- The damage of the inverter was caused by the ground impact and the external heat after the impact.

*Figure 9: The inverter of the aircraft*

Ground impact and the external heat after the impact caused the damage of the inverter. (1.16.2)
