Synopsis

On 7 July 2018, shortly after engine start, the pilot intending to take off for agricultural purposes perceived intense vibration from the direction of the tail part when clutching, so he aborted clutching and shut the engine. He got out of the aircraft and realised by visual inspection that a tube of the tail boom had fractured at the connection of the left-hand side horizontal stabilizer, the tail boom had been deformed, causing the tail rotor drive shaft to fracture at the carrier bearing № 4. No one was injured in the event and the aircraft sustained repairable damage.

Occurrence category:		Serious incident			
Date of occurrence:		21/07/2018, 11:20LT			
Location of occurrence:		Tata (South, 2 km)			
Type and registration of aircraft:		SA 318C Alouette II, HA-PPI			
Year of manufacture, serial number:		1964, 1944			
Type and number of engines:		Single engine, Turbomeca Astazou III A			
Purpose of flight:		Agricultural			
People	Number:	Crew	Passenger	Other	
	Injured:	1	0	0	
		0	-	-	
Damage to property:		The aircraft was damaged, but not beyond repair.			
Flight experience of PIC:		CPL(H), FCL.740			
Age and citizenship of PIC:		59 years old, Hungarian			
Flight experi

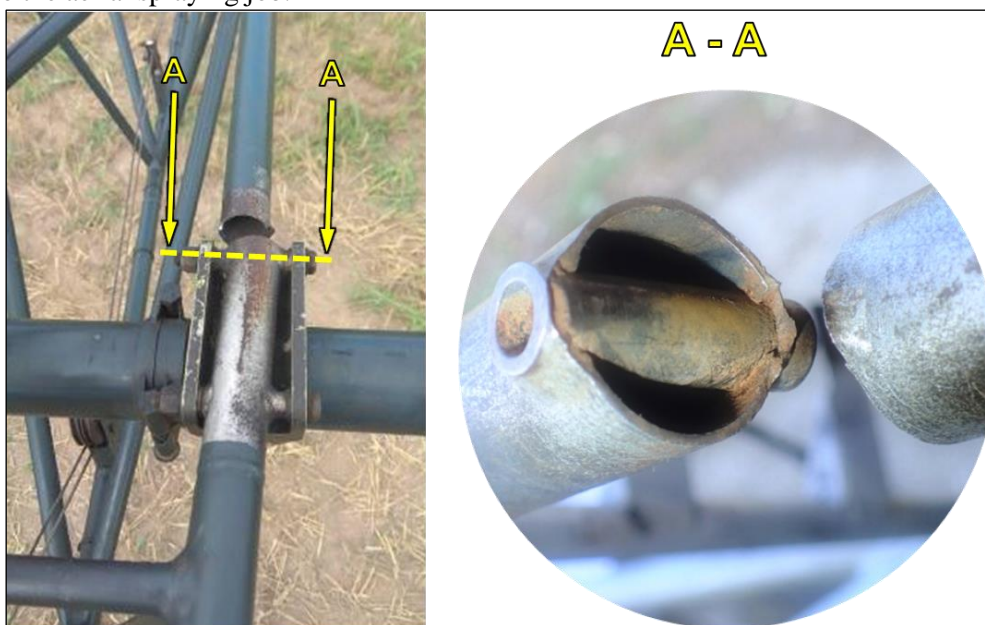
A tube of the tail boom fractured next to the rear left sleeve of the horizontal stabilizer (*Figure 4*), which deformed the tail boom to such extent that it caused the tail rotor drive shaft to fracture. On the basis of the photos taken at the supplementary site visit, the IC concluded that the structure of the tail boom showed possible signs of fatigue fracture, but the fact of this cannot be clearly established.

Figure 4: Fracture of a tube of the tail boom

In the IC's opinion, the affected tube of the tail boom split in two along an existing crack prior to the engine start.

Therefore, it is very likely that the fracture took place between the last landing and the engine start preceding the occurrence. The IC cannot unambiguously determine the direct cause of the final outcome of the suspected crack on the basis of information available, but finds any of the following causes likely:

- touch-down with a possible lateral skid during the preceding landing, or
- a ground-service device had hit the tail boom.

The Organisation replaced the tail boom in the month after the event and issued a Certificate of Release to Service (CRS) relating to it on 10 August 2018.

According to its *Technical Measure* document, on 03 August 2018, the Organisation scheduled a crack test of the tail booms of its helicopters of similar type by pressurising the tail booms, and a visual crack inspection (at 10-times magnification) of the weld seams of the tail rotor drive shaft as specified in the relevant Maintenance Manual. It was also ordered that such maintenance items should be carried out annually or after 100 hours of flight on the SA 318 C helicopters operated by the Organisation.
