MINISTRY OF
TECHNOLOGY AND INDUSTRY
TRANSPORTATION SAFETY BUREAU

FINAL REPORT

AirSerbia, Airbus A319, YU-API, ASL73E
Travel Service, Boeing 737-800, N917XA, TVS5WZ
SunExpress, Boeing 737-800, TC-SEZ, SXS1R
Érsekvadkert area, 28 September 2018

Serious Incident
2018-0732-4

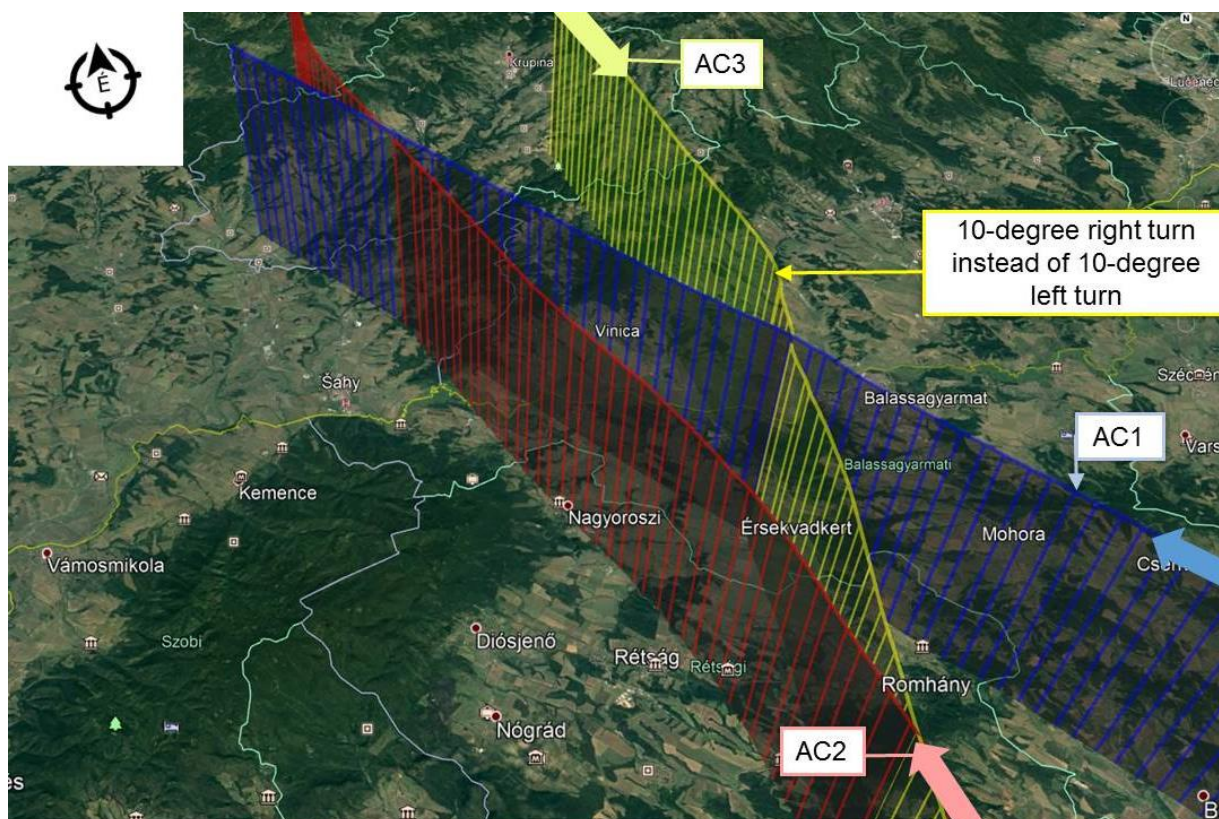
Figure 1: Flight paths of the aircraft involved in the occurrence

At about 17 o'clock on 28 September 2018 in the area of Érsekvadkert, a separation minima infringement occurred in the controlled airspace of Hungary, which involved three aircraft (AC1: SXS1R, AC2: ASL73E, AC3: TVS5WZ) crossing one another's routes. The air traffic controller of the sector who managed these aircraft received AC3 (entering the country from the north) at FL360 from the previous sector, and authorised it to climb to FL390.

Owing to the correctly issued turn orders, the mandatory radar separation minima would probably not have been infringed but, due to AC3's erroneous turn (left instead of right,) AC2 and AC3 were on a converging track at the same height.

As a result of the erroneous turn, the shortest distance between AC2 and AC3 decreased to 2.9 NM horizontally and 500 ft. vertically. The mandatory radar separation minima are 5 NM and 1000 ft.

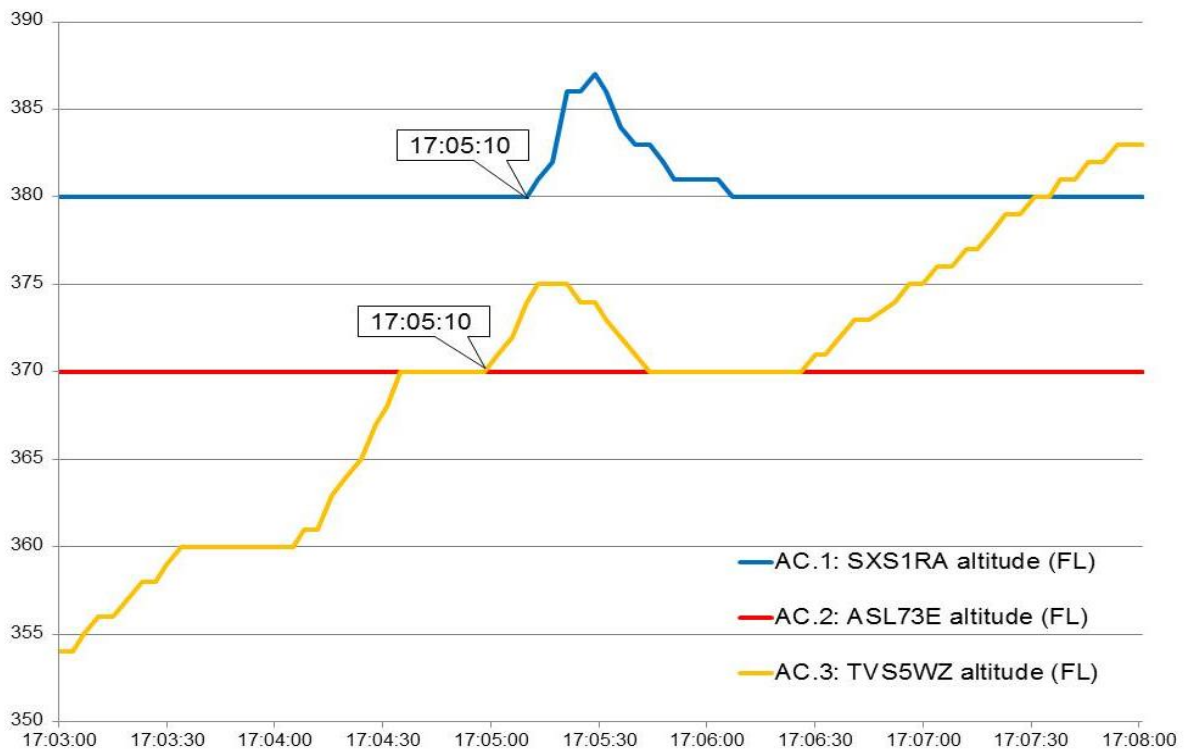
Figure 2: Flight altitudes of the aircraft involved in the occurrence

The crew of AC3 correctly read FL370 back, and requested confirmation for the 10-degree right turn instead of the previously received left turn order. The air traffic controller erroneously confirmed the order. Due to the right turn, AC3 turned in the direction of AC2 at the same altitude and, at 6.2 NM distance – at 17:04:58, i.e. short after starting the turn – AC3's TCAS gave the crew a climb command (Figure 2). While the TCAS' evasive manoeuvre command was issued and performed, the shortest distance between AC2 and AC3 decreased to 2.9 NM horizontally and 500 ft. vertically.

When, at 17:05:10, AC3 exceeded FL373 during its climb due to the TCAS RA, then AC1, flying above AC3, was also given a TCAS RA climb command due to the threatening aircraft coming from beneath (Figure 2). The horizontal and vertical distances between AC1 and AC3 decreased to 2.3 NM and 600 ft..

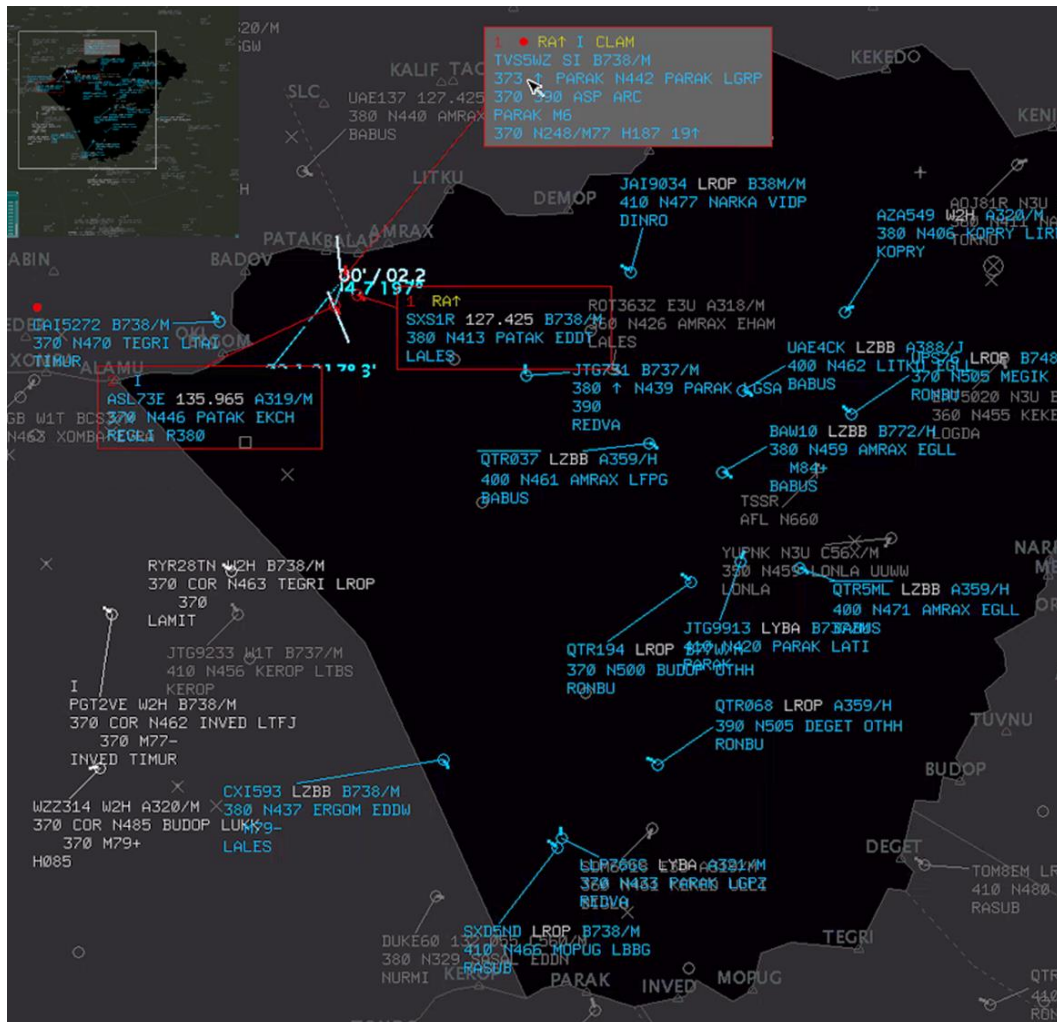
Figure 10: EH EC's MATIAS screen at the time of the occurrence

It is conceivable that this procedure could be a useful part of the work technology in certain circumstances, once it has been integrated into the system after a preliminary analysis. However, in the point of view of the IC, this circumstance contributed more to the loss of information during the course of events and thus to the occurrence. This is confirmed by the fact that the controller of the receiving sector concerned did not notice it and did not even attempt to keep AC3 at FL360.

The result of all that was that the EC concerned, fulfilling AC3's request (despite the fact that it could have stayed at FL360), cleared the requested climb from FL360 to FL390 without noticing its expected conflict with AC1. However, due to the allowed climb, AC3 came into conflict with AC1 arriving opposite on FL380. In the IC's view, these factors that led to the conflict situation (taking over AC3 and allowing it to climb to FL390) contributed to the subsequent occurrence, because the resolution of the conflict situation they created forced the EC concerned to give instructions to AC3 subsequently. Furthermore, when examining the conflict research of the EC concerned prior to the clearance of the climb of AC3, the IC found that the measurement of the distance for checking the distance of significant number of relevant traffic, the conflicts between AC1 and AC2; and AC1 to AC3 had been omitted. In the view of the EC, this fact also confirms that the high traffic load contributed significantly to the occurrence.

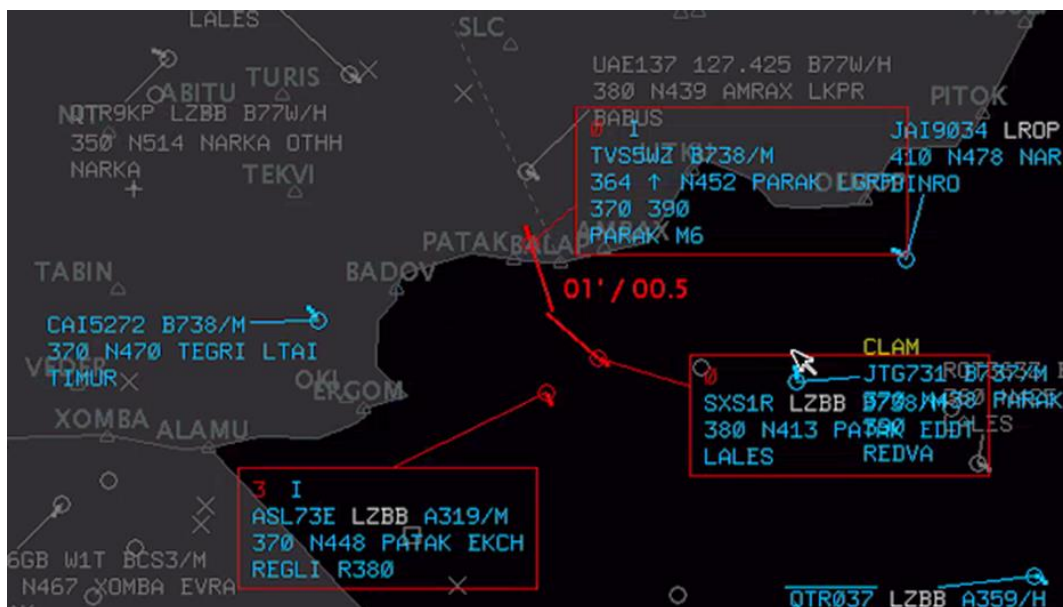
Figure 11: Appearance of the STCA alert when AC3 climbed from FL360.

In this situation, the EC concerned instructed AC3 to stop climb at FL370 and turn left 10 degrees, and AC2, coming opposite at the same altitude (FL370), was instructed to turn left to the 320-degree direction (while STCA had already given alert to all three aircraft (Figure 11)(Appendix 1).

The quick, sudden change to the earlier instruction may have caught AC3 by surprise. Reacting to this – executing an “abrupt” stop of the climb – certainly implied an increase in workload for the pilots. According to the IC, this factor may have contributed to the AC3's pilot's reading back an incorrect turn direction. His uncertainty is illustrated by the fact that he specifically asked for confirmation of the instruction for the turn he had been reading back. However, the EC concerned – presumably due to the stress of the heavy workload and the urgency to resolve the conflict situation as soon as possible – did not detect and confirmed (as detailed in 1.1) the mistaken turning direction (right instead of left) for AC3. The IC

assumes that this miscommunication could possibly have been prevented if AC3 had been instructed by the controller to turn to a specific heading (e.g. to 155 degrees) instead of a relative heading (by 10 degrees). The fact that – due to the noise from the workroom (interspersed with advice), the ever-increasing workload and the time pressure – the EC concerned possibly “heard back what he wanted to hear” may have contributed to the confirmation of the wrong turn. (It should be noted that, for the same reasons, presumably the PC concerned did not detect the mistake either.) The IC considers these activities of the controllers concerned as traffic-following behaviour instead of planned traffic control.
