MINISTRY FOR
INNOVATION AND TECHNOLOGY
TRANSPORTATION SAFETY BUREAU

FINAL REPORT

2018-734-4
serious incident

K-7
HA-5087

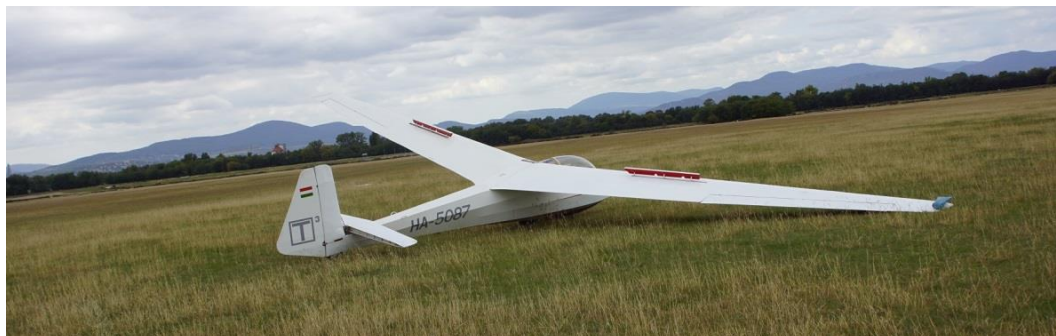
The RH elevator was detached from the horizontal stabilizer (see fig. 3) and fell to the ground.

Figure 3: The glider on the ground. Note the missing RH elevator

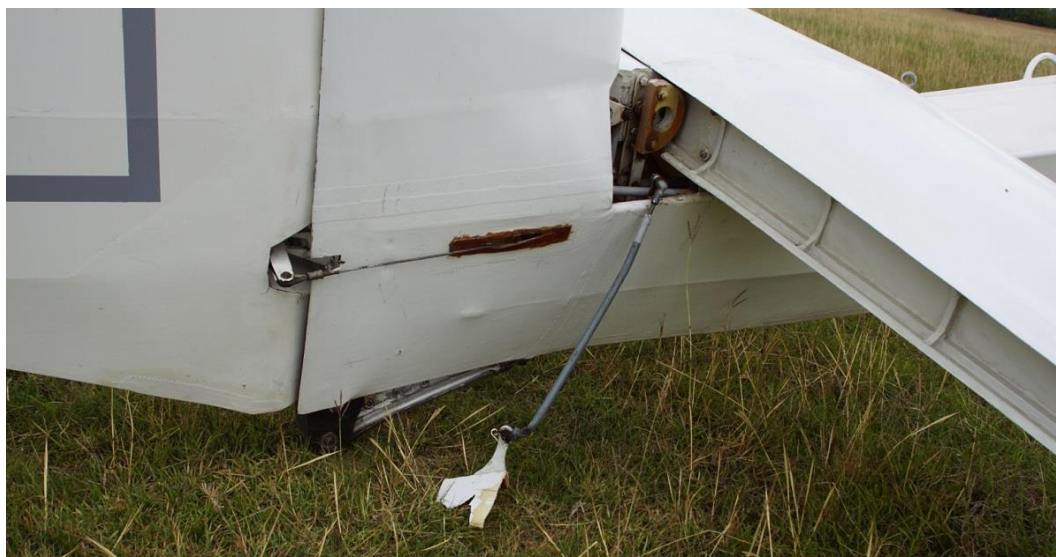
The trim linkage was deformed under the weight of the elevator. The trim surface eventually broke (see fig. 4) and the elevator fell to the ground.

Figure 4: The RH horizontal stabilizer. Note the trim linkage with a piece of trim

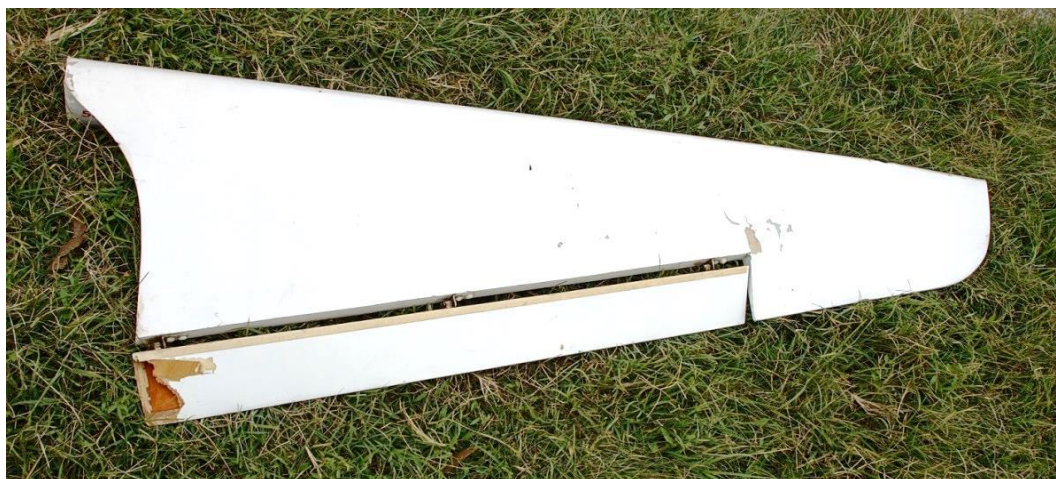
The IC determined that the detachment of the elevator was caused by the failure of gluing between the elevator's core rib and fabric.

The elevator was later found at a nearby horse racing track (see fig. 5).

Figure 5: The damaged RH elevator and attached trim

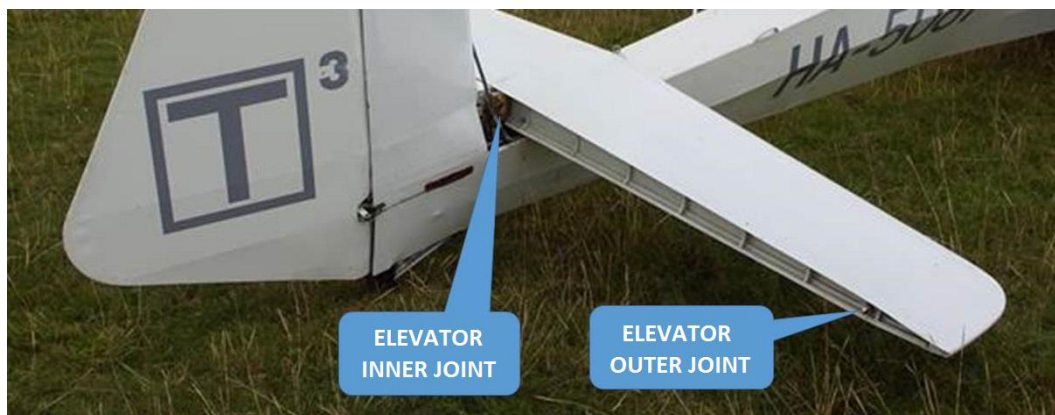
The elevator is connected to the horizontal stabilizer at two joints that ensure its deflection upwards and downwards (see fig. 6).

Figure 6: Fixing locations of the RH elevator

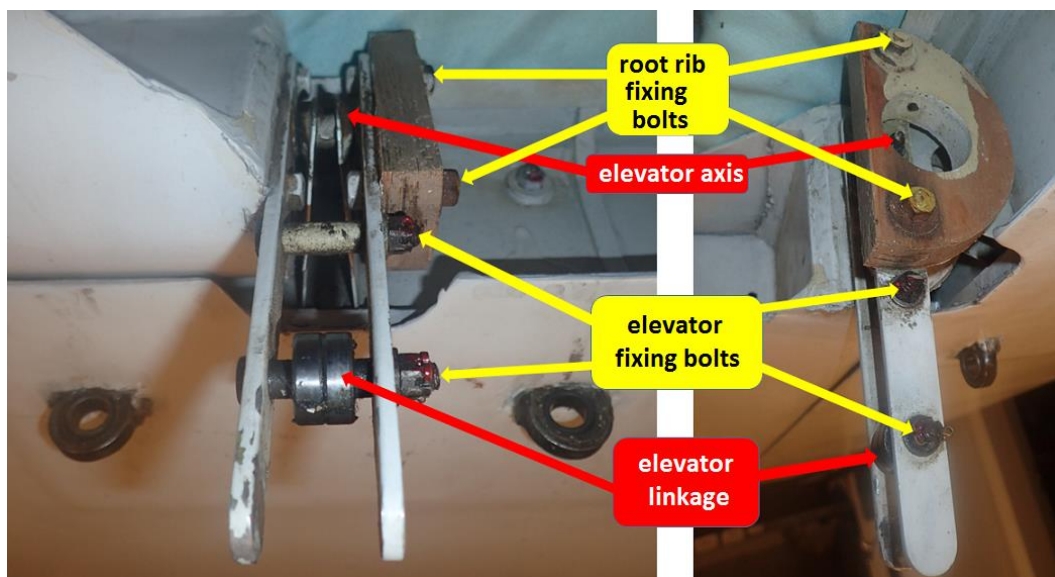
The elevator's inner joint links the elevator's core rib with a steel rod by two bolts (see the root rib fixing bolts in fig. 7 and 8). The rotation axis of the elevator is situated between the two bolts. Another two bolts – marked as elevator fixing bolts - connect the LH and RH elevator rods. The elevator linkage is connected to one of these bolts as well.

Figure 7: Rear view of root rib

Figure 8: Side view of root rib

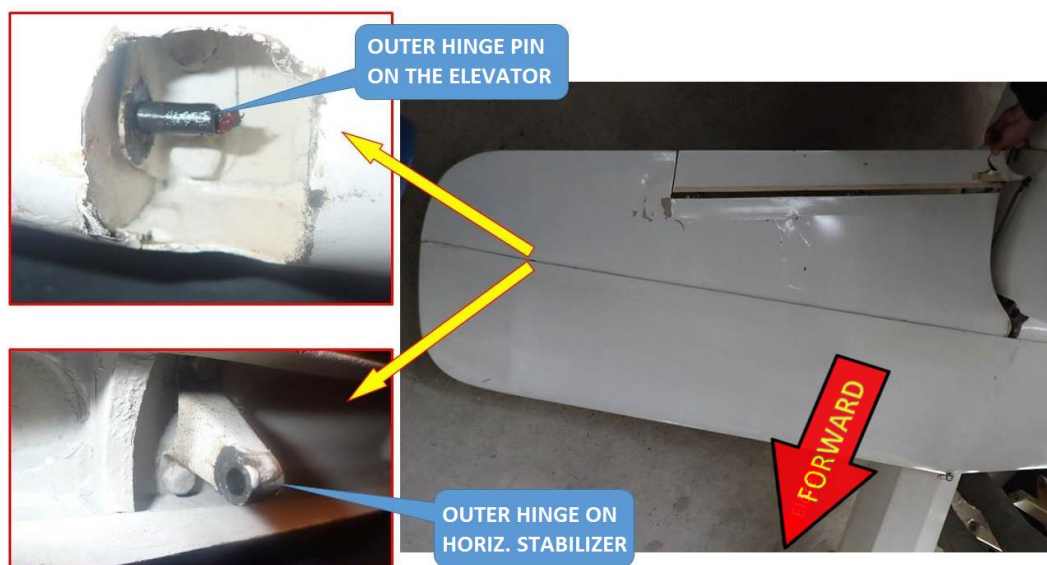
The outer joint of the elevator (see fig. 9) is a pin-and-hinge connection, where the pin is located on the elevator while the hinge is fixed onto the horizontal stabilizer. During assembly, the elevator is attached to the horizontal stabilizer from outward direction.

Figure 9: Top view of the RH elevator with fixing locations

The outer joint does not have any safety device that would prevent the elevator from sliding off the horizontal stabilizer.

Therefore, in case the elevator's inner joint fails, the elevator is able to move sideways. Should the movement be more than the free length of the pin of the elevator, it is possible that the elevator is entirely detached from the horizontal stabilizer.

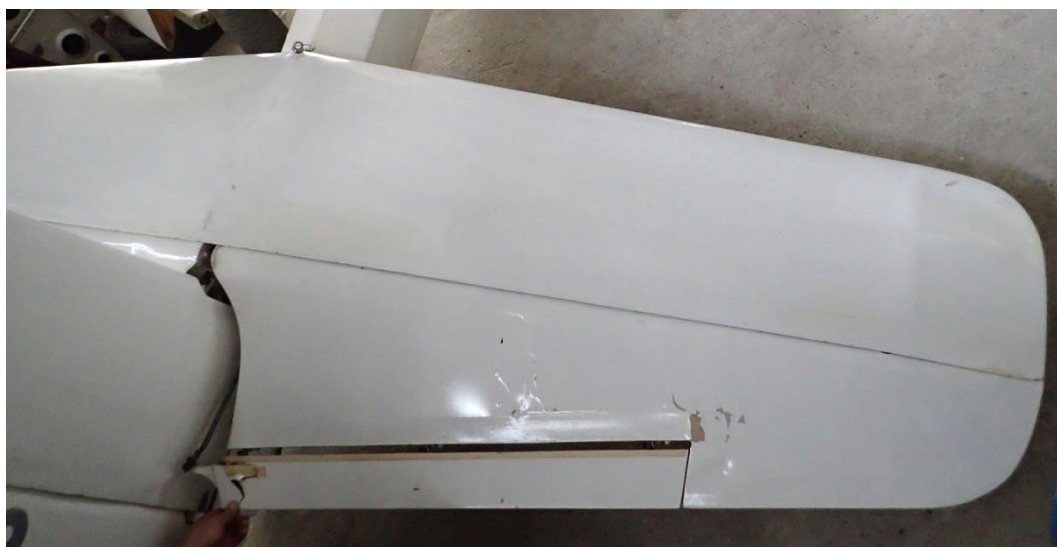
The elevator went back onto the core rib smoothly (see fig. 10).

The play of the elevator mechanism was also checked. The play, measured between the trailing edges of left and right elevators, was 15-20 mm, within the normal range.

The IC determined that the glider involved in the occurrence had pins without holes.

Figure 10: The RH elevator re-attached to the horizontal stabilizer

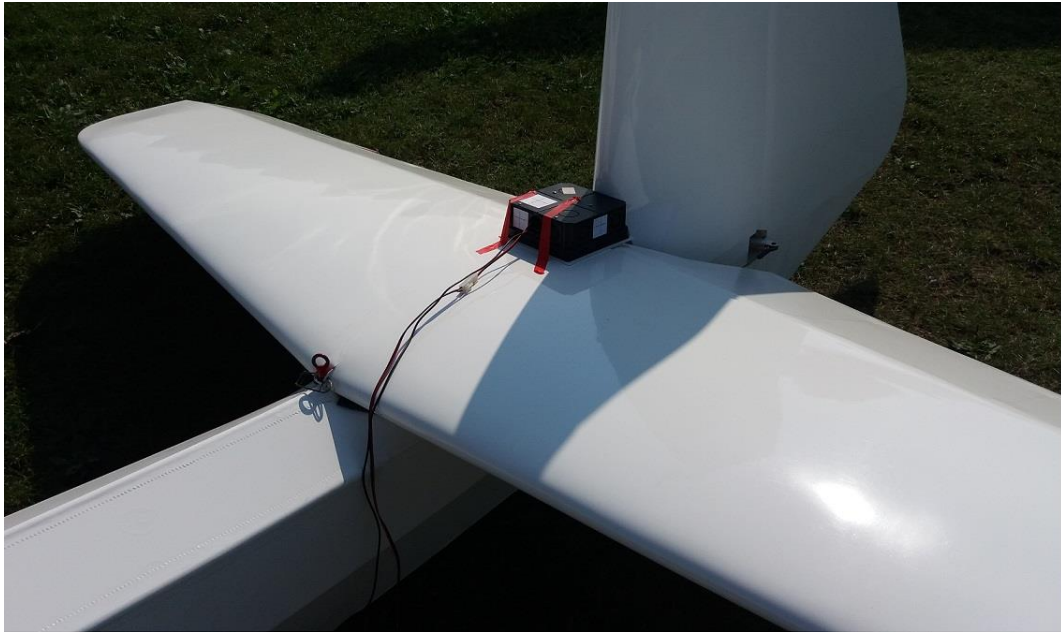
An accelerometer was attached to the tailplane of another K-7 glider (see fig. 11). The winch start was simulated by lifting and then releasing the tail by hand.

Figure 11: The accelerometer secured to the tailplane of a K7 glider

Measured acceleration reached -48 m/s^2 .

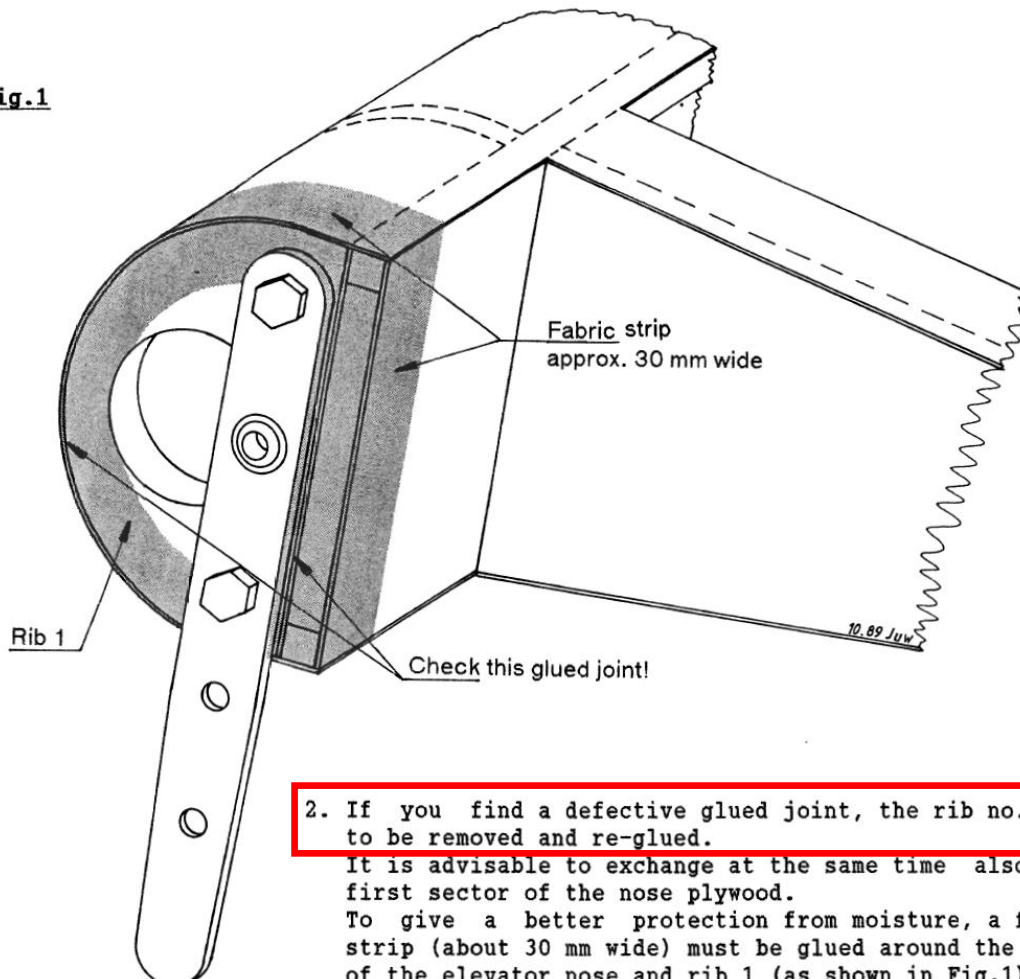
Fig.1

<p><u>Action:</u></p> <p>1. Remove elevator. Check that the glued joint between rib 1 and the leading edge plywood and the elevator spar respectively is in good condition (see Fig.1). Before doing so check whether the LTA 72-7 of Feb.9, 1972 was already previously accomplished (this is not applicable to K9, K11 and ASK 18); if yes then the fabric strip first carefully has to be detached in order to be able to check the glued joint.</p>

2. If you find a defective glued joint, the rib no.1 has to be removed and re-glued.

It is advisable to exchange at the same time also the first sector of the nose plywood.

To give a better protection from moisture, a fabric strip (about 30 mm wide) must be glued around the edge of the elevator nose and rib 1 (as shown in Fig.1).
