## Synopsis

| <b>Date of occurrence:</b> | 7 December 2018, 10:11LT <sup>1</sup> | | | |
| <b>Location of occurrence:</b> | Esztergom airfield (LHEM) | | | |
| <b>Aircraft model and registration:</b> | AT-3R100, HA-BHL | | | |

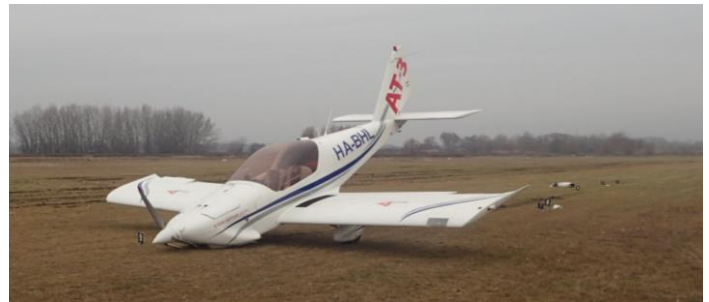
After throttling back the engine ran for another 23 seconds at idle until it quit on impact, in which the nose gear separated and the propeller blades got damaged from ground contact. The aircraft came to a halt tipped on its nose as shown in *figure 1*.

The aircraft sustained substantial damage in the accident. The nose gear separated on impact, all three propeller blades got bent, the spinner and the cowling, as well as the engine mount were damaged. The aircraft came to a halt on the turf 260 metres past the 20 airstrip threshold.

*figure 1. The aircraft after the accident (HA-BHL)*
