MINISTRY FOR
INNOVATION AND TECHNOLOGY
TRANSPORTATION SAFETY BUREAU

PRELIMINARY REPORT

2018-322-4

Magnus eFusion

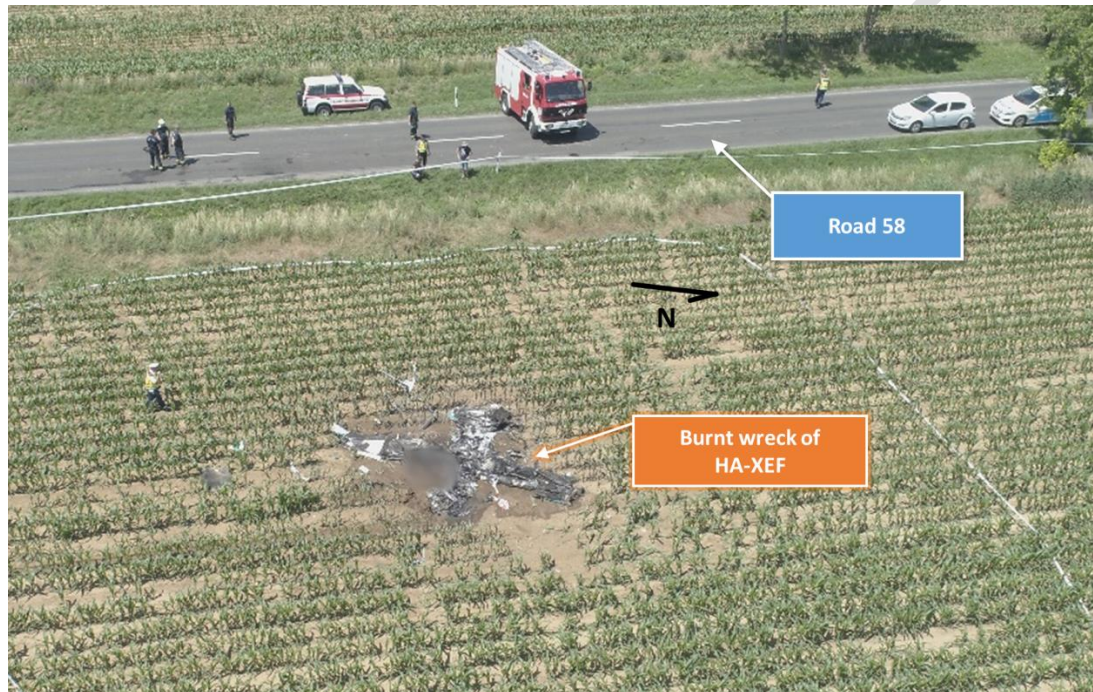
Figure 2: Scene of the accident (source of the photo: Police)

The wreck of the aircraft was found on the spot with geographical coordinates N45.97551° E018.23002°, by Road 58, as shown in Figure 2.
