TRANSPORTATION SAFETY BUREAU

FINAL REPORT

Aeroflot – Russian Airlines, Airbus 320-214, VP-BMF

Serious Incident

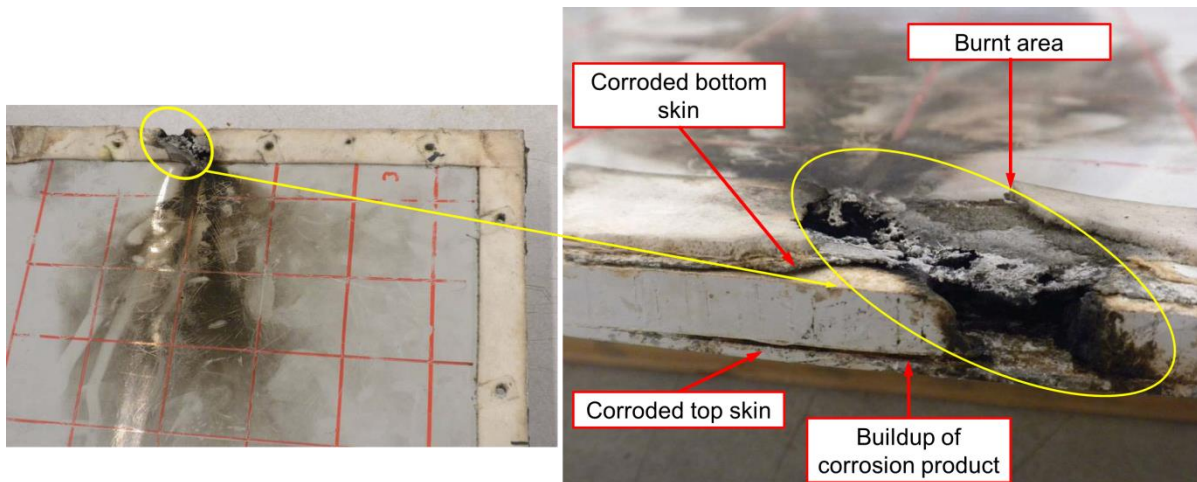
- aluminium bottom skin is porous and missing material in the area of overheat damage (aft edge) (*Figure 3*),

Figure 3: The burnt and deficient area

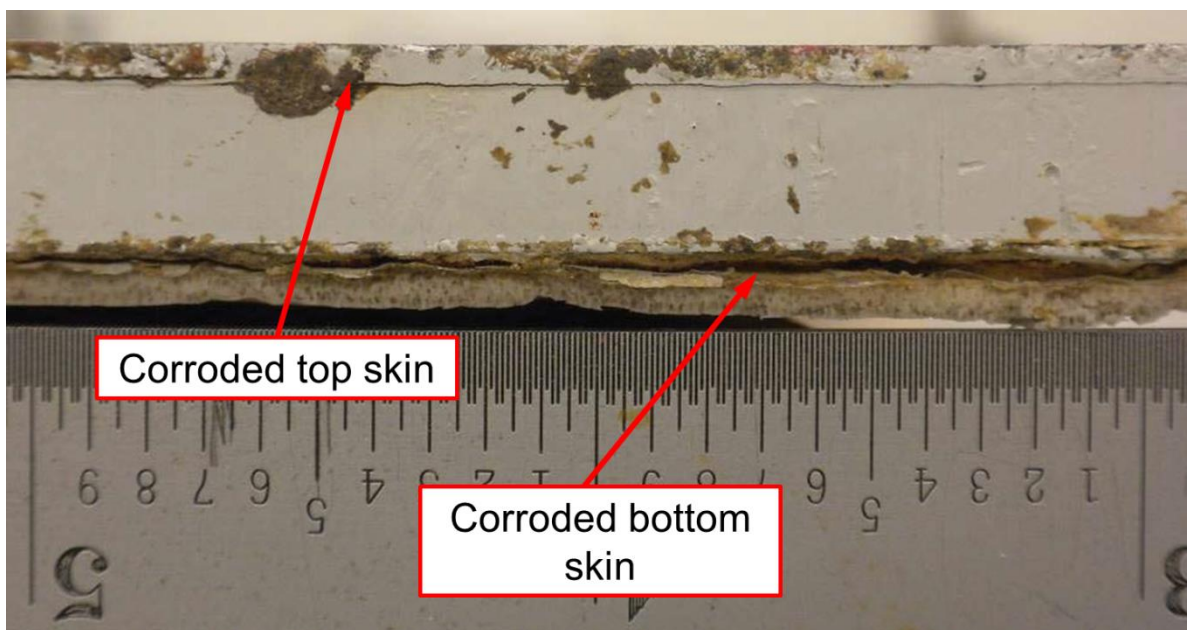
- there were corrosion damages in several places on both the top and bottom skins, resulting in delamination (*Figure 4*),
- there were dents, deep scratches and delamination in several areas on both the top and bottom of the panel.

Figure 4: Corrosion marks on the top and bottom shells of the heated panel

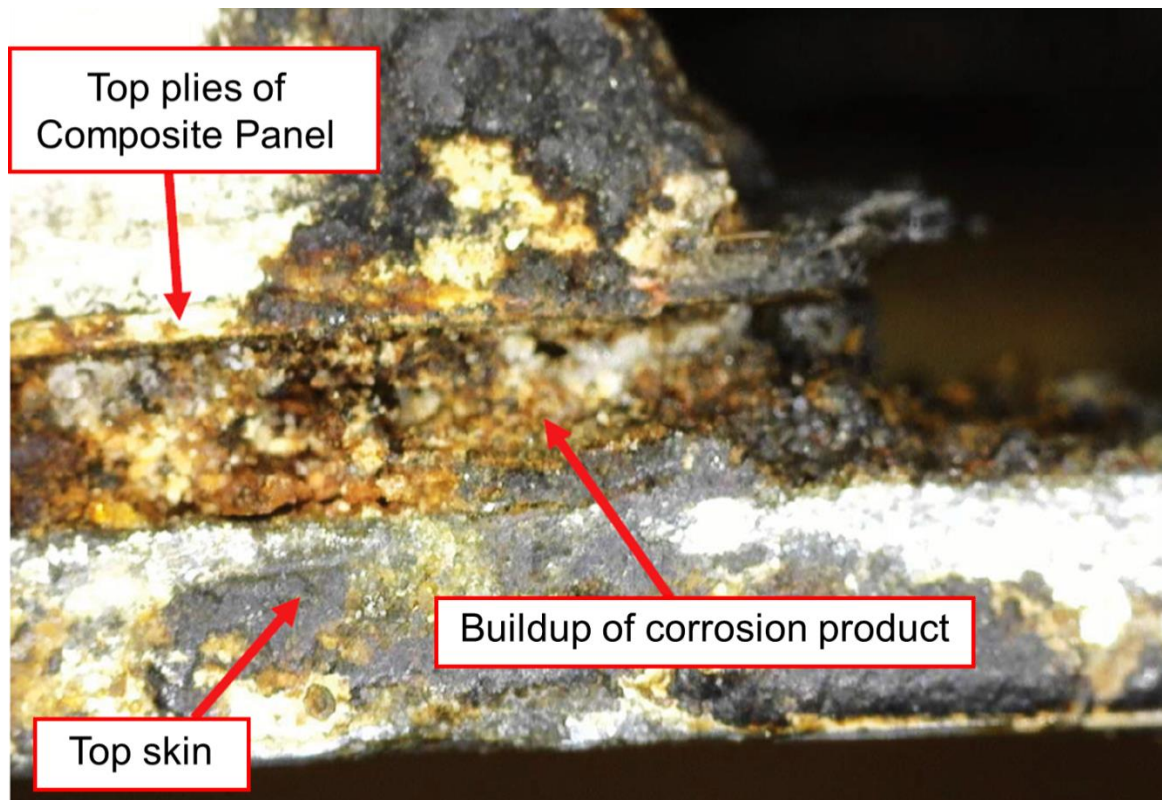
The manufacturer's investigation found that corrosion at the trailing edge of the heated floor panel had led to the failure of the heating element. (*Figure 5*)

Figure 5: Corrosion product buildup at the trailing edge of a heated floor panel

As a result of the investigation the IC concluded that the root cause of the incident was an electrical short circuit of the heating element due to corrosion of the outer edge of the heated floor panel with part number 4E4140-1.

And as a permanent solution, it recommends using the new titanium skin heated floor panels instead of the aluminium skin ones, as the titanium skin resist corrosion and mechanical stresses due to their stronger design.
