TRANSPORTATION SAFETY BUREAU

FINAL REPORT

Arcus Air GmbH&Co.KG, Dornier 228-212/1, D-CAAL
Győr-Pér Airport (LHPR), 21 March 2019

Serious Incident

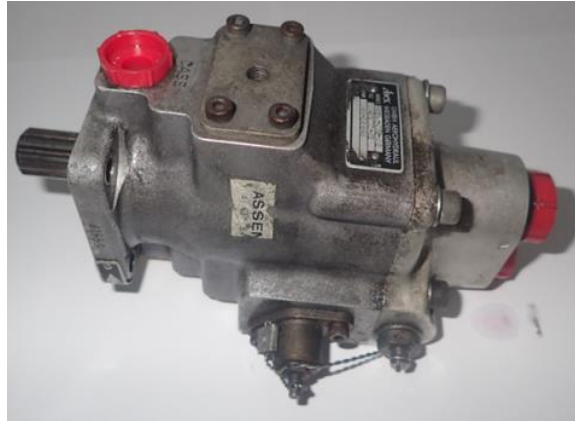
During the on-site investigation, it was found that the electric motor was damaged due to exposure to high temperature. The pump assembly was removed and examined on site by the technicians of the authorised maintenance organisation of the operator, with the consent and in the presence of the accident investigators of the TSB. The on-site inspection of the electric motor showed that its shaft was jammed. The pump which was removed from the electric motor (*Figure 2*) remained rotatable, but the force during rotation was slightly higher than that of the already prepared replacement part.

Figure 2: The removed pump

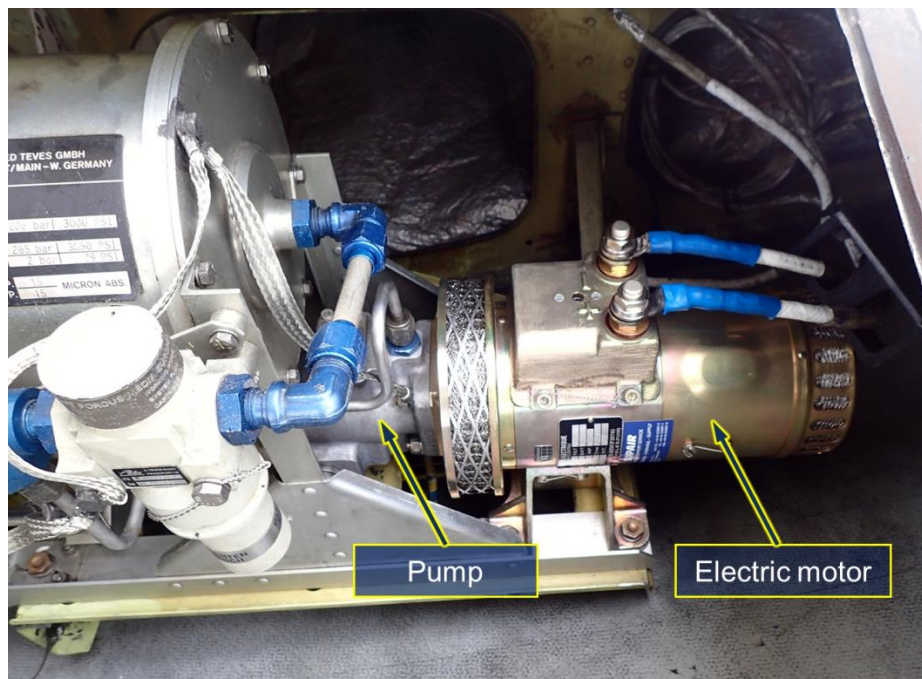
Figure 3: The replaced electric motor with the pump

The pump assembly (electric motor and pump) that failed during the incident was seized by the TSB for further investigation. The authorised technician replaced the failed motor and the pump unit (Figure 3).

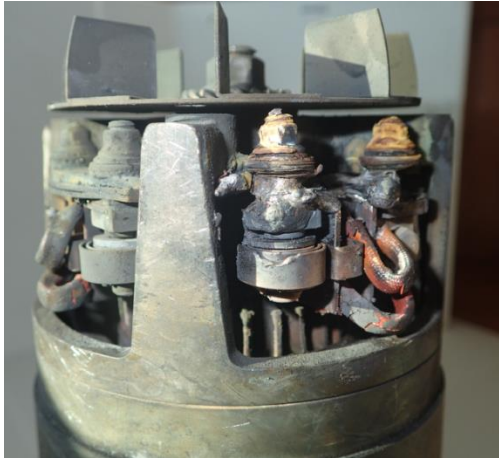
During the on-site investigation it was found that the smell of smoke after take-off, followed by a drop in pressure in the hydraulic system before touch down and smoke after stop was probably due to the failure of the rotating parts of the electric motor (commutator, carbon brush) (Figure 4), which generated heat of such an extent that the internal structure of the electric motor melted and the molten component parts burned through the case of the electric motor (Figure 5).

Figure 4: Burnt parts of the electromotor

The electric motor manufacturer concluded from the photographs collected and the parts provided, as well as the nature of the failure, that an electrical arc inside the motor caused the equipment to fail and that the electrical arc caused the motor casing to melt. However, they could not confirm this assumption fully because they received the motor already disassembled. (1.16)

In January 2023, the manufacturer of the electric motor informed the IC that the carbon brushes had been improved and that only this new one could be installed in the motors in 2020, and it was stipulated that only the new version with the new part number could be used when replacing the carbon brushes. In their opinion, this will eliminate the possibility of a mixed version and reduce the likelihood of failures. In addition to the above, the electric motor manufacturer has issued Service Bulletin SB 1259-29-003, with an amendment date of 18 May 2020, entitled '*Modification of Brushes Grade of the Motor Part No. 1259A of the DO228 ...*'.

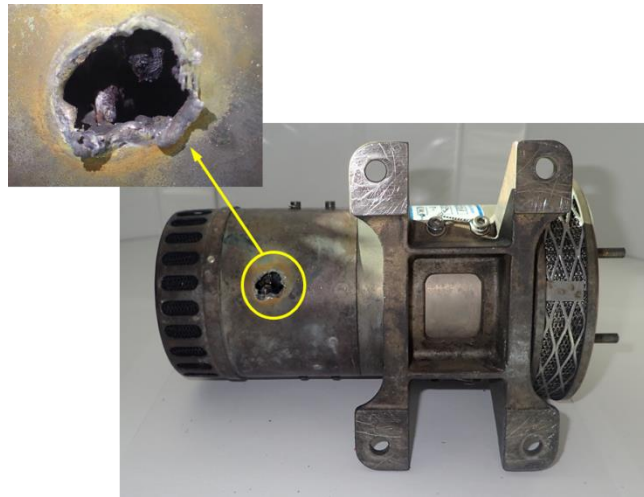
Figure 5: The melted motor casing
