Synopsis

The pilot took off from Farkashegy airfield (LHFH) for time-building with a Piper 32-300 aircraft with registration mark HA-API, and after a flight of approximately 10 minutes, he noticed a decrease in engine power. Due to the terrain conditions, he was unable to return to the departure airfield and turned back towards Budaörs Airport (LHBS), during which he reportedly lost a lot of altitude and made an emergency landing in a field near Törökbálint.

Occurrence category:		Incident		
Date of occurrence:		1 June 2019, 16:40LT ¹		
Location of occurrence:		In the vicinity of Törökbálint (N47°26.885' E018°55.816')		
Type and registration of aircraft:		Piper 32-300 Cherokee six (PA32), HA-API		
Year of manufacture, serial number:		1966, 32-40220		
Type and number of engines:		Single, type Lycoming IO-540-K1A5, 6 cylinders, piston engine		
Purpose of flight:		Non-commercial (practice)		
People	Number:	Crew	Passenger	Other
	Injured:			
		1	0	0
		0	0	0
Damage to property:		Aircraft: Undamaged 3rd party damage: None		
Licence and ratings of PIC:		PPL(A) ² , MEP(Land) ³ , NVFR ⁴ , SEP(Land) ⁵ , Towing / S+B ⁶ , ATPL(A) Theory ⁷ ,		
Age and citizenship of PIC:		38 years old, Hungaria

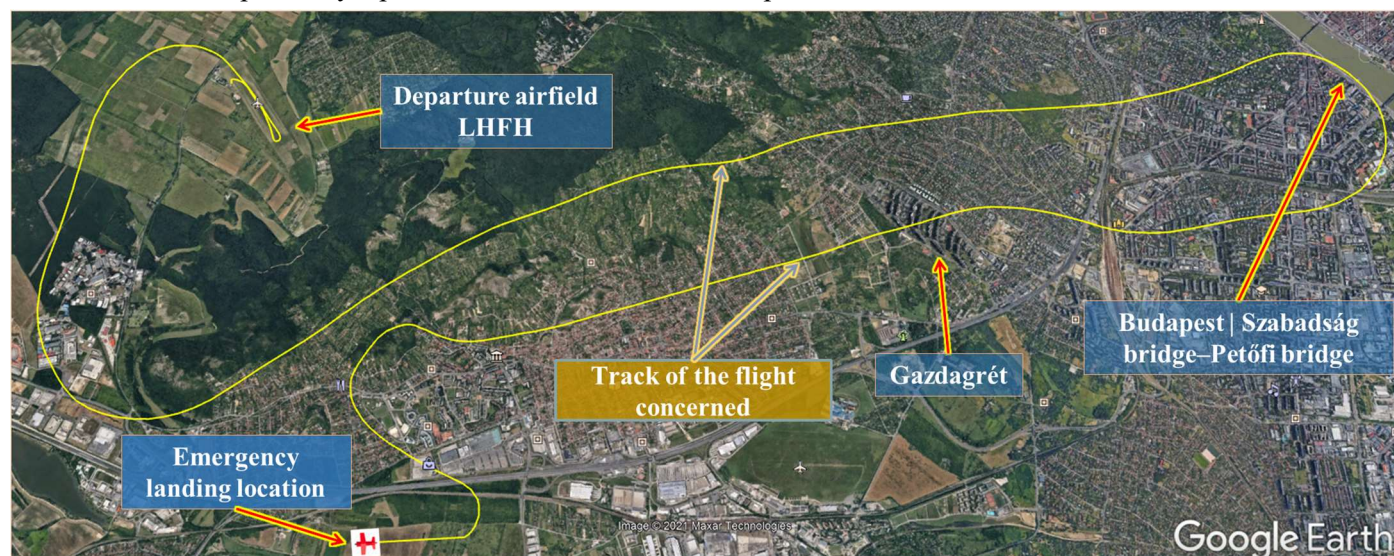
Figure 1: The actual track of the flight leading to the occurrence

He said he flew to Gazdagrét, (see *Figure 1* for actual route) and then turned back and was flying at an altitude of about 2,000 feet with approx. 100 knots when he noticed decrease in power (engine speed dropped to 2,000 rpm). In response, he applied full throttle, but that did not help; then he adjusted the propeller to the smallest angle, but the engine still remained around 1900 to 2000 rpm. Preparing for a possible engine failure he realised that, due to his position and the terrain, he would not be able to return to Farkashegy airfield, so he turned in the direction of Budaörs airfield (LHBS). According to his report, he lost a lot of altitude during the 180° turn, so he decided to land in a field situated near Törökbálint (*Figure 2*).

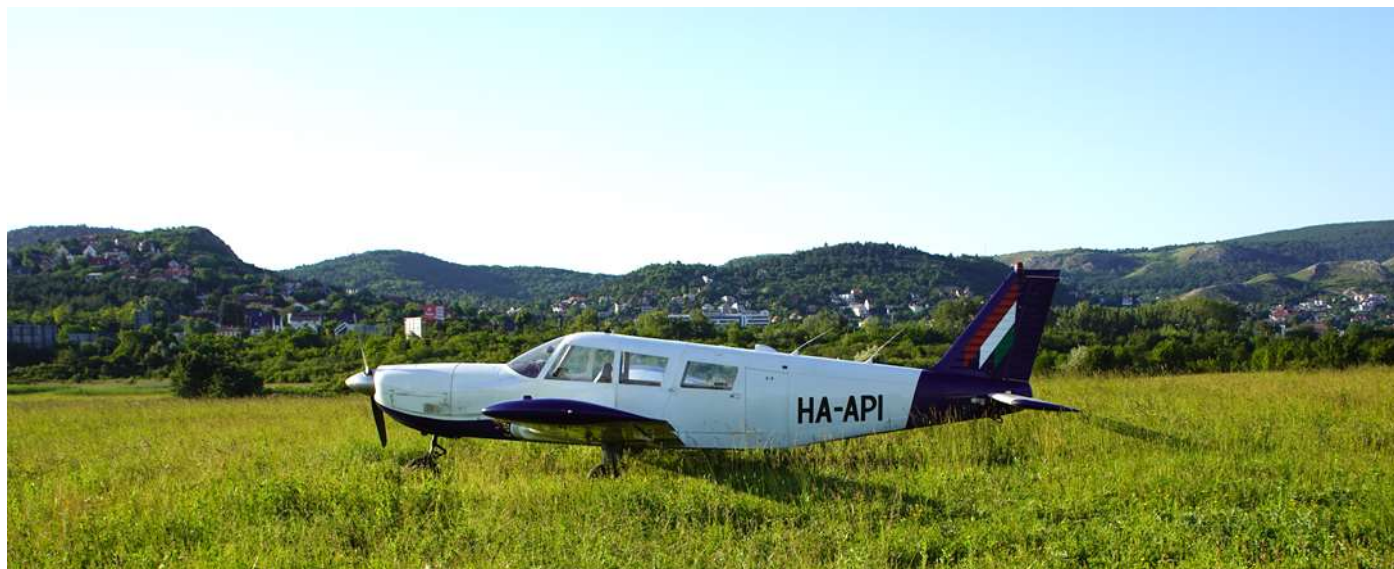
Figure 2: The aircraft involved in the event, after the emergency landing

The aircraft landed in a field outside Törökbálint (N47°26.885' E018°55.816'); without any injuries to the pilot and without damage to the aircraft. The chosen landing area was a grassy field about 600 metres long and 250 metres wide.

During the on-site inspection, the IC took photographs of the site, the aircraft, the documents found on the site, checked the fuel levels of the internal tank and found them to be almost fully filled. Then the IC took fuel sample from the inboard tanks and sent it to experts for examination¹¹. During the on-site inspection, the IC recorded that the aircraft's engine hour meter was at 9091,55 and that all seat belts were unbuckled and loose. After assessing the findings on the spot, the IC decided that a secondary inspection was necessary. Documents not available on the spot were requested from the pilot and from the aircraft owner.

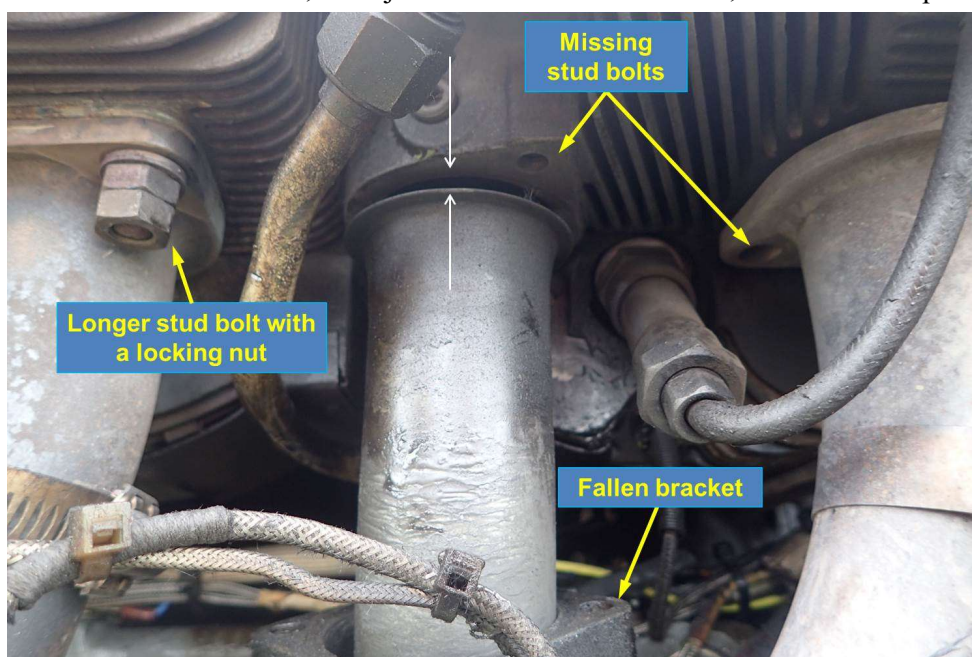
Figure 3: The malfunctioned engine

- The inner surface of the removed engine cowl showed spots of thermal load.
- Cyl. 6 on the LH side of the engine:
 - lacked the stud bolts of the mounting bracket of the intake manifold.
 - The intake manifold had moved away from the cylinder, leaving a gap of ca. 20 mm between its flange and the cylinder (*Figure 3*.)
 - The exhaust manifold had also loosened; one of the two stud bolts broke inside the cylinder and the locking nut of the other got unscrewed.
 - The exhaust manifold provided no sealing, and the emitted hot exhaust gases melted the adjacent cables of the exhaust gas temperature (EGT) sensor, leaving soot marks behind.
- Removal of the spark plugs demonstrated that 4 of the 6 plugs of the lower row could be unscrewed by hand.

- Rotation of the engine evoked no sound referring to any other malfunction of the engine. Compression checks carried out with manual sealing of the holes of the removed spark plugs showed significantly reduced compression in the front LH cyl. 2.

- The engine contained 10 units of heavily coke polluted black lube oil.
- The bolt joints and sealing used to secure the exhaust manifold and intake manifold of all cylinders reflected different solutions. There were stud bolts of different lengths, securing with locking nuts, and type and quantity differences in the case of washers.

- The engine reflected a generally neglected state; the signs of significant oil spills were visible on the engine.
- The removed air filter showed pollution from normal operation; the air intake and the associated line to the injector was permeable and free of pollution.

During the additional site inspection, the IC saw an inadequately maintained aircraft engine (refer to Malfunctioned Equipment paragraph for details). During the investigation, the IC was unable to establish with any degree of certainty which of the numerous significant deviations or unprofessional solutions described in the previous chapter, or which of these errors interacted to cause the power degradation during the incident. In the experience of the IC, most of these failures are capable of causing a power degradation on their own.

The IC attributed the cause of the incident to maintenance deficiencies linked to economic considerations.

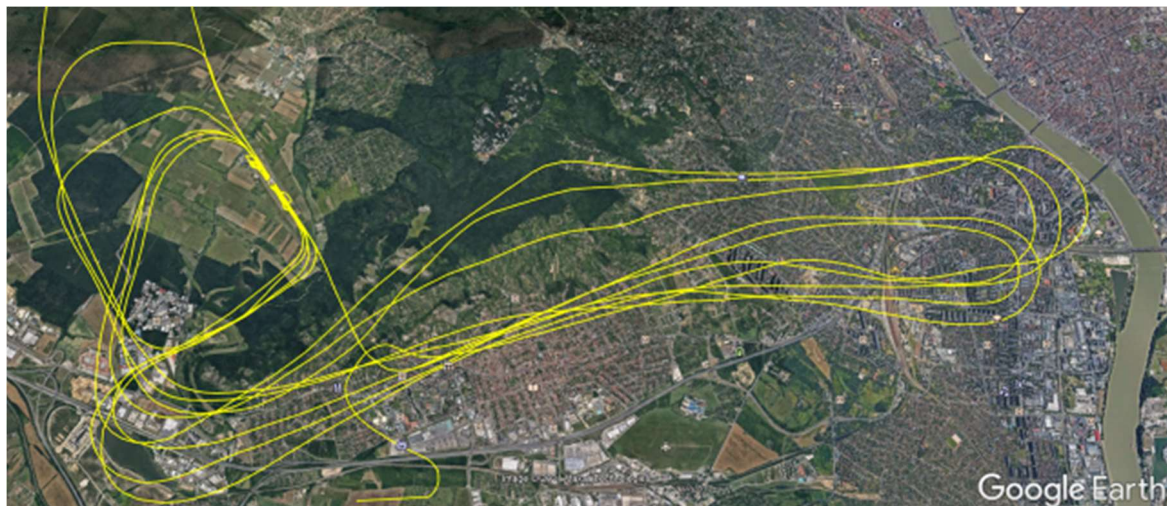
Figure 4: Recorded flights of the aircraft involved in the event on 01/06/2019

According to his account, the pilot did not operate the transponder, only an OGN tracker. During the investigation, the IC obtained data recorded by the OGN tracker (*Figure 4*), and on the basis of it found that:

- On the day concerned, the aircraft with reg. mark HA-API flew twice to the airspace above District XI (Lágymányos) of Budapest;
- On one occasion, it flew to Pilisvörösvár and back to Farkashegy airfield;
- Then it flew to the airspace above District XI, Budapest again, twice, along the earlier route;
- The flight ending up in the incident was the sixth take-off on the day concerned, as well as the fifth flight over Lágymányos (District XI). The decrease in power leading to the incident took place on the way back to Farkashegy airfield.

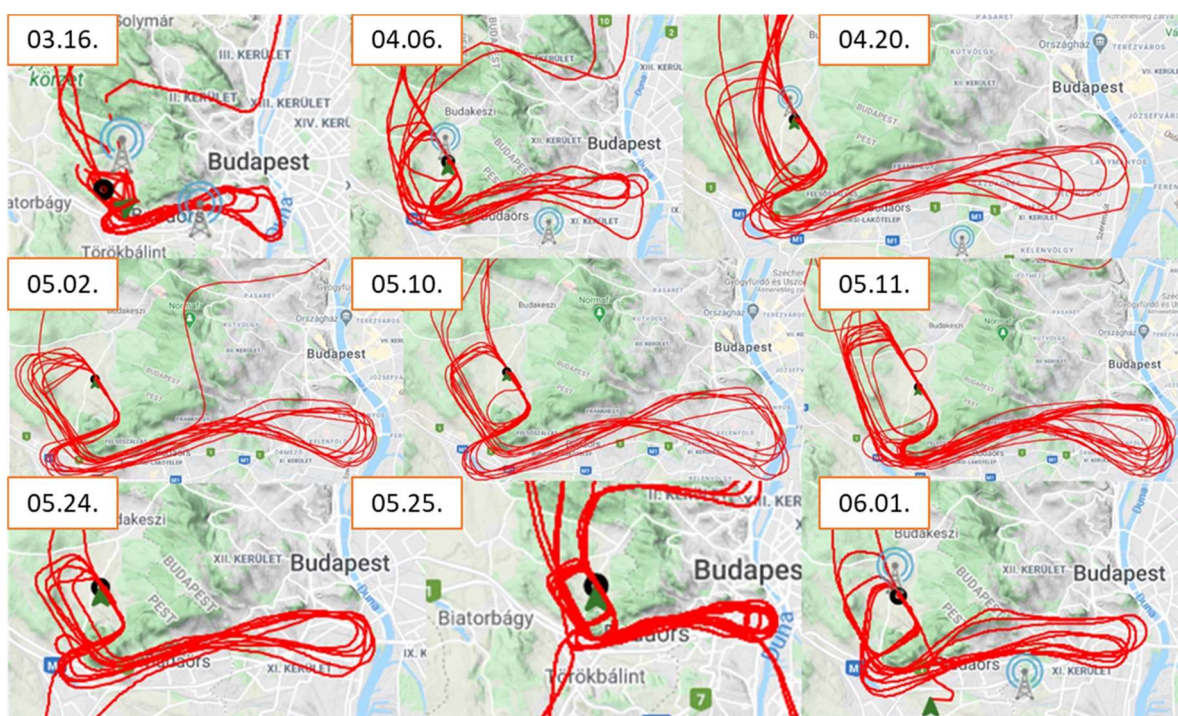
Figure 5: Some flights of the aircraft concerned in 2019

The IC also viewed previous flights of the affected aircraft through the OGN system (*Figure 5*), several dates of which were indicated in the pilot's flight log book as well. OGN data shows that both the aircraft and the pilot flew regularly on exactly the same route like the flight over District XI (Lágymányos), Budapest that preceded the event.

An analysis of the historical routes recorded by the OGN system shows that the aircraft involved in the incident usually flies the routes advertised on the website of the company which signed the aircraft liability insurance.
