TRANSPORTATION SAFETY BUREAU

# FINAL REPORT

Wizz Air Hungary Ltd., Airbus A320-232, HA-LYD  
Debrecen International Airport (LHDC), 04 January 2020

2020-0008-4

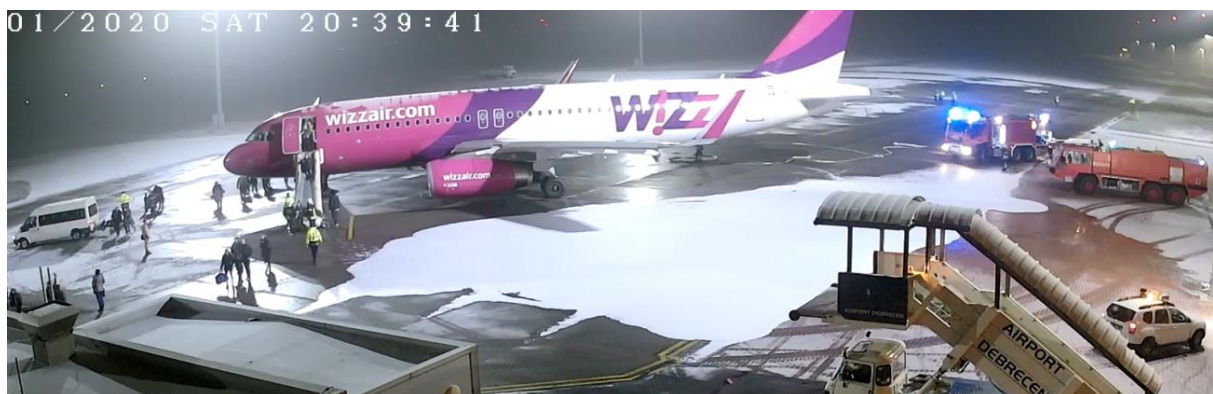
On 4 January 2020, flight W67868 of Wizz Air Hungary Ltd., registration HA-LYD, from Debrecen to Paris, had completed pre-departure de-icing procedure, when the ground handling agent servicing the flight detected a light phenomenon on the left horizontal stabilizer of the aircraft. Identifying it as fire, he alerted the Aerodrome Fire Service for immediate assistance. Arriving at the scene, the fire service assessed the situation and decided to commence extinguishing the fire on the left stabilizer. By then the aircraft crew, following the Fire Captain's firm instructions, had made a decision to evacuate the aircraft. Every person on board disembarked without injury, using the emergency slides at the right and left front doors (Figure 1).

Figure 1. The aircraft during evacuation (source: Debrecen Airport)

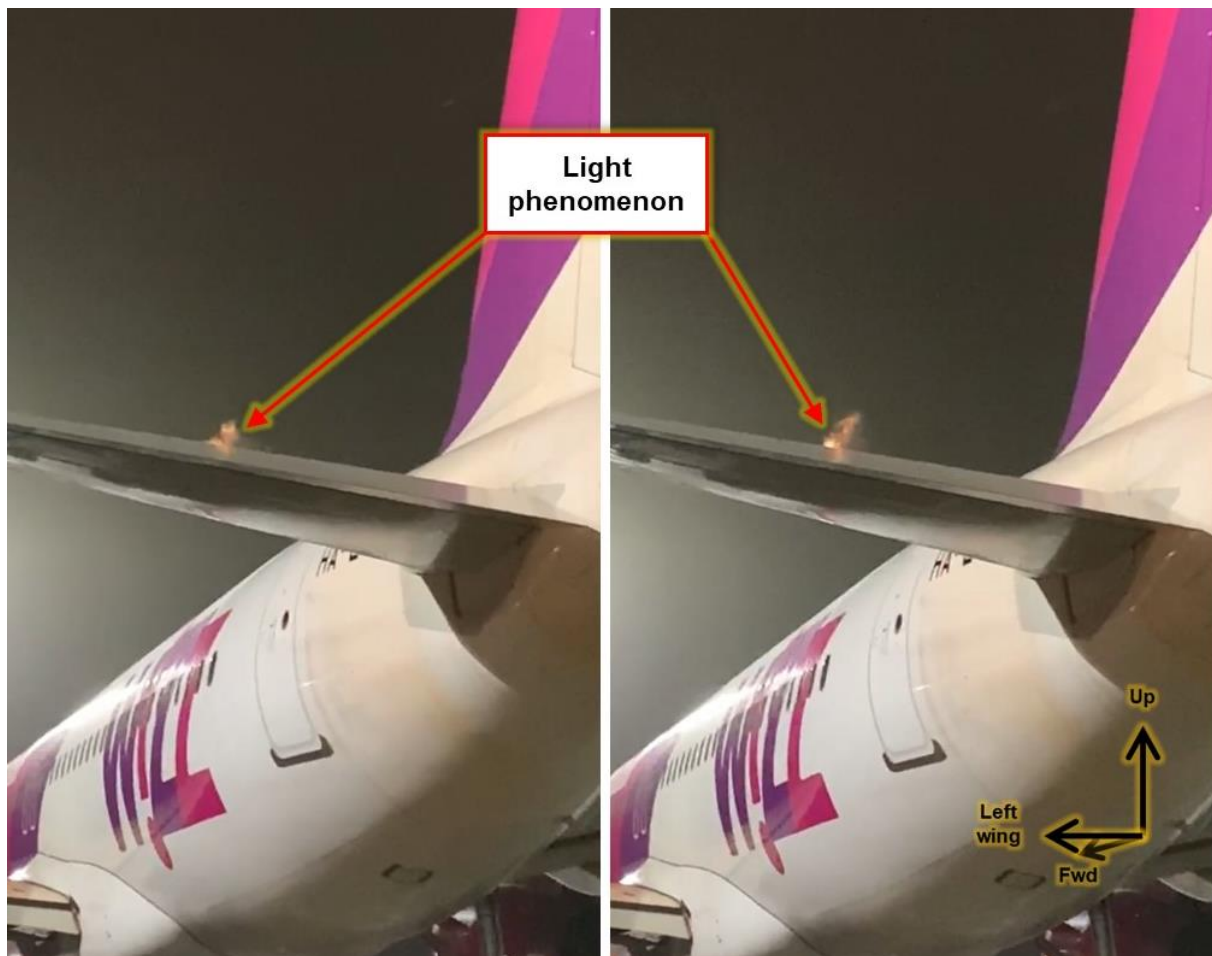
The on-site survey revealed that the logo light lit up de-icing/anti-icing fluid vapours rising from the stabilizer surface, which created an illusion of fire and smoke. No actual fire occurred during the event and the aircraft did not sustain any damage.

Two minutes after the alert call the Fire Watch units arrived at the scene in two fire engines and a Fire Command vehicle. In the course of their visual reconnaissance they found the light phenomenon on top of the left stabilizer and identified it as fire. Before starting spraying, the Fire Captain firmly instructed the Ramp Agent to tell the flight crew to shut down the engines and commence passenger evacuation.

Figure 2. The light phenomenon spotted (source: Ramp Agent)

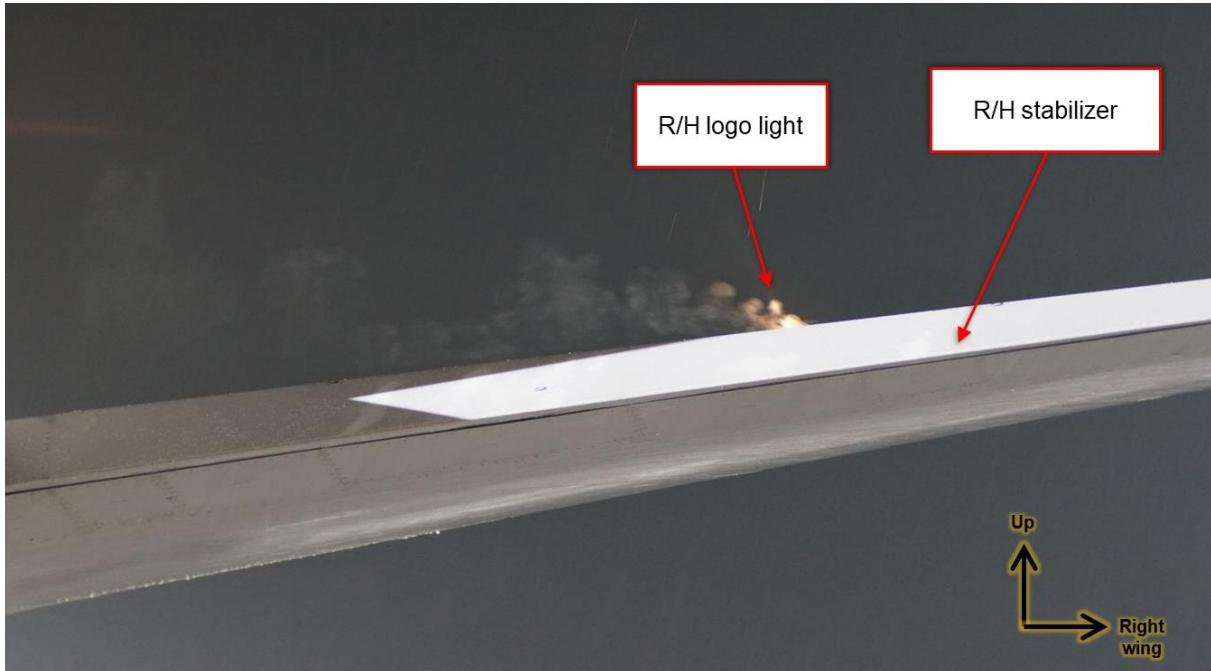
he made this decision because he saw a 40-something-centimetre orange “flame” with a bluish hue on the horizontal stabilizer, about a metre outboard from the fuselage axis. Furnished with the Ramp Agent’s information on the fire, corroborated by his own visual perception, the Fire Captain had no hesitation in concluding it was actual fire he was dealing with. The use of a thermal image camera, readily available in each fire engine, had not been considered.

Figure 5. Right stabilizer during TSB’s survey

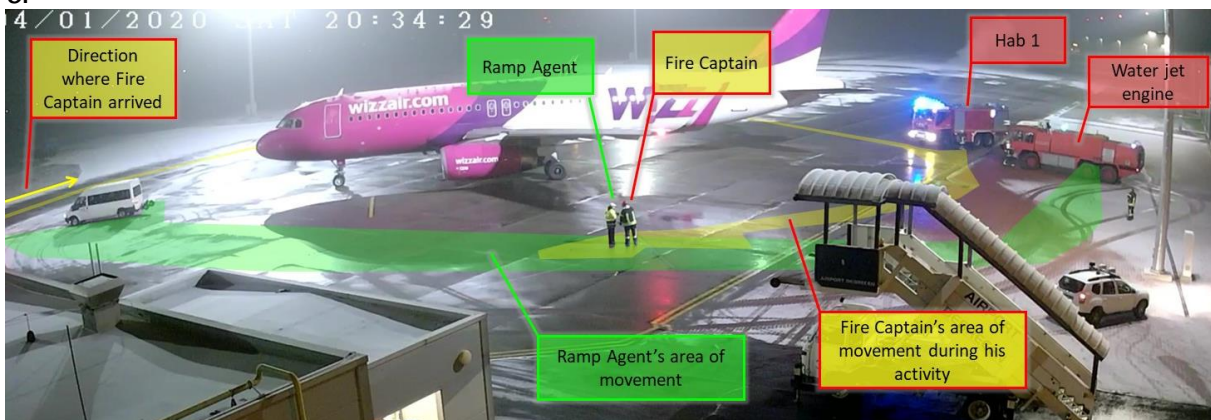
HAB1 started foam blasting 2 minutes and 9 seconds after the Fire Captain arrived at the aircraft. The Fire Captain’s area of movement during his activity is marked in yellow in Figure 6.

Figure 6. The Ramp Agent’s and Fire Captain’s area of movement before fire activity (picture’s source: Debrecen Airport)

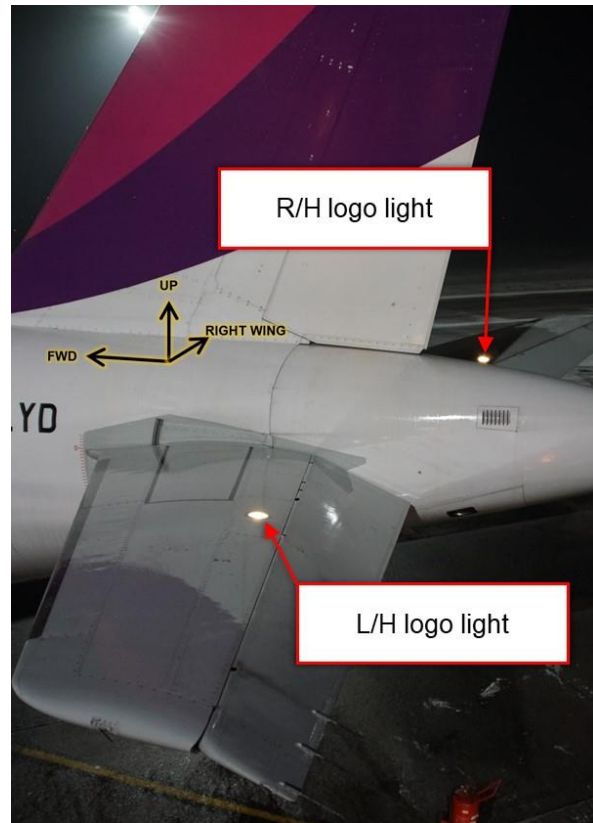
Figure 7. Logo lights of A320

The Ramp Agent stated that he had not quite been accustomed to the new LED apron lighting that had been installed shortly before the occurrence. In the given the weather conditions, the de-icing and anti-icing fluid was heavily evaporating over the logo light.

**BA2020-0008-4-4:** The IC has found that the training material used to train the Ground Handling Service personnel at Debrecen International Airport did not cover light phenomena potentially capable of causing optical illusions induced by aircraft lights, including upright beams, interacting with the environment.

**Therefore, the Transport Safety Bureau of Hungary recommends that the Air Navigation and Air Navigation Services and Aerodromes Supervisory Department of the Ministry of Construction and Transport seek to revise the training material used by Aerodrome Ground Service Providers to train their personnel, by including the discussion and explanation of light phenomena potentially capable of causing optical illusions when aircraft lights, including upright beams, interact with the environment. Furthermore, TSB recommends that the a.m. authority reject any further ground handling service provider training curricula submitted for approval, unless revised according to the above.**
