MINISTRY OF
TECHNOLOGY AND INDUSTRY
TRANSPORTATION SAFETY BUREAU

FINAL REPORT

TOMI AX-8, HA-864

Vál, Aligvári dűlő, 5 September 2020

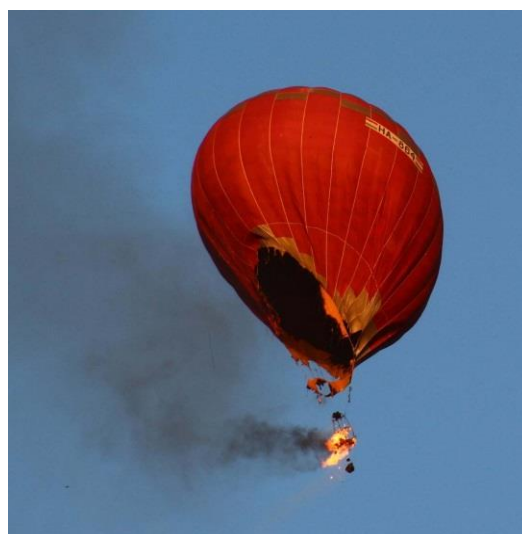
*Figure 1: The burning balloon soaring back up
(Source of photo: National Directorate General for Disaster Management)*

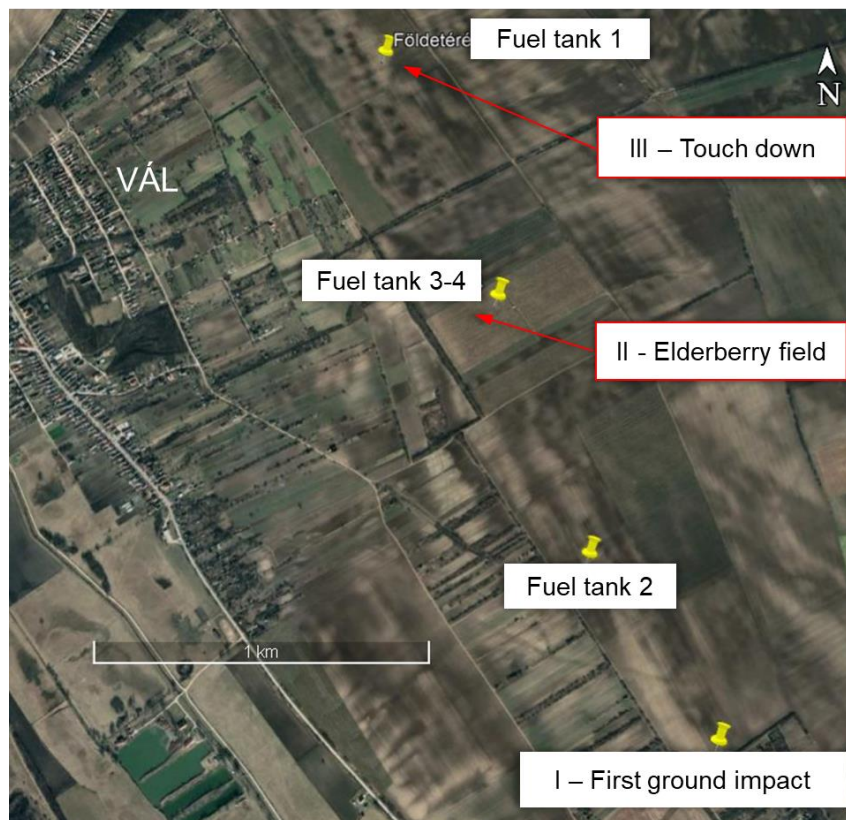
- I. The first ground impact of the balloon HA-864 happened next to Vál, on an agricultural land $47^{\circ}20'55,44''\text{N}$ $18^{\circ}42'38,89''\text{E}$. According to the marks on the ground, the basket got blocked during landing, and then lifted in the air again and travelled approx. 2 metres. Then it touched down again, and carved a trench of 4-5 m length and 20-25 cm depth into the soil. This is where the gas leaked, caught fire, and where the injured occupants left the burning basket. The fastening bracket of a fuel tank, the data plate of the envelope, and a couple of minor burnt pieces of the envelope were found a few metres away.

- II. The body of the fatally injured passenger and two 23 kg fuel tanks (Fuel tank 3 and 4, Serial numbers: A69308, A60242) were found in an elderberry field.

- III. The envelope (about one fifth of it had burnt out) with the gas burner, and the remains of the basket dragged by it, as well as a 2-kg pilot flame fuel tank (serial number: 13472) and a 23-kg fuel tank (Fuel tank 1, serial number: B38186) – both tanks exploded – landed here in the corn field $47^{\circ}22'11.36''\text{N}$ $18^{\circ}41'46.60''\text{E}$.

Another 23-kg fuel bottle (Bottle 2, serial number: A54141), which was found last (for a long time regarded as lost) had fallen to the ground roughly halfway between scenes I and II. It was finally found during harvest on 12 October 2020 in a filled state.

Figure 4: Locations of the touch-down, the gas bottles, and the burnt-out wreck

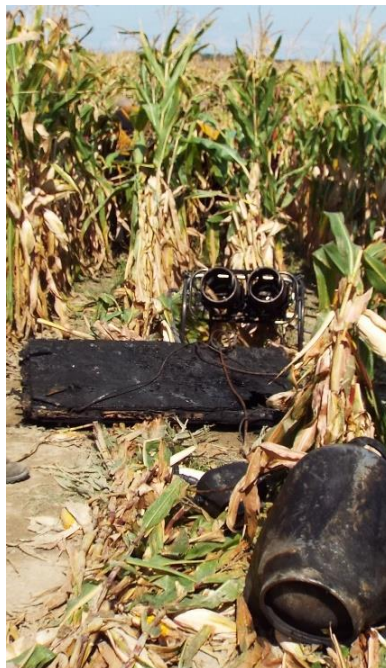
Intensive leakage of liquid gas occurred suddenly in the fuel system during the landing; the leaking gas caught fire when its vapour reached the pilot flame and then the burning gas set the inside and the cane wicker of the basket on fire. The burning hot-air balloon ascended again, and the heat accumulated in the basket caused several gas-filled fuel bottles to explode.

The balloon and its burnt-out basket landed in a cornfield where the fire was prevented from spreading.

Figure 5: Burnt remnants of the hot-air balloon

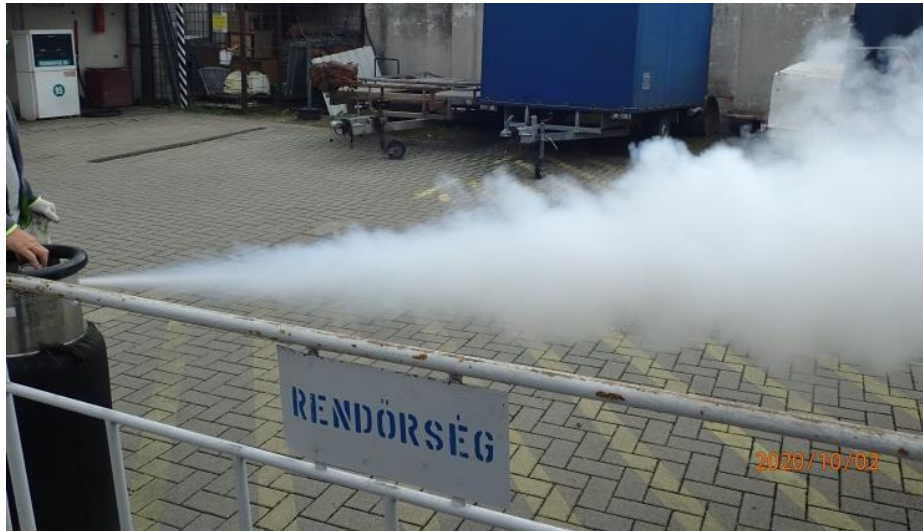
On October 2, 2020, one of the operators of a hot air balloon in Hungary presented the opening of a full fuel tank in the yard of the Székesfehérvár police station. The purpose of the study was to determine the form in which an outflow of pressurized gas escaping from a tank or an open system would flow without a constriction without obstruction to the outflow. The high-pressure liquid-phase gas could flow freely in full cross-section through the tap of the tank. As a result of the sudden pressure drop, the liquid immediately turned to gas and formed a dense, compact, white mist that one could not see (Figure 6).

Figure 6: Gas flowing out of the bottle with the valve open

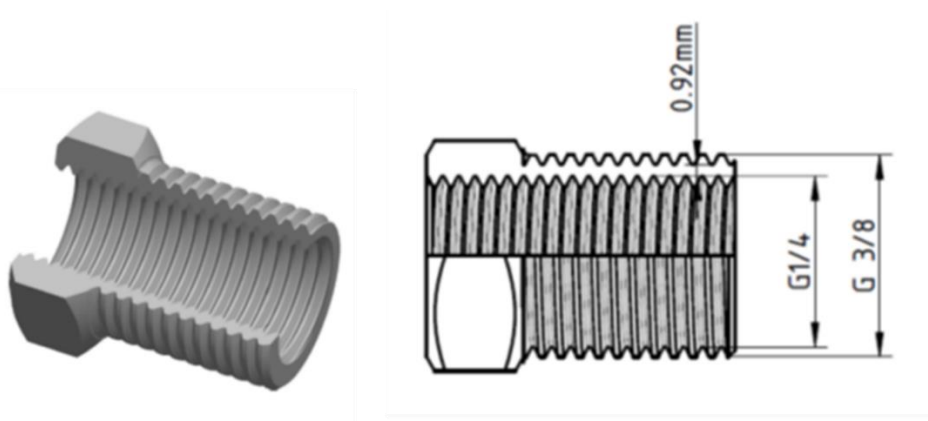
The IC examined the characteristic (theoretical) structural dimensions of the fuel tank fuel hose/manifold assembly and the fuel tanks quick release connector, using computer component modelling. A thread adapter with an external thread size of G3 / 8 and a thread of G1 / 4 on the inside was installed between the quick coupling and the attached hose. With the help of the modelling program, the smallest distance between the outer and inner trenches was measurable (Figure 7). Construction suggests that the smallest theoretical wall thickness is less than 1 mm.

According to the calculations of the IC, in the case of a copper alloy component with such a wall thickness, if the characteristic load (e.g. external force) is concentrated on a 100mm lever arm, the component may break under a load of 105N (~ 10.5kg). The flexible hose fastened onto the quick-release coupling applied can be connected to the quick-release coupling, through a joint bolt, with a threaded hose end embedded in a rigid armature. The distance between the fractured surface and the rigid hose end was almost 100 mm.

Figure 7: Section drawing of the fractured joint bolt

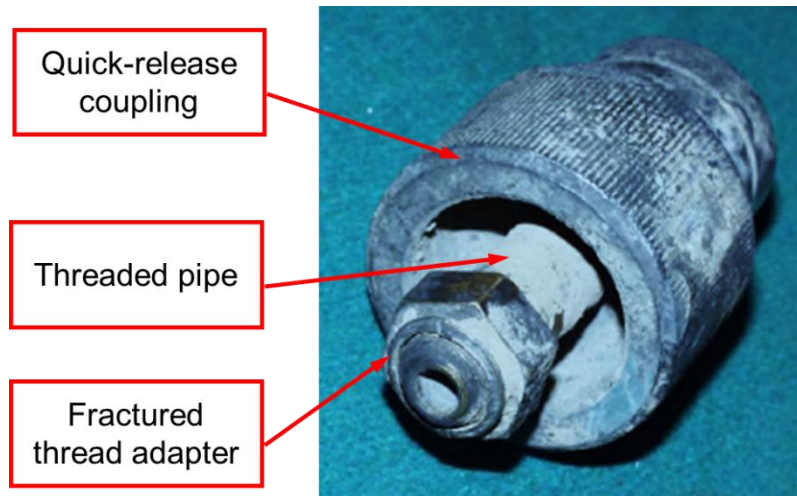
The IC ordered metallurgical examination of the fractured thread adapter used with the hose which connected the fuel tanks (*Figure 9*). While the bronze types typically used in the manufacturing of machine parts are copper alloys with 6% to 10% tin content, the test found that the thread adapter was made of brass-lead alloy. This alloy is typically used as base material in bearings, owing particularly to its good gliding properties.

Figure 8: The quick-release coupling with the fractured joint bolt

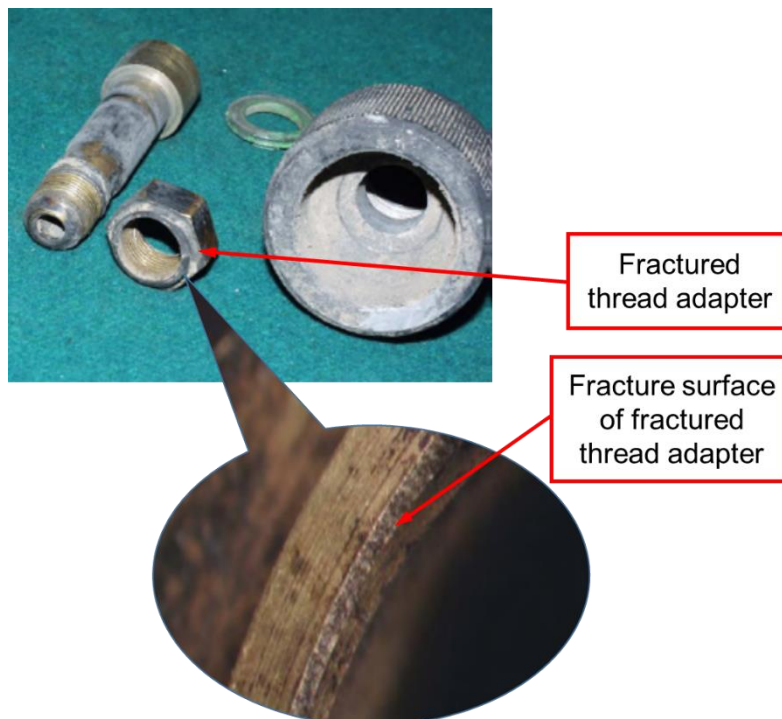
The material testing demonstrated neither macroscopic nor microscopic material defect in or around the fractured surface of the joint bolt. However, the thickness of the fracture surface varied significantly, between 0.3 mm and 0.8 mm. A possible cause of the formation of an asymmetric fracture surface is that the axes of symmetry of the external and internal threads are not identical, which may as well refer to a possible error of manufacturing. The analysis shows that the fracture of the joint bolt was not preceded by significant plastic strain: the pattern of the fracture surface suggests that a brittle-type fracture occurred (*Figure 9*). Hardness measurement showed noticeable hardening in the location where the fracture started.

Figure 9: The joint bolt with fractured surface

During the safety investigation, the IC concluded that the direct cause of the accident was the ignition of the escaping gas due to the fracture of the thread adapter of fuel tank № 3.

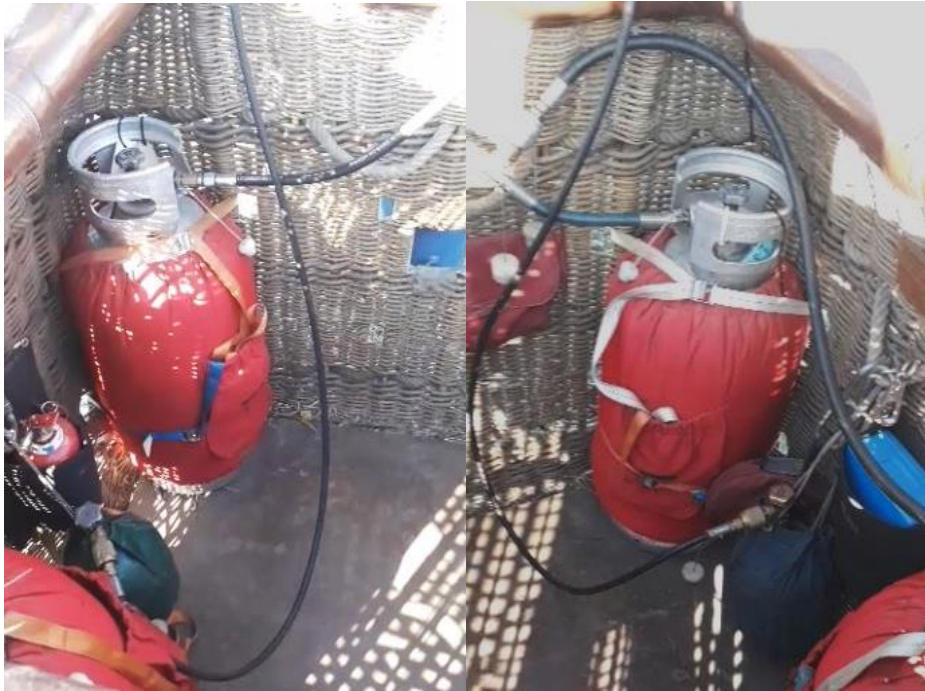
Figure 16: Arrangement in the basket involved in the occurrence, right before the take-off

The photos taken by the passengers right before the take-off show that the gas hoses in the basket of the aircraft sagged deeply into the passenger area (*Figure 16*). The gas bottle outlets were not turned in towards the basket wall and the gas hoses were also tied to the basket walls occasionally with plastic cable ties only. The hose of a pilot flame bottle was not secured in the basket and its lowest point was situated within stepping height (from the bottom of the basket). Thus, there was the possibility that occupants grab it or bump into it with a foot.

The couplings of the outlets of the fuel tanks were not turned towards the basket walls. The fuel hoses, which were too long compared to the size of the basket and only partially secured, as well as the unsecured hoses (placed within stepping height from the bottom of the basket) of the pilot flame bottles (1.18.8) made it possible for occupants to grab or tread on, thus exposing such items to potential extreme loads. In addition, the fracture of the improperly applied low grade thread adapter could have occurred upon load from a concentrated force of 105N (approx. 10.5 kg) on the given load, according to the IC's calculations. Taking into account the body mass of an average adult and the grasping force applied, the given system of the fuel bottles, quick-release couplings and hoses implied significant flight safety risks.

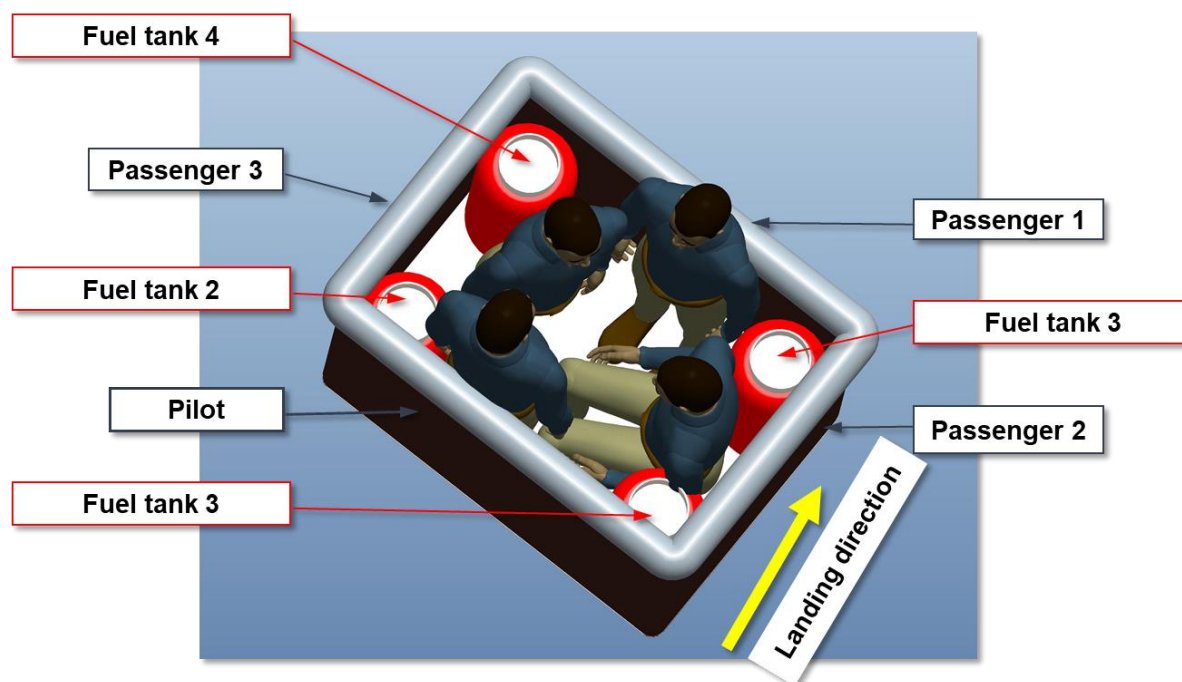
Figure 17 shows the positions of the passengers and the pilot in the basket during landing. According to information available to the IC, the passengers were standing facing the inside of the basket; therefore, during landing, Passenger 1 was facing backwards, while the two other passengers were facing side wards relative to the direction of the landing. Passenger 2 (situated on the pilot's right) was squatting, while the other two passengers were waiting for the touchdown with their knees bent. The fuel hoses placed inside the basket were located in close proximity to the occupants, in unsecured or partly secured state, while the couplings on the fuel bottles were not pointing to the basket walls but typically to the inside of the basket. Neither the fittings nor the hoses located close to the passengers were separated from the passengers therefore there was the chance that such items be close at hand, even if inadvertently. Fuel tank № 3 was behind the back of Passenger 2 (squatting on the pilot's right) where the thread adapter broke.

Figure 17.: Locations of the occupants in the basket during the landing

During landing, passengers turned facing the inside of the basket, following the Pilot's instructions, i.e. the passengers at the touch-down side were facing backwards (*Figure 17*). The IC supposes that, as an effect of the jolt, which was sudden and more intense than expected according to their account, the passengers instinctively tried to get a grip. Presumably, one of the passengers fell back against the incorrectly routed hose of the fuel bottle № 3, which resulted in fracture of the thread adapter, or she inadvertently grabbed the hose itself, and the resulting pull might have caused the adapter to break. According to the IC, when the hose are properly routed and fastened (short wall jointing in case of jointing), passengers cannot grab / step on them, so extreme loads cannot occur and, if used proper and robust material is used, the otherwise improperly installed adapter will not break even when a greater force is applied. .
