FINAL REPORT

Piper Seneca I. PA-34-200, HA-SOA

Atkár-Gyöngyöshalász Airfield, 7 November 2020

2020-0523-4

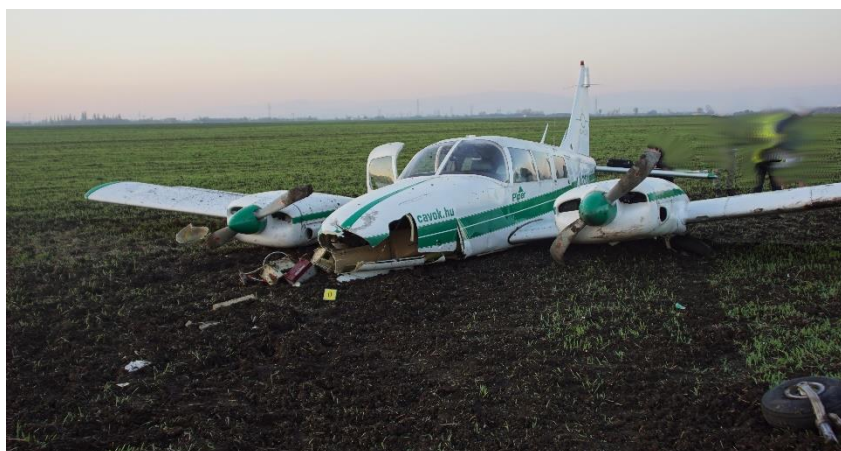
Figure 1.

On November 7, 2020, at 13:35 local time, the crew of a Piper Seneca I (PA-34-200) aircraft, during instruction and on short final for RWY 02 of Atkár-Gyöngyöshalász Airfield, attempted a single engine go-around from a practice engine failure. The aircraft veered left and lost altitude, the left wingtip struck the ground in the plow field left of the runway. The aircraft crashed and came to a stop in the soft wet soil, spinning about 150 degrees to the left, sustaining substantial damage. The crew of two managed to escape without injuries.
