Short summary of the occurrence

Occurrence category:	Accident			
Date of occurrence:	30 November 2020, 14:42 LT ¹			
Location of occurrence:	Esztergom Airfield (LHEM) (47°45',48 N; 18°43',80 E)			
Type and registration of aircraft:	Pipistrel Virus 912, 35-12 (not in valid registration in Hungary)			
Year of manufacture, serial number:	2011, S/N 408V912			
Type and number of engines:	Single, Rotax 912, S/N 912 67770185			
Validity of liability insurance:	No valid liability insurance			
Purpose of flight:	Non-commercial (private, local)			
People involved in the accident	Crew	Passenger	Other	
Number:	1	0	0	
Injured:	1, minor injury	-	-	
Damage to property:	Aircraft: Substantially damaged 3rd party: No damage			
Licence and ratings of PIC:	No valid rating			
Medical certificate of PIC:	No valid medical certificate			
Age and citizenship of PIC:	83 years old, Hungarian			
Flight experience of PIC:	Total	On the type	Last 90 days	Last 7 days

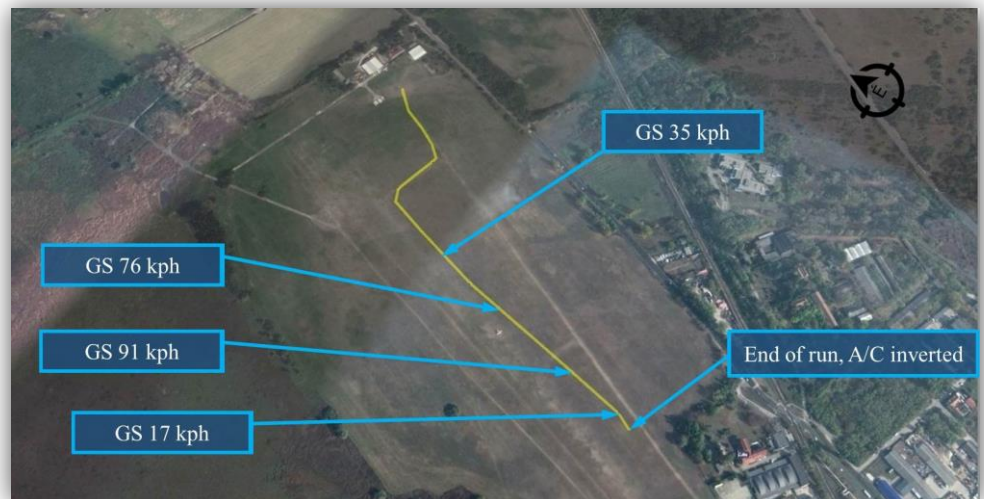
Figure 1 *Hiba! A hivatkozási forrás nem található.*, his track during the take-off run was characterised by an increasing deviation to the left off the runway centreline. During the first 200-or-so metres, which was less than half of the full take-off run, the deviation angle increased from a few degrees to as much as 12 degrees. At the peak of acceleration the speed of the aircraft, as recorded by the onboard GPS, reached 91 kph or more. Based on the low sampling frequency of the GPS, this value could still be increasing past the last point of sampling before the ground speed actually started to drop. Owing to the hard braking at high speed, the nose wheel sunk in the uneven ground and the bolts at the lower end of the nose strut snapped while the nose wheel fork separated from the assembly. With the bare nose strut burying in the soil, the aircraft tipped over and inverted, came to a skidding halt with its air brakes extended.

Figure 1. - Acceleration track and speeds as recorded by the on-board GPS (GS: ground speed, 'É' represents North in the compass rose)

Analysis of flight data recorded by the onboard GPS system revealed the following facts. The total length of the take-off run was 530 metres in total. The aircraft reached VR⁶, which is published in FM⁷ as 60 kph, in a roll not longer than 190 metres⁸. Shortly after, the airspeed reached 64 kph, a safe minimum lift-off speed, which assures adequate lift to keep the aircraft airborne. Past this point the aircraft continued acceleration and not later than covering 270 metres from the beginning of the take-off roll, the ground speed reached 91 kph⁹, which significantly exceeds the published 64 kph stall speed (*refer to Table 1*). Based on the above and considering the fact that the actual take-off mass was about 10% lower than MTOM, it is safe to say that the airspeed associated with adequate lift was readily available as early as covering the first third of the take-off run. Allowing for the low sampling frequency of the track recording, the above calculation can be considered rather conservative.

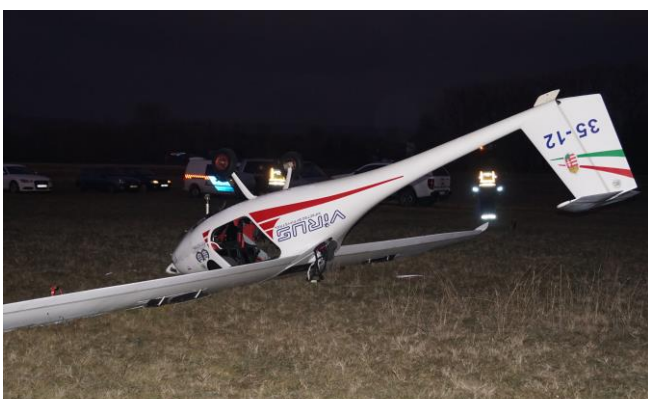
Figure 2. - The aircraft on its back with bent spoilers

The damage sustained by the aircraft is comprised of separation of the nose wheel, destruction of both propeller blades and the spinner, breach of the nacelle and the hull along the tail section and the fuselage. The damage to the airbrake's spoilers mounted on the upper surface of the wings support that they were in the open position during the impact. With the aircraft tipping over, the airbrakes got caught in the soil and being bent forward during the skid, provided further traction to stop the aircraft (Figure 2).
