## Short summary of the occurrence

<b>Occurrence category:</b>	Serious incident			
<b>Date of occurrence:</b>	2 August 2020, 08:15LT <sup>1</sup>			
<b>Location of occurrence:</b>	Farkashegy airfield (LHFH); Hungary			
<b>Type and registration of aircraft:</b>	SF 25E Falke, HA-1227			
<b>Year of manufacture, serial number:</b>	1975, 4312			
<b>Type and number of engines:</b>	Single, Limbach L2000 EA 1			
<b>Purpose of flight:</b>	Non-commercial (training)			
<b>People</b>		<b>Crew</b>	<b>Passenger</b>	<b>Other</b>
	<b>Number:</b>	1	1	None
	<b>Injured:</b>	None	None	---
<b>Damage to property:</b>	<b>Aircraft:</b> Significantly damaged <b>3<sup>rd</sup> party damage:</b> None			
<b>Licence and ratings of PIC:</b>	Valid flight instructor licence and medical certificate			
<b>Age and citizenship of PIC:</b>	60 years old, Hungarian			
<b>Flight experience of PIC:</b>	<b>Total</b>	<b>On the type</b>	<b>Last 90 days</b>	<b>Last 7 days</b>
	<b>Flying hours:</b>	672	93:15	44:50

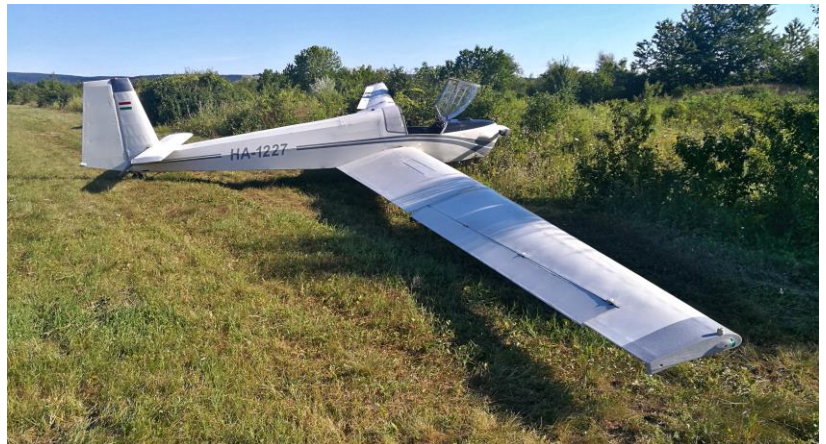
Early in the morning on 2 August 2020, a flight instructor and his student pilot started training flights in a type SF-25E Falke aircraft with registration mark HA-1227 at Farkashegy airfield. They carried out 5 take-offs in the first round on that day, flew traffic circuits and performed emergency tasks. During the first take-off in the second round, both the flight instructor and the student pilot perceived that the aircraft was pulling to the right during climb; the flight instructor took over control of the aircraft and returned to the destination airport. During the landing, the aircraft drifted to the right on the airstrip, then it left the airstrip, its right wing hit a bush and it came to a halt.

*Figure 1: The aircraft after the event  
(Source: the student pilot involved)*

After touch-down, the aircraft ran off the airstrip, crashed to a bush outside the service area and halted after a 90-degree rotation. The aircraft was removed from the scene of the event and carried to a hangar at the airport before the IC arrived. The IC obtained the photos taken by the flight instructor and the student pilot, and those photos indicated the geographical coordinates of the location where they had been shot. Accordingly, the aircraft came to a rest at the spot with the coordinates N47°29'20.59" E018°54'51.36"<sup>2</sup>.

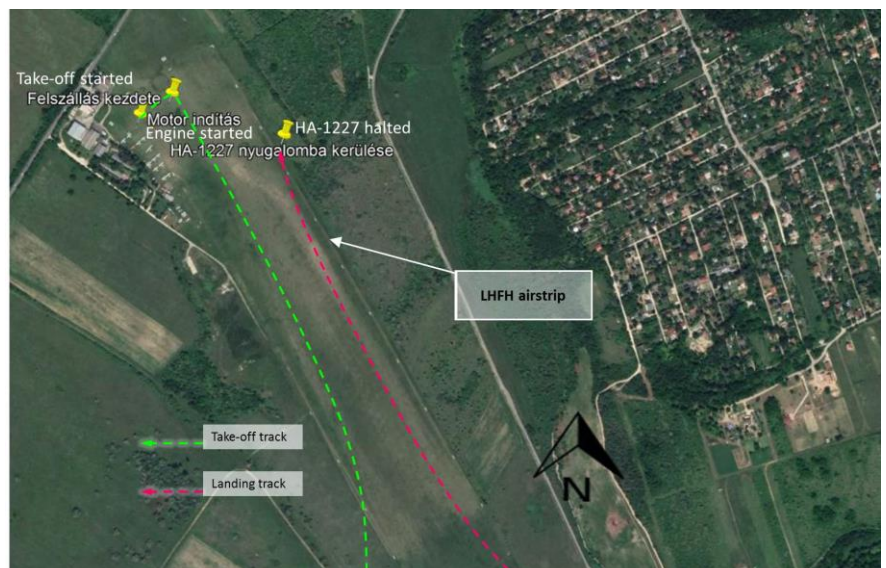
Figure 2: Flight track of the HA-1227  
(Source of map: Google Earth)

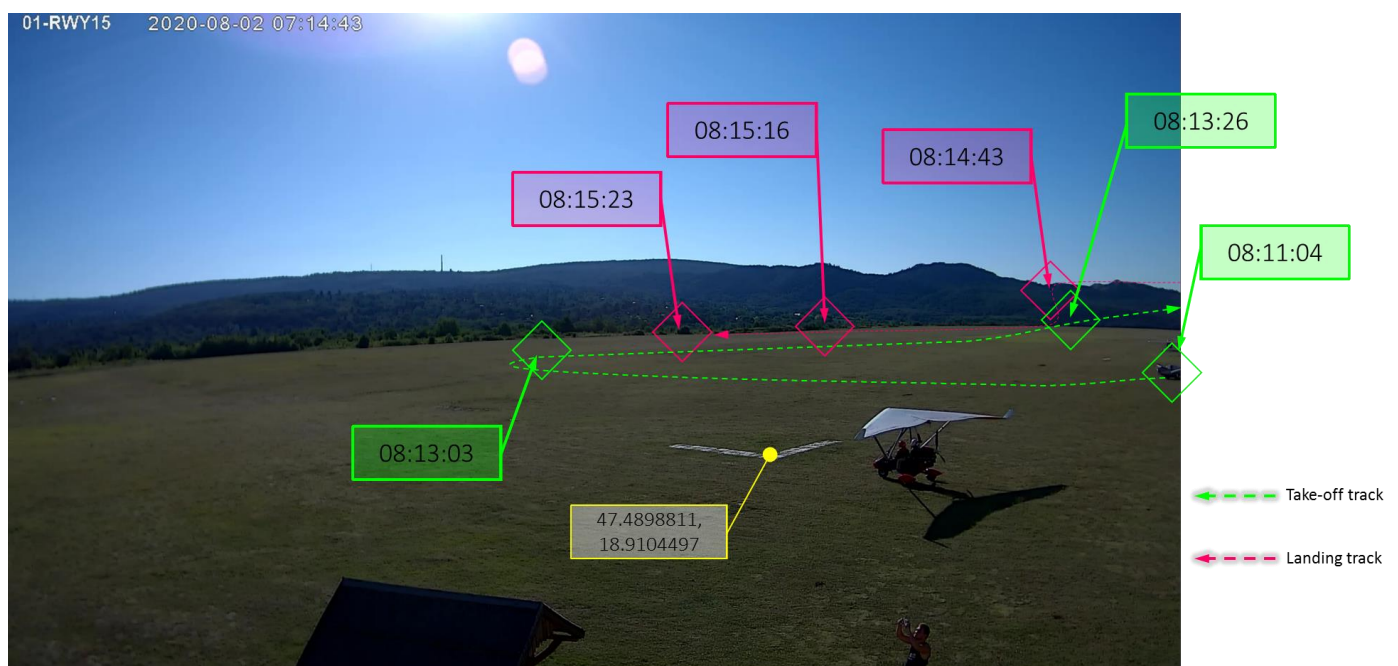
Figure 3: flight tracks of the HA-1227 during take-off and landing  
(Source: surveillance camera records; the indicated times correspond to the time stamp of the camera)

- The engine of the aircraft was started at 08:11:06;
- The aircraft commenced taxiing from its parking space to airstrip 15 at 08:12:14;
- No motions referring to pre-flight check of the aircraft controls can be seen between the time of the engine start and the start of the take-off;

- The aircraft moved in straight line as well in the course of taxiing to the airstrip;
- The aircraft moved in almost straight line from the start of the take-off to its lift-off;

- After lift-off, the aircraft started to fly in a left bank, slightly crosswise (from 08:13:26), and after ca. 20 seconds, it disappeared from the camera view, approaching the right-hand side of the airstrip;

- The aircraft approached the airstrip 33 at an acute angle, from the right, at 08:14:43;
- The aircraft touched down at the RH side of the airstrip 33, with its left wing lower than the other, at a speed higher than usual, at about 08:15;

- At 08:15:22, the aircraft crashed into a bush on the RH side of the airstrip with its right wing, which made it turn 90 degrees to the right and halt.

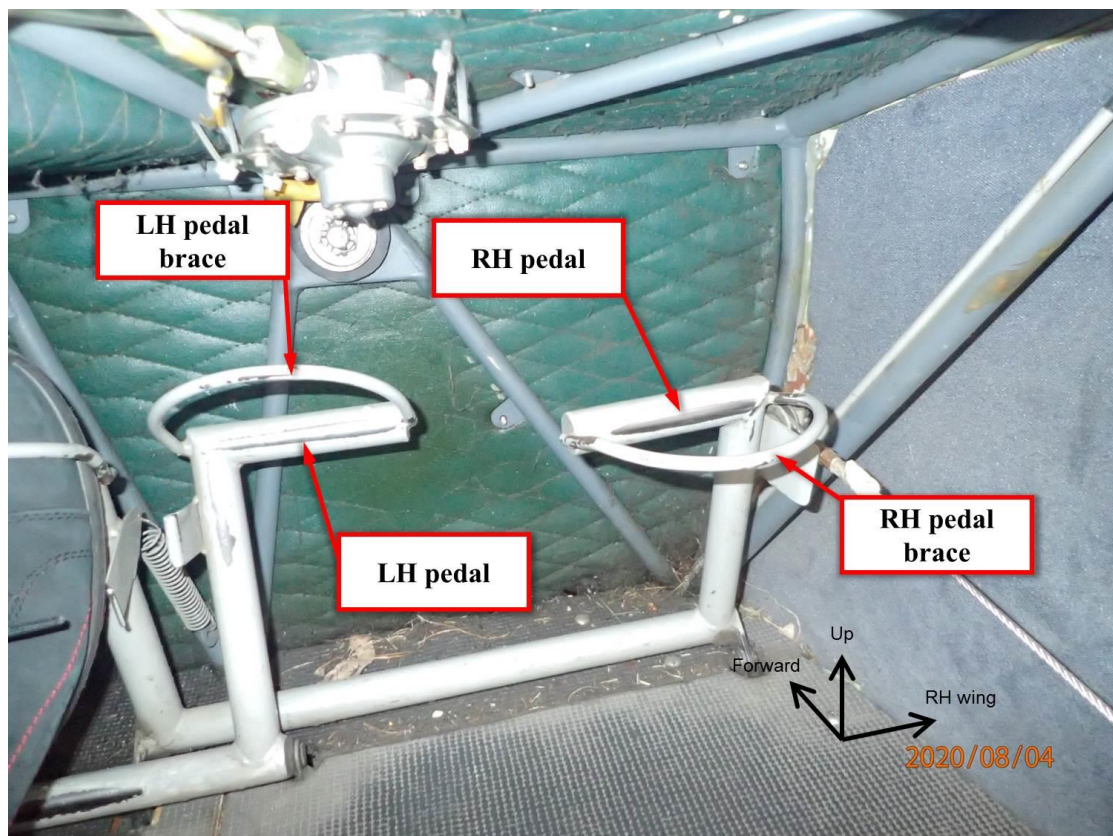
On 10 August 2020, the training organisation held a meeting where the event was analysed in the presence of several flight instructors (including the one involved in the event). As part of the reconstruction of the event, the flight instructor concerned was asked to sit in the aircraft seat and set the rudder pedals in home position. Participants saw that in the pedal position which seemed symmetrical to the flight instructor, the rudder was significantly deflected to the right. In this position of the rudder, the left foot of the flight instructor was on the LH rudder pedal, and his right foot was on the metal brace of the RH rudder pedal (Figure 4). A record of this test was subsequently sent to the IC both by the flight instructor and the training organisation.

The flight instructor's explanation to this phenomenon was that, due to his bodily characteristics, he could not check the balance of the pedals visually and erroneously supposed it was symmetrical.

Figure 4: Rudder pedals for the RH seat of the aircraft

The IC saw no control motions in the records of the airport surveillance cameras which would prove the pre-flight check of the aircraft controls by the aircrew before the take-off of the flight concerned. The pilot did not mention any control anomaly relating to his flights prior to the concerned flight ending up in a serious incident. After the event, the IC examined the controls of the aircraft in the presence of the representative of the aircraft's owner and found no anomaly. The test carried out and documented by the training organisation makes it plausible that when the flight instructor placed his feet on the pedals he did it in an asymmetrical way, thus creating the control anomaly detected.

The position of the IC is that no environmental effects (e.g. wind direction or wind speed) contributed to the event, i.e. the cause event was that the flight instructor had placed his feet on the rudder pedals asymmetrically.

Following the aforesaid flight instructor meeting, the training organisation made all of its contracted flight instructors aware of the lessons learnt from the event.
