## Synopsis

<b>Occurrence category:</b>	Serious incident			
<b>Date of occurrence:</b>	24 January 2021, 15:35LT <sup>1</sup>			
<b>Location of occurrence:</b>	Tököl aerodrome (LHTL)			
<b>Aircraft model and registration:</b>	Diamond DA42 Twin Star, HA-DAJ			
<b>Year of manufacture, serial number:</b>	2006, S/N: 42.139			
<b>Type and number of engines:</b>	Twin-engine, Thielert TAE 125-02-99			
<b>Purpose of flight:</b>	Training flight			
<b>People</b>	<b>Number:</b>	<b>Crew</b> 2	<b>Passenger</b> 1	<b>Other</b> 0
	<b>Injured:</b>	0	0	0
<b>Damage to property:</b>	<b>Aircraft:</b> considerably damaged			
<b>Licence and ratings of Flight Instructor:</b>	PPL(A) <sup>2</sup> , IR(A) <sup>3</sup> , SEP(land) <sup>4</sup> , MEP(land) <sup>5</sup> , FI(A) <sup>6</sup>			
<b>Age and citizenship of Flight Instructor:</b>	64 years old, Hungarian			
<b>Flight experience of Flight Instructor</b>	<b>Total</b>	<b>On the type</b>	<b>Last 90 days</b>	<b>Last 7 days</b>

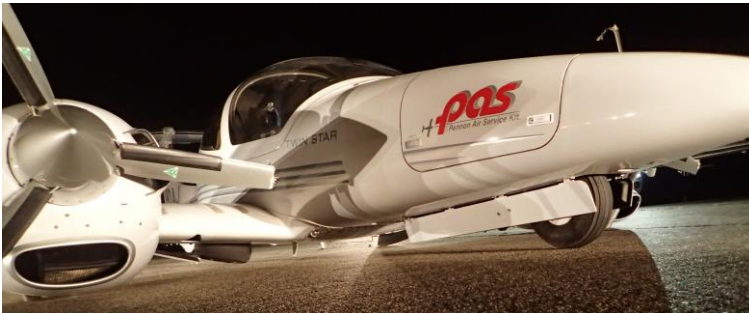
*Figure 1: The aircraft after the event*

and the aircraft carried out belly landing. No one was injured in the event and the aircraft suffered repairable damage. The Investigating Committee of Transportation Safety Bureau, Hungary (hereinafter: “IC”) attributes the cause of the event to human factors. The IC identified no circumstance which would warrant the issuance of a safety recommendation.

After the touch-down, the aircraft skidded ca. 250 metres on the concrete runway. As a consequence, the lower plates of the engine cowls got damaged, the propellers and the steps were destroyed, and the exhaust pipe got damaged, as well as the flaps (the latter to a small extent only).

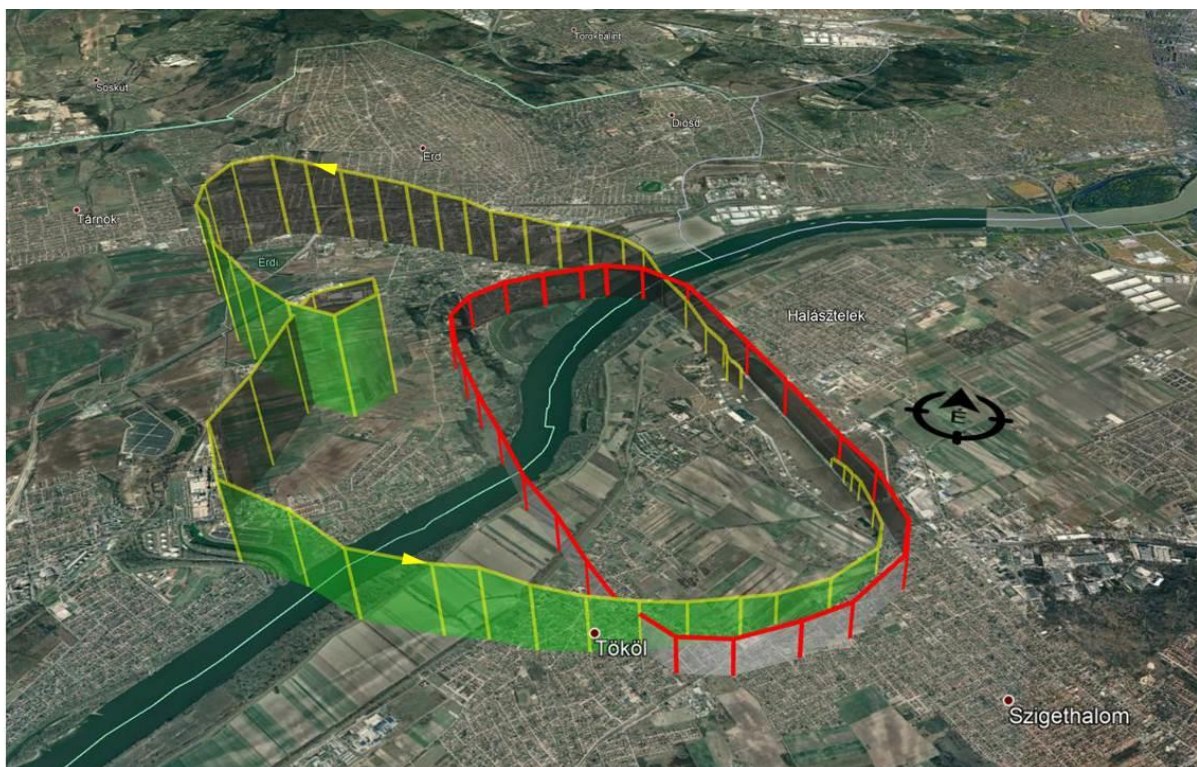
On 24 January 2021, in the afternoon, the Pilot and the Flight Instructor were flying traffic patterns with touch-and-go's on RWY 32 at Tököl aerodrome (LHTL). On the day before the event, the Pilot successfully completed the check flight needed due to a longer break, but she thought she needed more practice to revalidate her ME(IR)<sup>8</sup> rating due on the day after. A novice student pilot of the Flight Instructor occupied one of the back seats of the 4-seated aircraft. According to the Pilot, she did all of the checklist items during her flight. After the third touch-and-go, the Flight Instructor found that the Pilot had successfully corrected her earlier mistakes, and asked the Pilot to let him take over control in order to check the cloud base which was at 3500 feet. Following the takeover, the Flight Instructor left the traffic pattern westward, and after checking the cloud base, he made a radio call about his intention to land then rejoin the base leg of RWY 32 (Figure 2).

Figure 2: Flight track of the HA-DAJ
