MINISTRY OF CONSTRUCTION AND TRANSPORT

FINAL REPORT

Fly-Coop Kft., Beechjet 400A, HA-YFJ
Budapest Ferenc Liszt International Airport (LHBP)
1 March, 2021

2021-0040-4

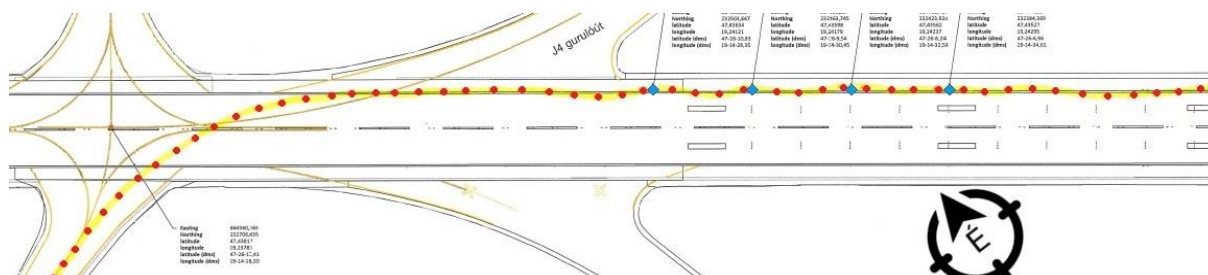
During taxi along the runway edge, the crew knocked down the first and second edge lights beyond intersection J4 with the aircraft's left main landing gear, and the fourth edge light with the nose gear (Figure 14). Approaching the threshold, they executed a right-left turn maneuver to align with the centerline of Runway 31L and took off as per the takeoff clearance. The rest of the flight was not affected by the incident under investigation.

Figure 3: Registered taxi track line of HA-YFJ, with the coordinates of the four affected edge lights

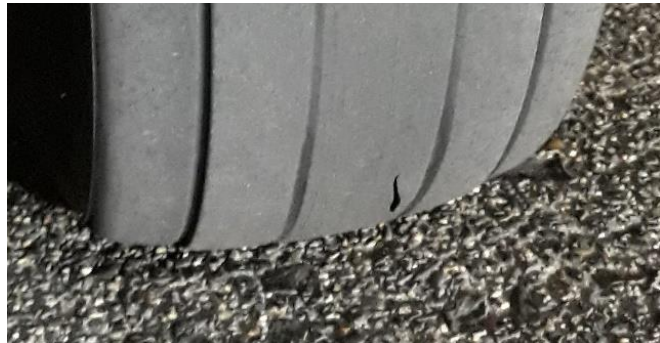
Figure 4. Incised damage on the left tire tread area

- Blunt impact marks on the corners of the left main gear oleo filling plug, which indicate a single frontal impact, rather than rotational, wrench-induced chipping. These impact marks, together with traces of yellow paint transfer, match the damage on light fixture No. 2 (Figure 15).
- A fore-and-aft scratch on the underside of the left main oleo strut, corresponding to the position of the glass dome latch spring arm of light fixture No. 2 (Figure 12).
- Two deep, sharp cuts about half an inch in length on the left tire tread surface. These cuts appear to be incised piercings, likely caused by rolling over broken glass (Figure 4).

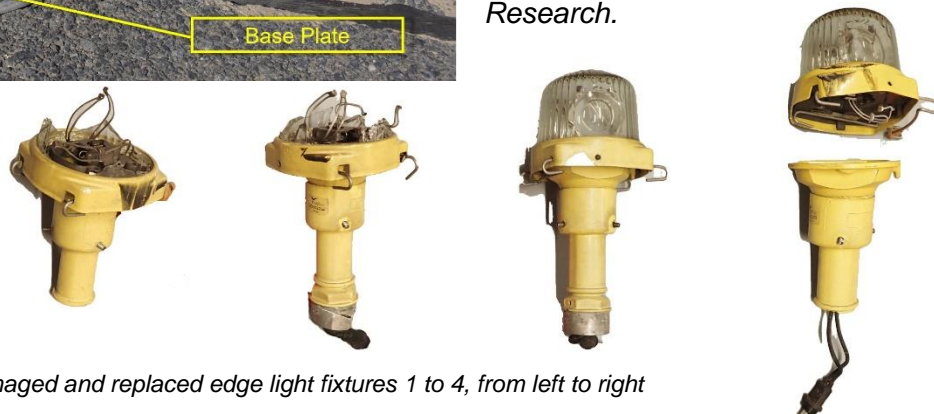
The frangible couplings of the first and fourth edge light fixtures gave way on impact with the tire. Further damage was caused when the lights landed on the runway surface. The second fixture broke off by its stump right below the frangible coupling (Figure 5).

The third fixture was replaced as a precaution. A comparative analysis of damages of the aircraft and the fixtures is provided in Section 1.16 Tests and Research.

Figure 5. The damaged and replaced edge light fixtures 1 to 4, from left to right

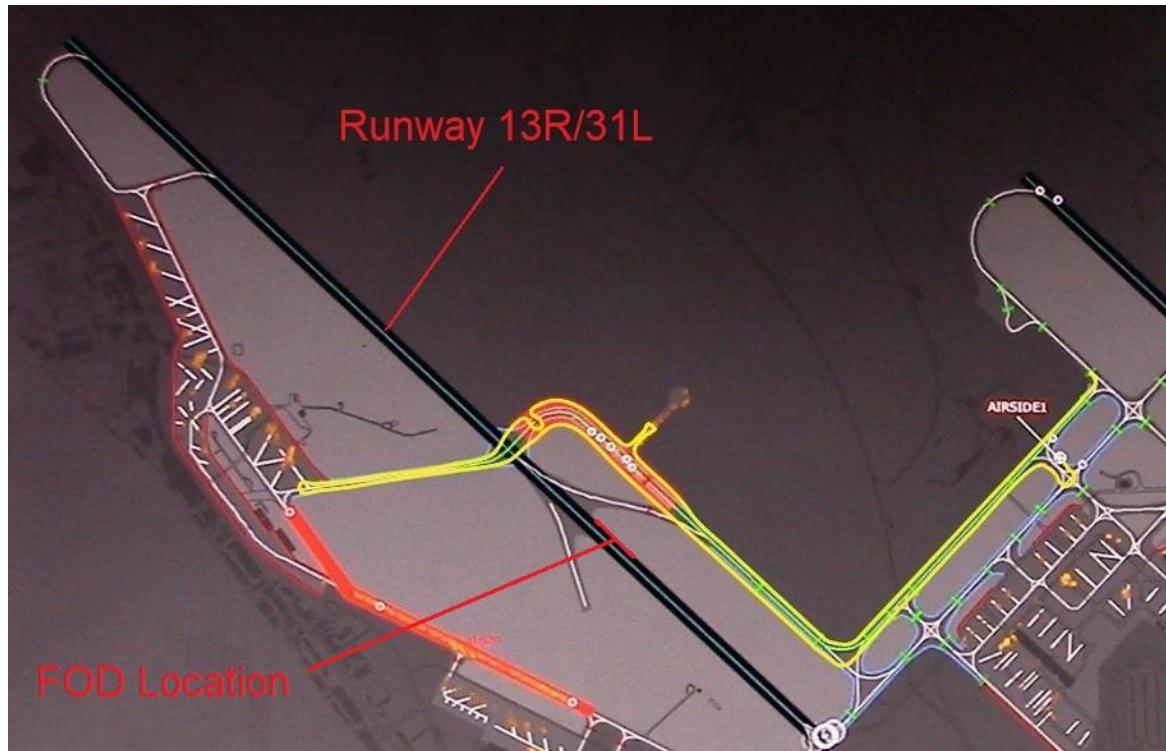
At the time of the omitted runway inspection, inspection personnel drove the vehicle marked 'AIRSIDE1' from the tower to Apron 1 via taxiway B2, which was partially closed and being used as a long-term aircraft parking area. Without stopping on Apron 1, the vehicle turned around and returned to taxiway B5 via the same route (*Figure 8*). The only time the vehicle spent on the runway was during runway crossing. No runway inspection was performed.

Figure 8. Track of the inspection vehicle (AIRSIDE1) during the time of the omitted runway inspection

Since the runway crossing was about 300 meters away from the damage site and the debris scattered on the runway was out of sight in the dark, the broken edge lights were not discovered – again. It took another four and a half hours before the DAM found the debris during the third runway inspection carried out under daylight conditions.

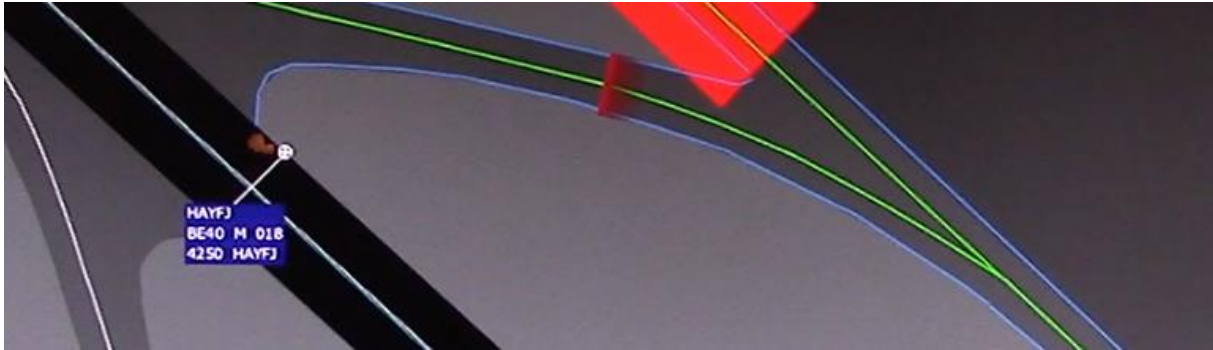
Figure 9. An ATS radar display image of HA-YFJ taxiing on the runway edge at the damage site.
(Source: HungaroControl A-SMGCS data)

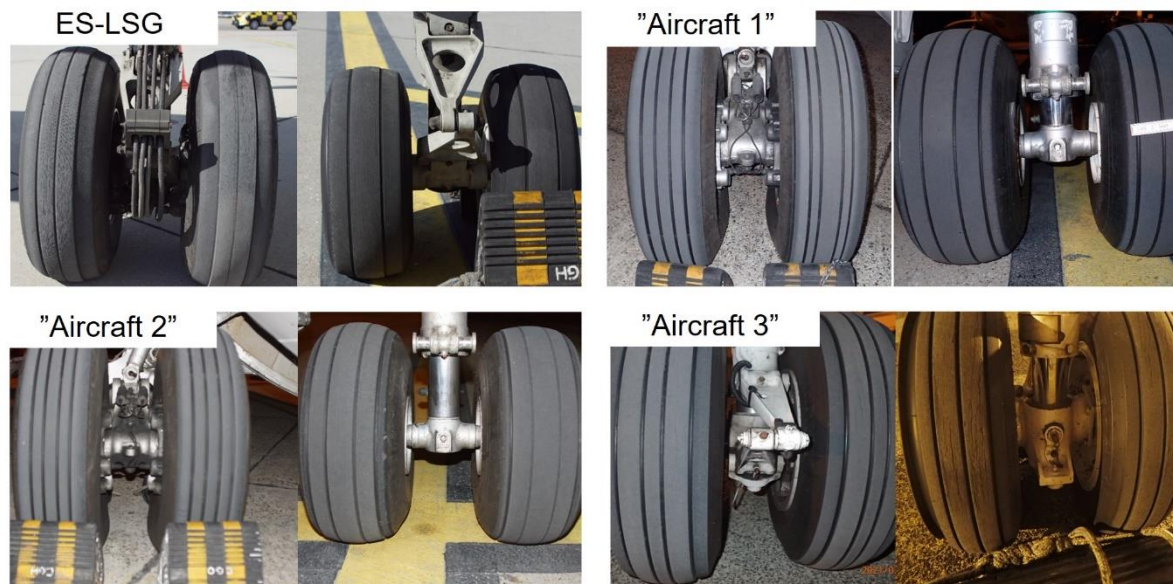
Figure 10. Tread patterns of the aircraft passing by intersection J4 on RWY 13R/31L between 08:00 and 13:30. (left: main gear, right: nose gear on each pair of photos)

These patterns were compared with the tread marks found on the steel base plates of the damaged edge lights (Figure 11), but no matches were found. Furthermore, the data from the Saab 340's FDR, processed in the meantime, confirmed that this aircraft (ES-LSG) was already airborne before reaching the location of the affected edge lights, and passed 150 feet above the first one. Additionally, its tire tread patterns were markedly dissimilar from the recorded tread marks. Consequently, this aircraft was excluded from further investigation.

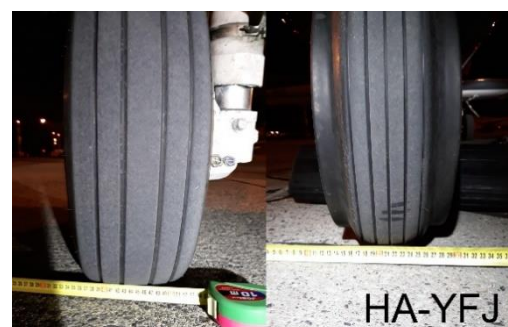
Figure 12. Main and nose gear treads of HA-YFJ. (Left: main gear, right: nose gear)

gear tires both show an exact match to the tire marks collected from the base plates (*Figure 11; Figure 12; Figure 16; Figure 17 and Figure 14*). Additionally, a minor scratch on the left main oleo strut corresponded to the type of damage that could be caused by a dome latch spring arm of HIEL No. 2 (*Figure 13*).

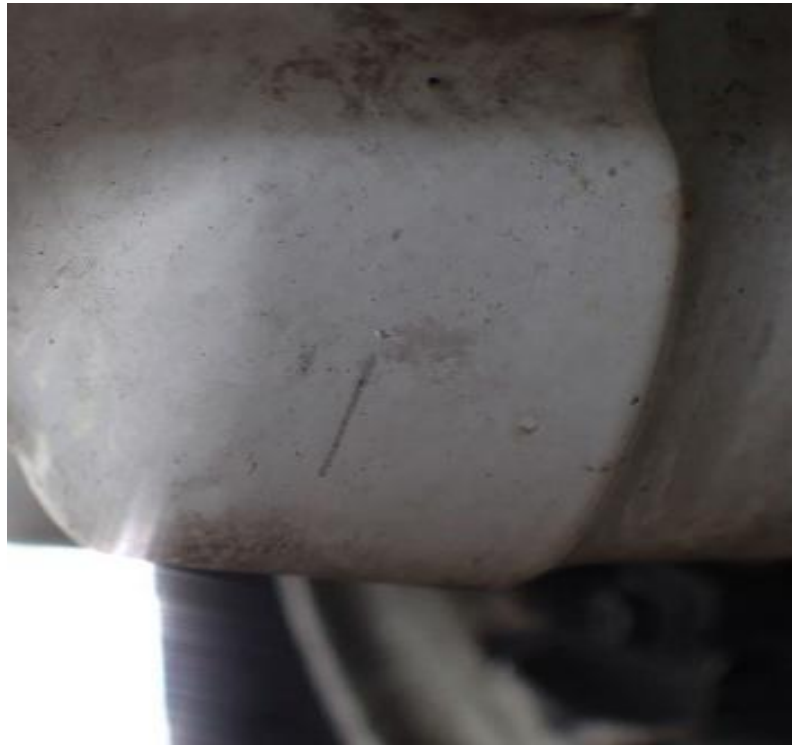
Figure 13. Scratch on the underside of HA-YFJ's left main oleo strut.

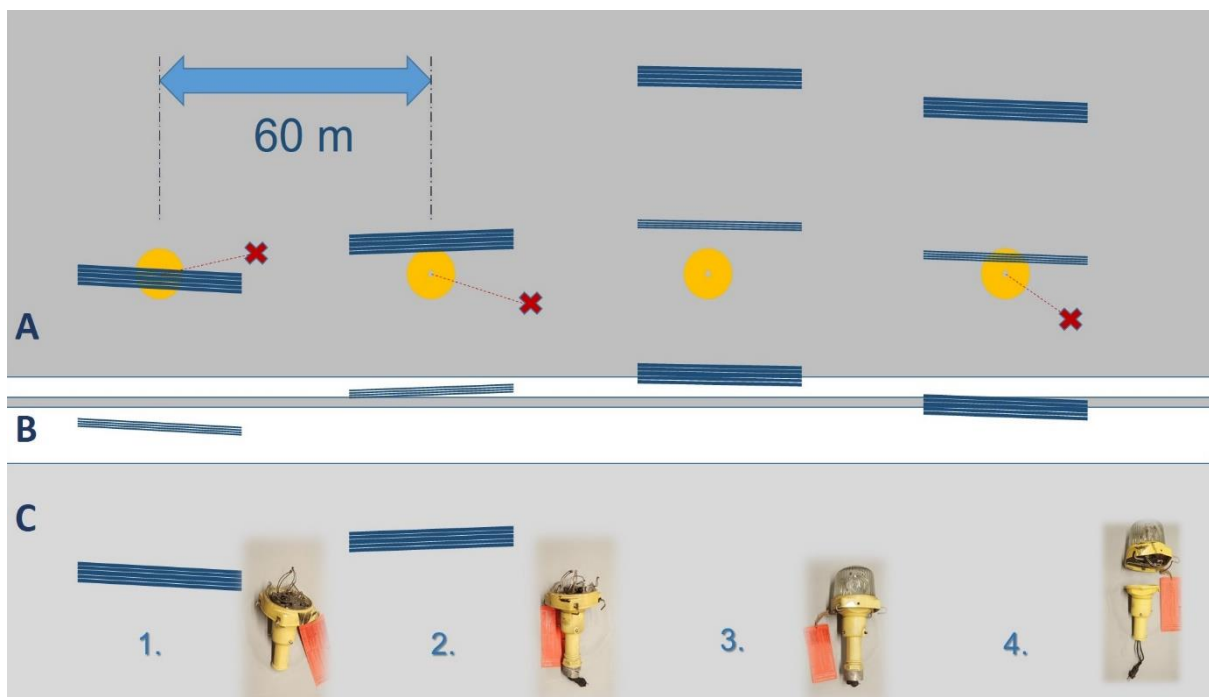
The angles and directions of the tread marks found on the base plates also aligned with the corresponding segments of HA-YFJ's recorded ground track (*Figure 3 and Figure 14*).

Figure 14. Aircraft heading angles at the affected edge lights.
 Note: distance intervals between the lights are not to scale. Taxi direction: left to right.
 A: Shoulder Surface; B: Runway Edge Line; C: Runway Load Bearing Surface

Figure 14 demonstrates the direction of each taxi path segments at the affected edge light locations. These track segments are recreated from A-SMGCS data (Figure 3) and the angles of tread marks found on the base plates. The red 'X' marks indicate where the knocked-down light fixtures ended up following the impact, and the red dashed lines, originating from their installed positions, indicate impact vectors.

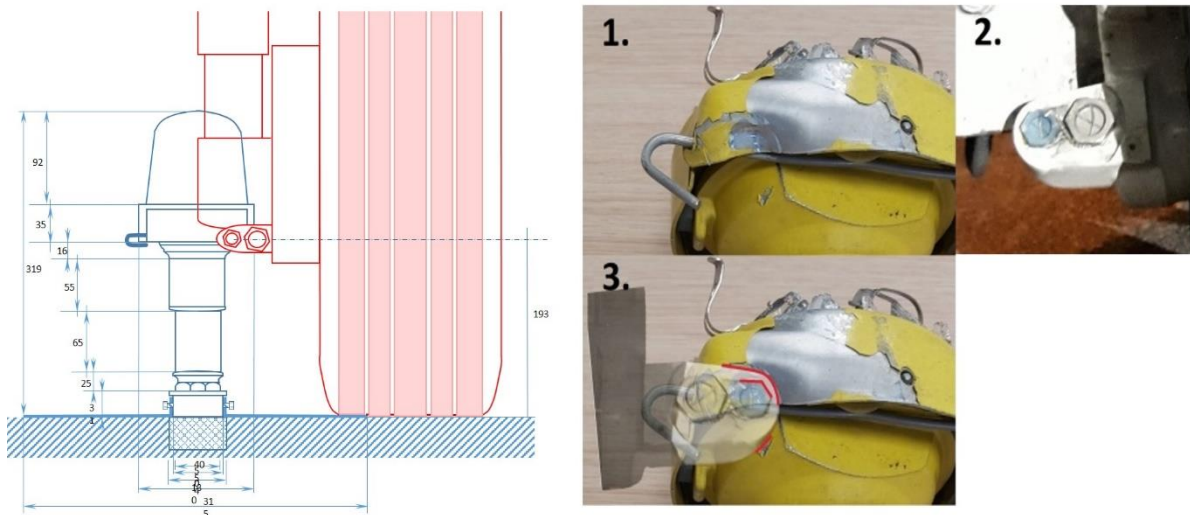
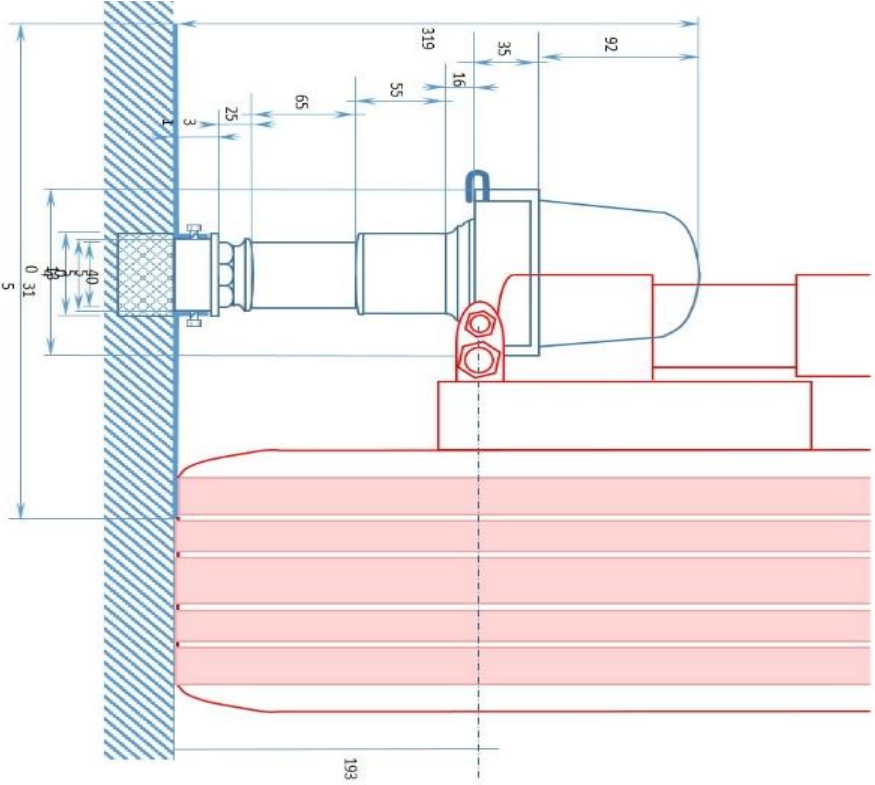
HIEL No. 1 was hit by the left main landing gear tire (Figure 17) going across the middle of the base plate. HIEL No. 2 was impacted by the left oleo strut (Figure 15), with the tire rolling over the last few inches at the edge of the base plate. HIEL No. 3 went between the nose gear and the right main gear, sustaining no damage. HIEL No. 4 was knocked over by the nose wheel tire (Figure 17).

The damage to the aluminum side skirt of HIEL No. 2 showed a distinct and exactly matching impression from a protrusion on the left main oleo strut, with details corresponding down to the tightening angle of the oil filling plug (Figure 15).

Figure 15. Correspondence of damage on the left main oleo strut and HIEL No. 2.
Left side: identical heights of the left gear's oil filler plug and the damage on the light.
Right side: 1. Damage on the fixture; 2. Strut protrusion with the filler plug; 3. Overlay of 1. and 2. – imprint characteristics of the oleo strut parts left on the fixture highlighted in red.
 (Image enlarged in Appendix 1.)

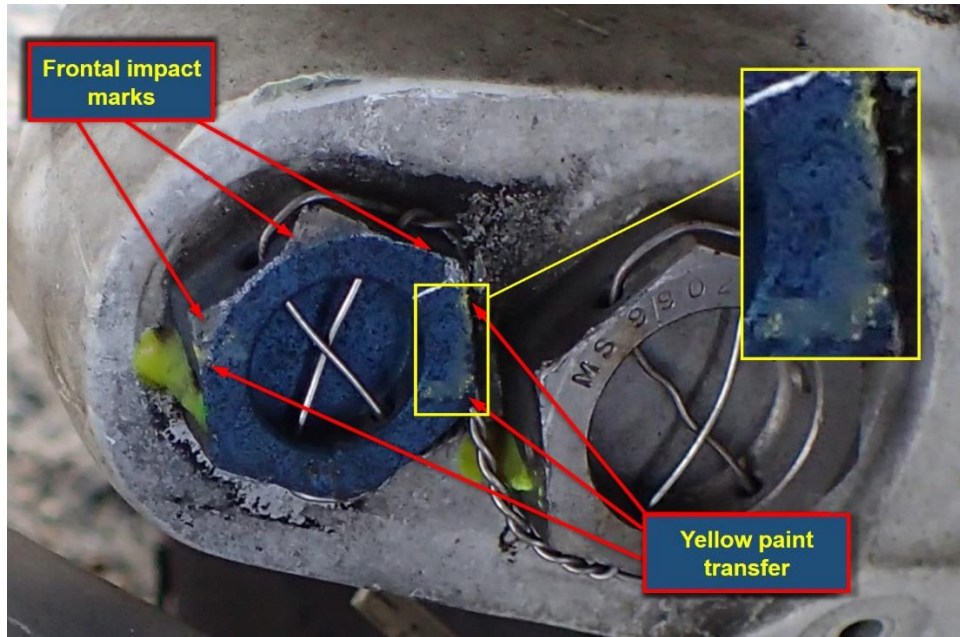
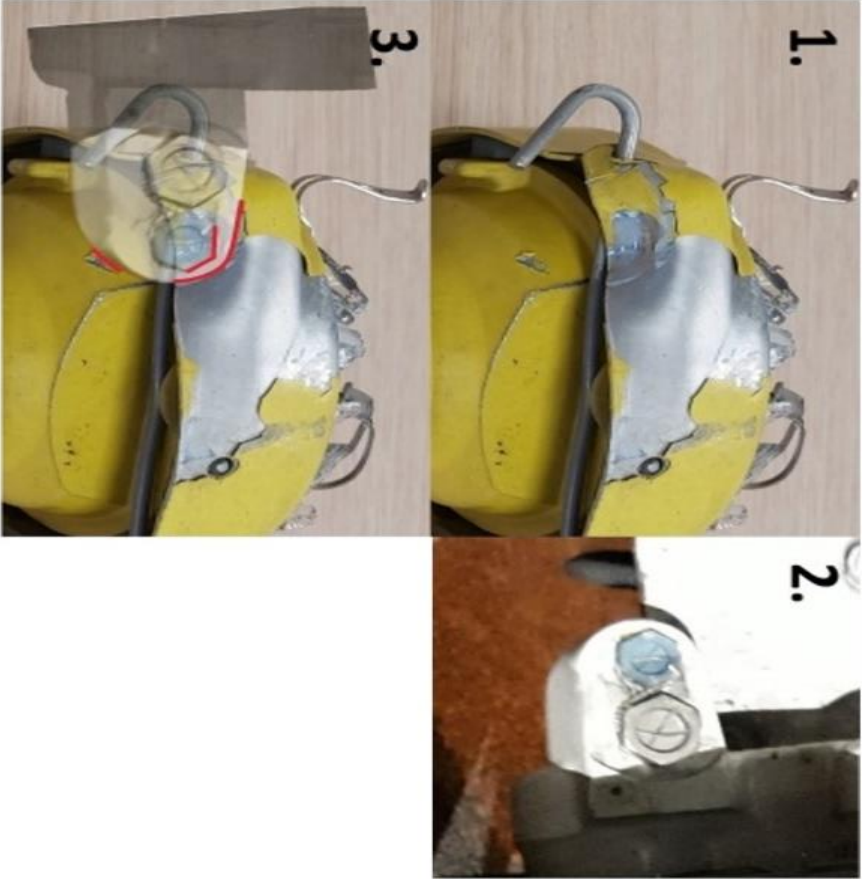
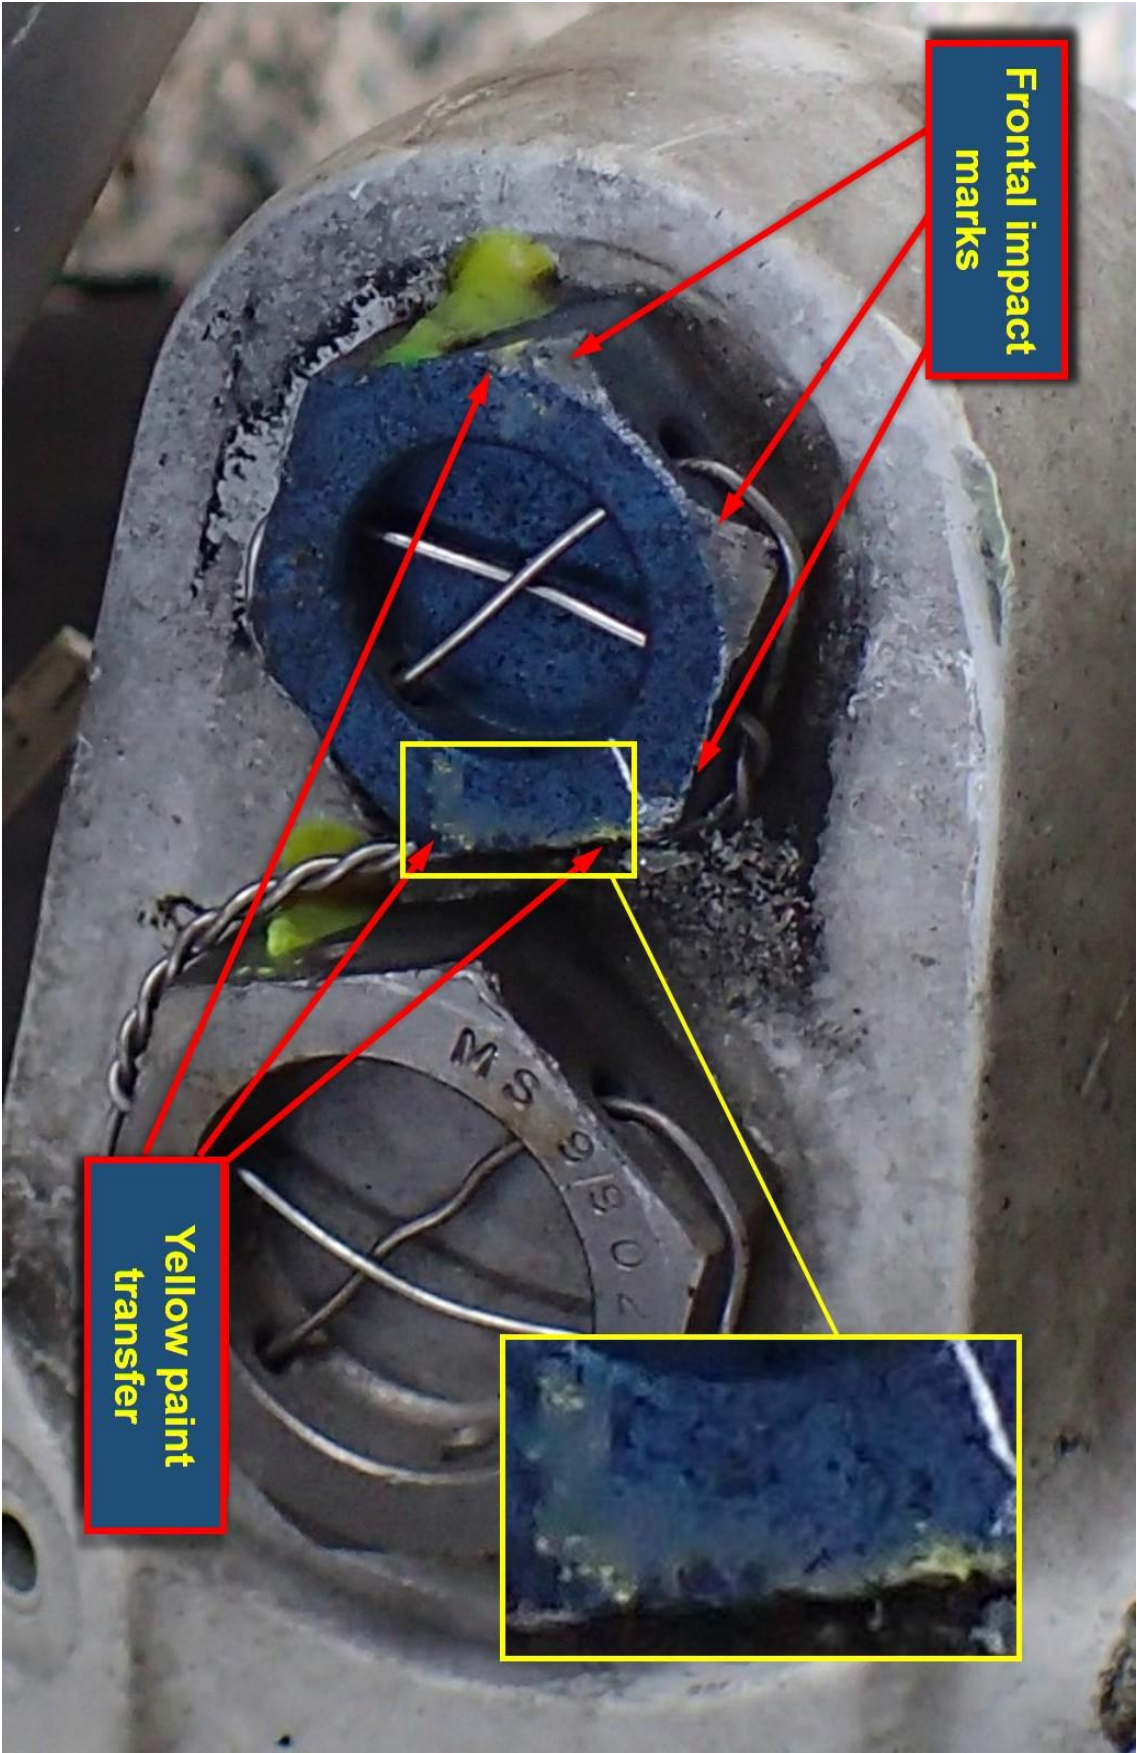
Figure 16. Frontal impact marks on the oil filling plug and paint transfer from the light fixture.
(Image enlarged in Appendix 1.)

Yellow paint transfer from the edge light was also located on the impacted face of the oil filling plug (Figure 16).

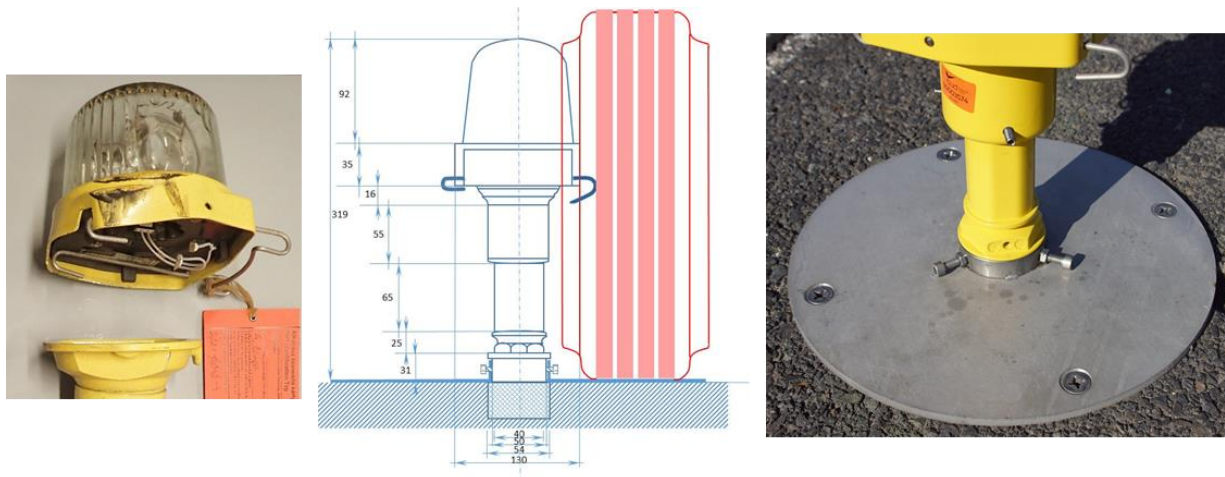
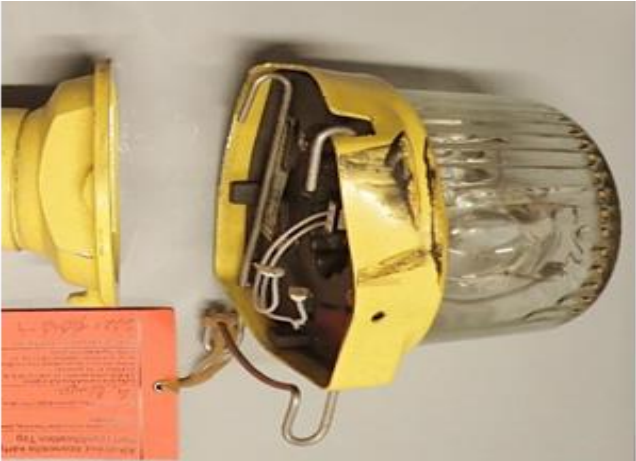
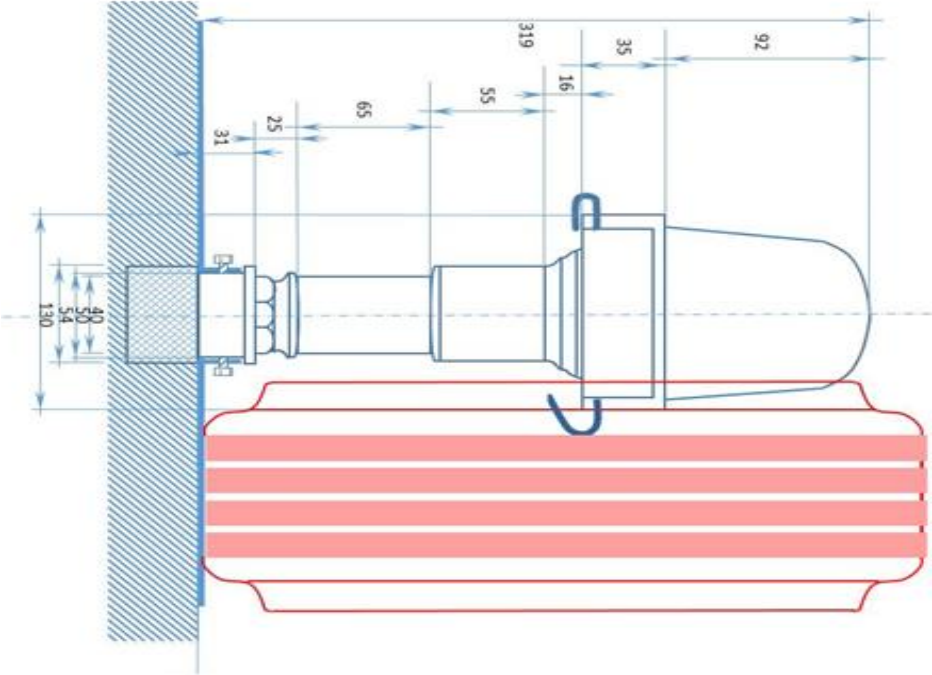
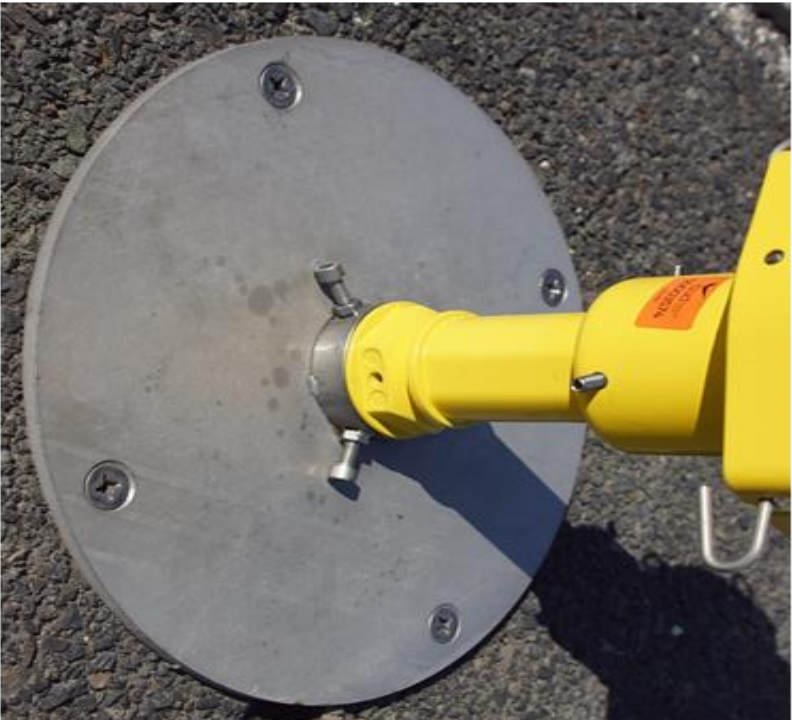
The tire track across base plate No. 4 was a precise match for HA-YFJ's nose gear, and for this single gear only, of every aircraft entering the runway during the scrutinized period. The rubber scuff mark left on the light fixture's side skirt when it was knocked down also matched the height and flanged design of this nose wheel (Figure 17).

Figure 17. HA-YFJ nose wheel and tread marks found on HIEL No. 4.
(The right side image shows the tire track across the base plate and a fixture that has been restored following the incident. Image enlarged in Appendix 1.)

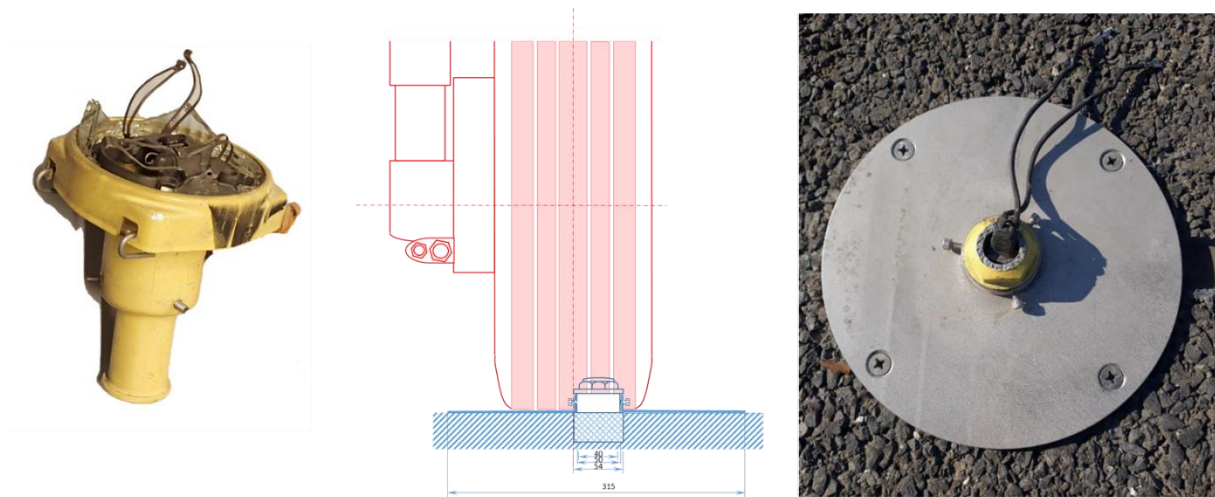
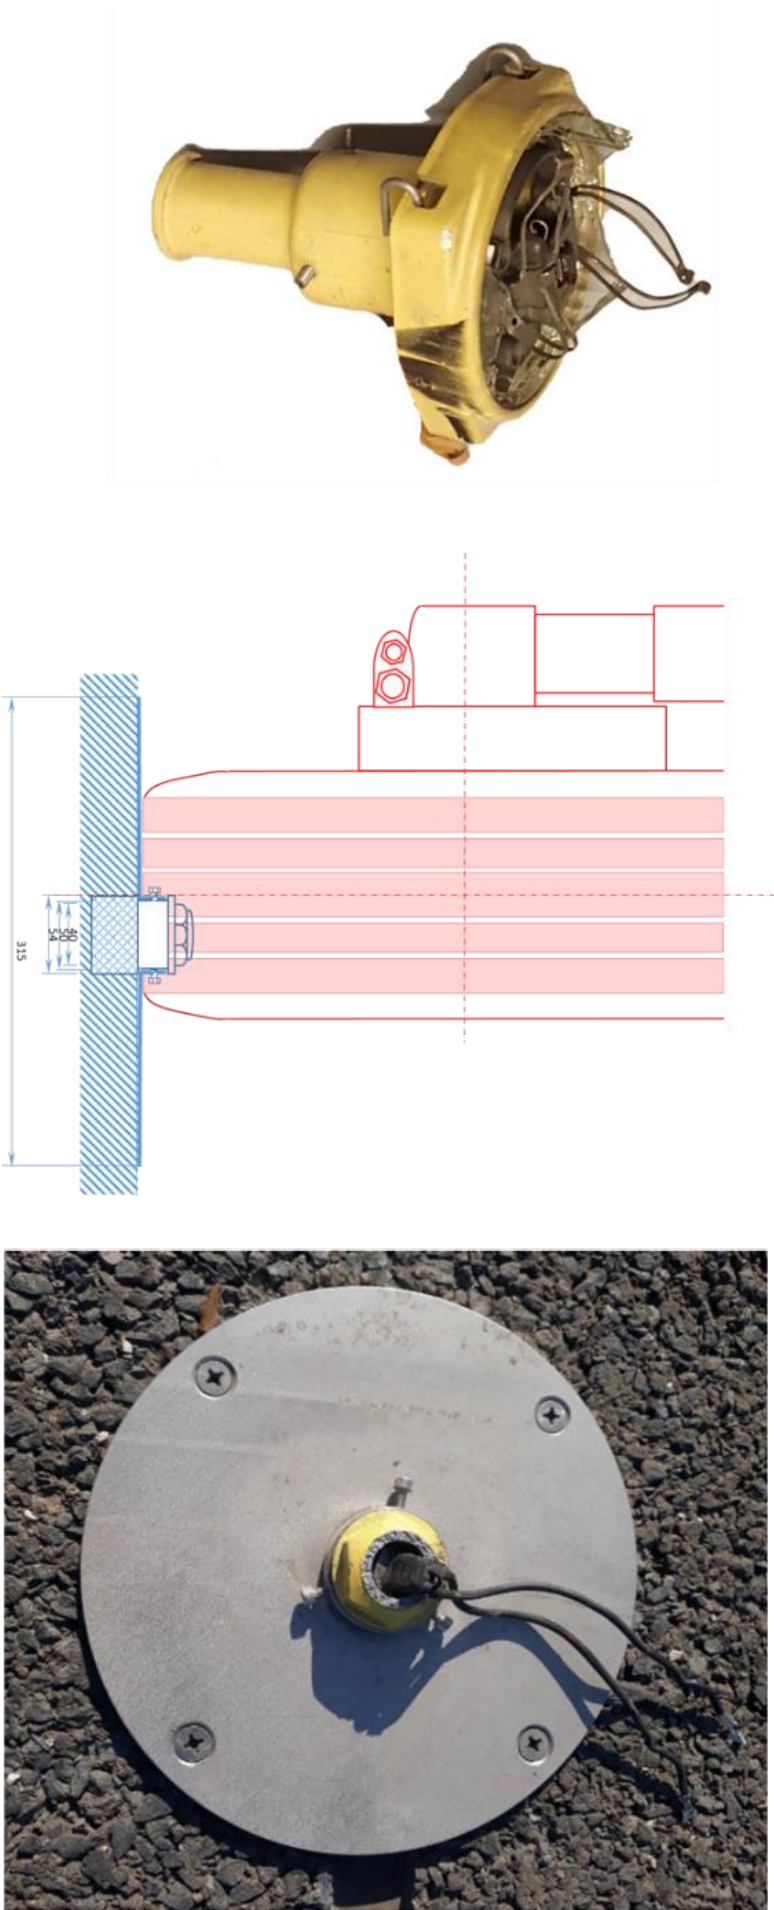
Figure 18. Tread marks on the HIEL No. 1 base plate matching HA-YFJ's left main gear tire.
(Image enlarged in Appendix 1.)

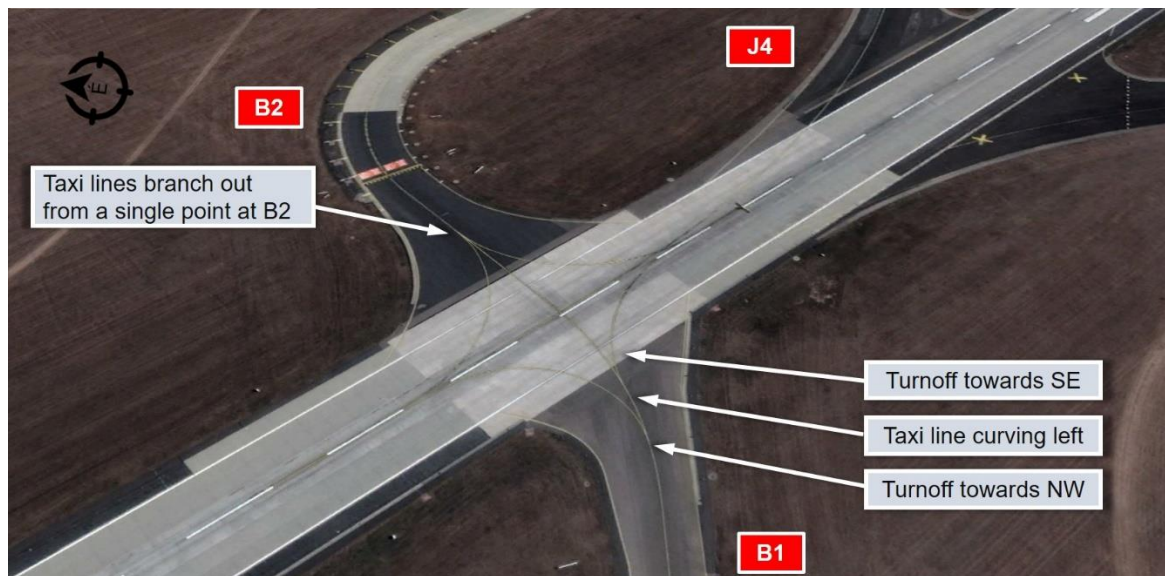
- The low-laying domes of the centerline light fixtures are not visible from the runway edge after dark.
- In contrast to the symmetric geometry of turnoffs branching out of Taxiway B2 in a single point, taxi lines branching out of Taxiway B1 towards NE and SW separate consecutively, with each turnoff initially starting to the left (*Figure 19*).

Figure 19. Aerial view of intersections B1, B2 and J4. (Source: Google Earth)

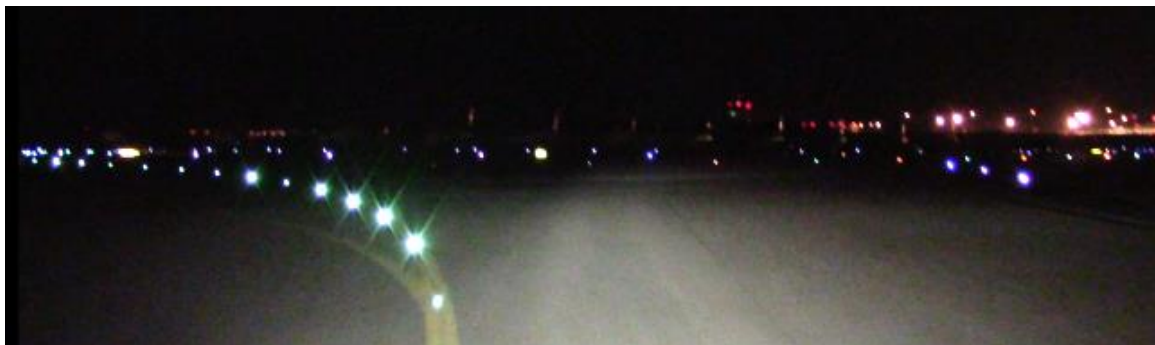
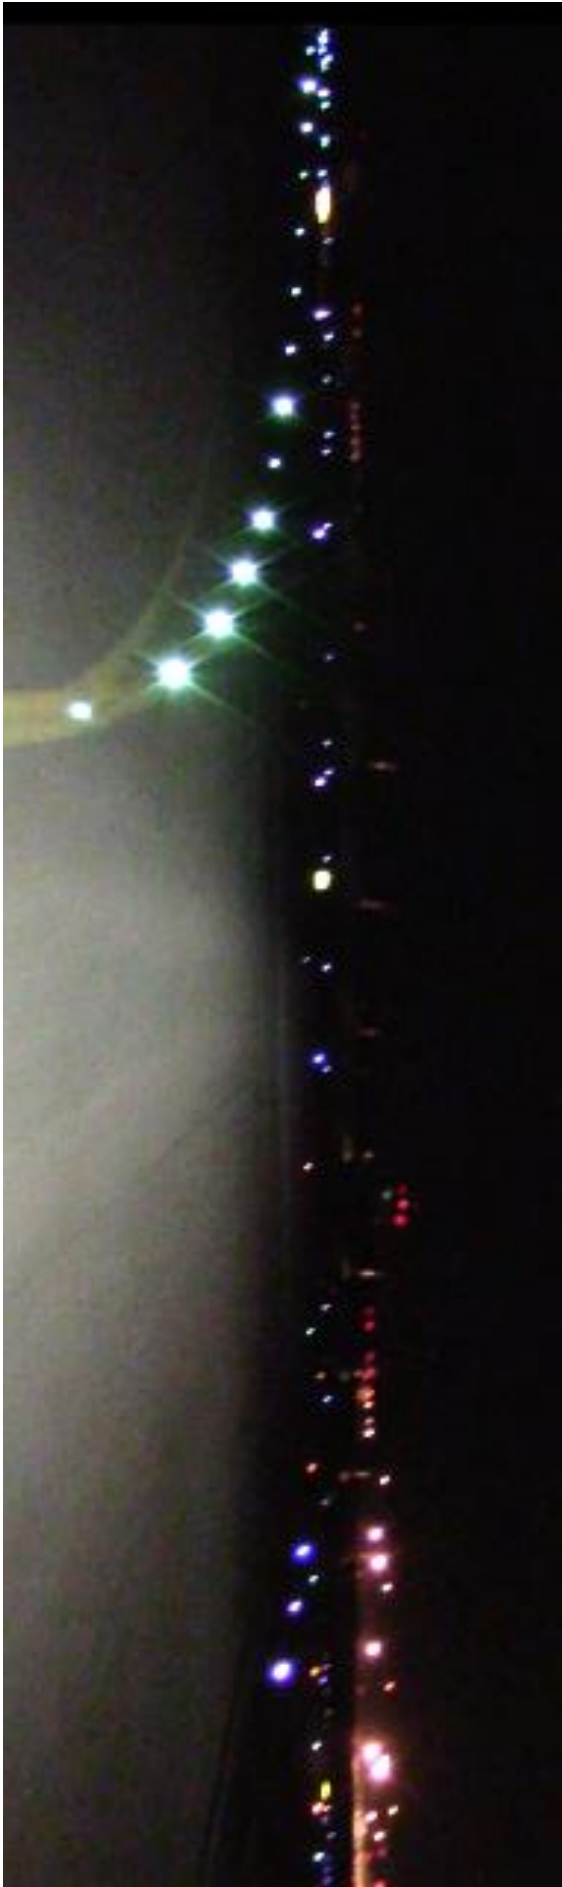
- Of the three diverging taxi lines after B1, only the middle one, leading across the runway to B2, is illuminated, and it begins with a wide left turn. The taxi line branching off to the right towards threshold 31L can only be glimpsed after initially following the lights turning left (Figure 20).

Figure 20. Taxi line turnoffs from Taxiway B1 towards NW and SE, all starting to the left. (Source: TSB Taxi Reconstruction. Image enlarged in Appendix 1.)

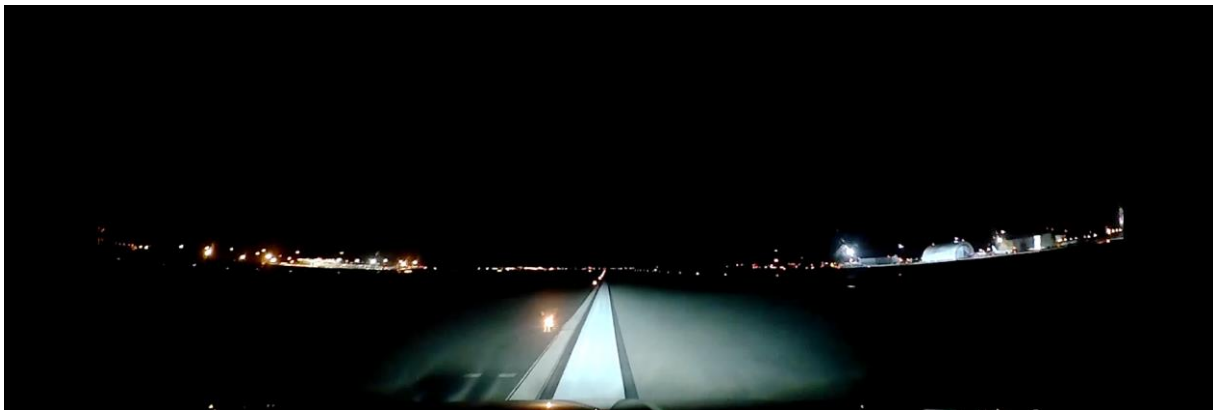
- The 7.5-meter-wide asphalt shoulder outside the runway edge line is of a darker color compared to the concrete load bearing runway surface. However, this difference is not as conspicuous in the dark though as it is in daylight conditions (*Figure 21*).

*Figure 21. Nighttime visual difference in the color of the concrete runway surface and the asphalt.
(Source: TSB Taxi Reconstruction)*

The surface of the concrete runway is of a lighter shade than the asphalt shoulder, which is quite visible in daylight conditions, but it is not as noticeable after dark.
